**CROWN CAPITAL ENTERPRISE
LIMITED**

**Demonstration of RJSeal™
Estrada de Pac On,
Taipa, Macao,
Peoples Republic of China**

March 2004

**TS² Consulting Inc.
Lamma, Hong Kong**

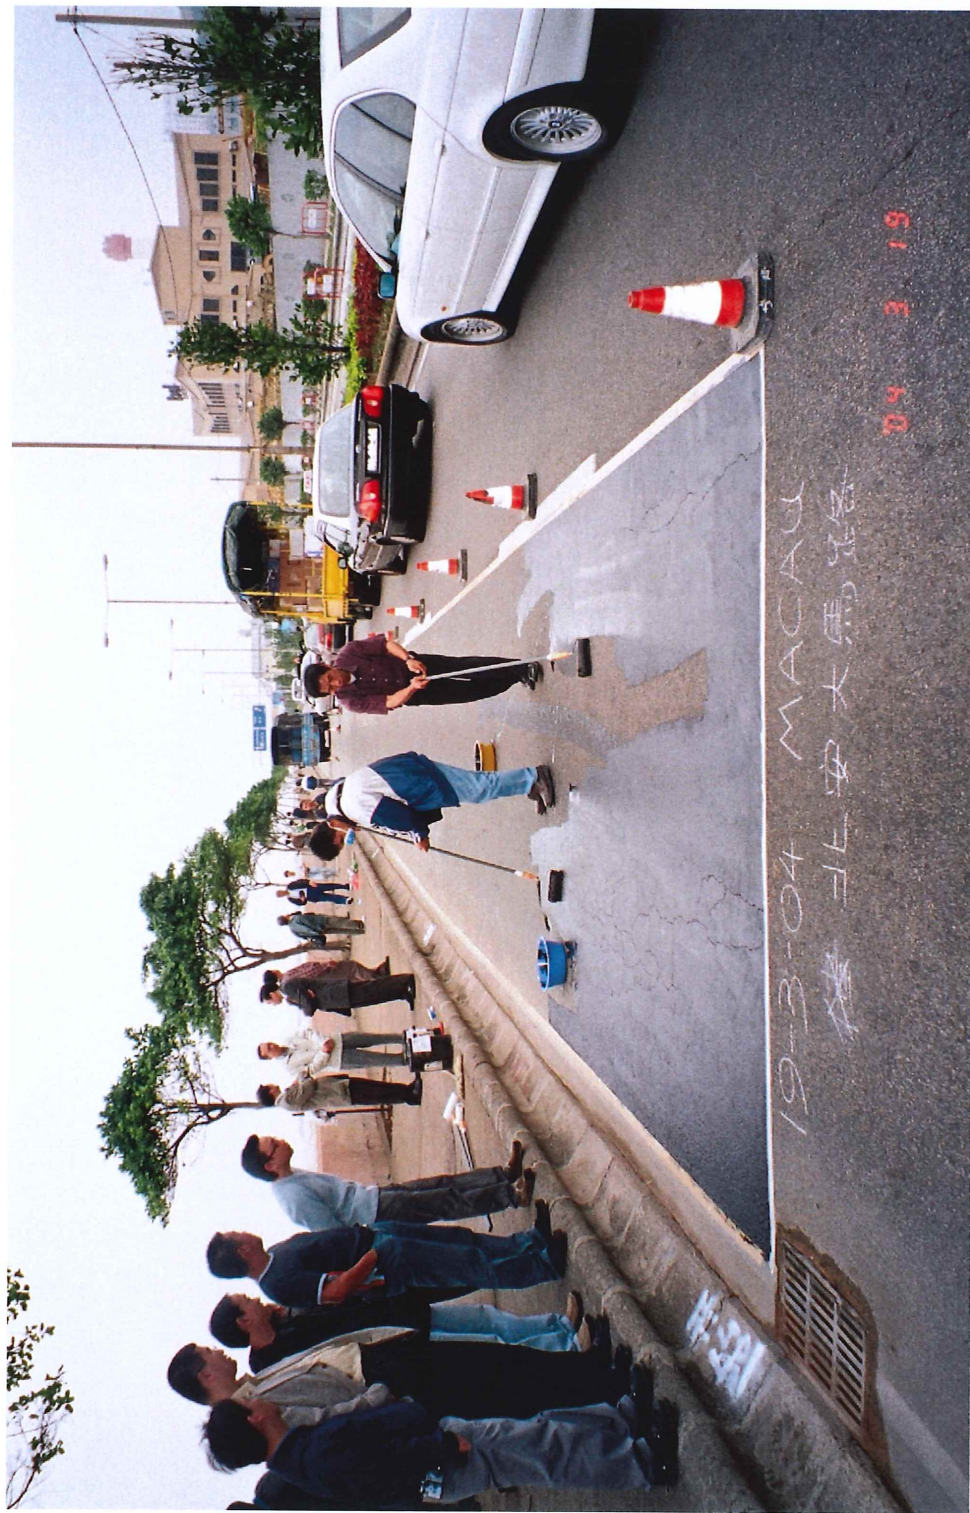
Figure 4.1 Typical Application Procedure for RJSeal

On March 19, a test strip, some 100 metres in length was marked off in the eastbound, curb (outside) lane. The width of this eastbound lane is 3.2 metres between the painted shoulder lane and the center center dividing line, which had a small shoulder portion. The RJSealTM was applied to each of the panels, using paint rollers and plastic pails.

Ambient temperatures at the time of the application were in the 23 degree Celsius range, with humidity in the 50% range. The application ceased at 12:30 am and the lane remained closed until 4:00 pm on March 19, when it was re-opened for traffic. Photos showing the test application of RJSealTM follow in figures 4.1, and 4.2 and on the following pages.

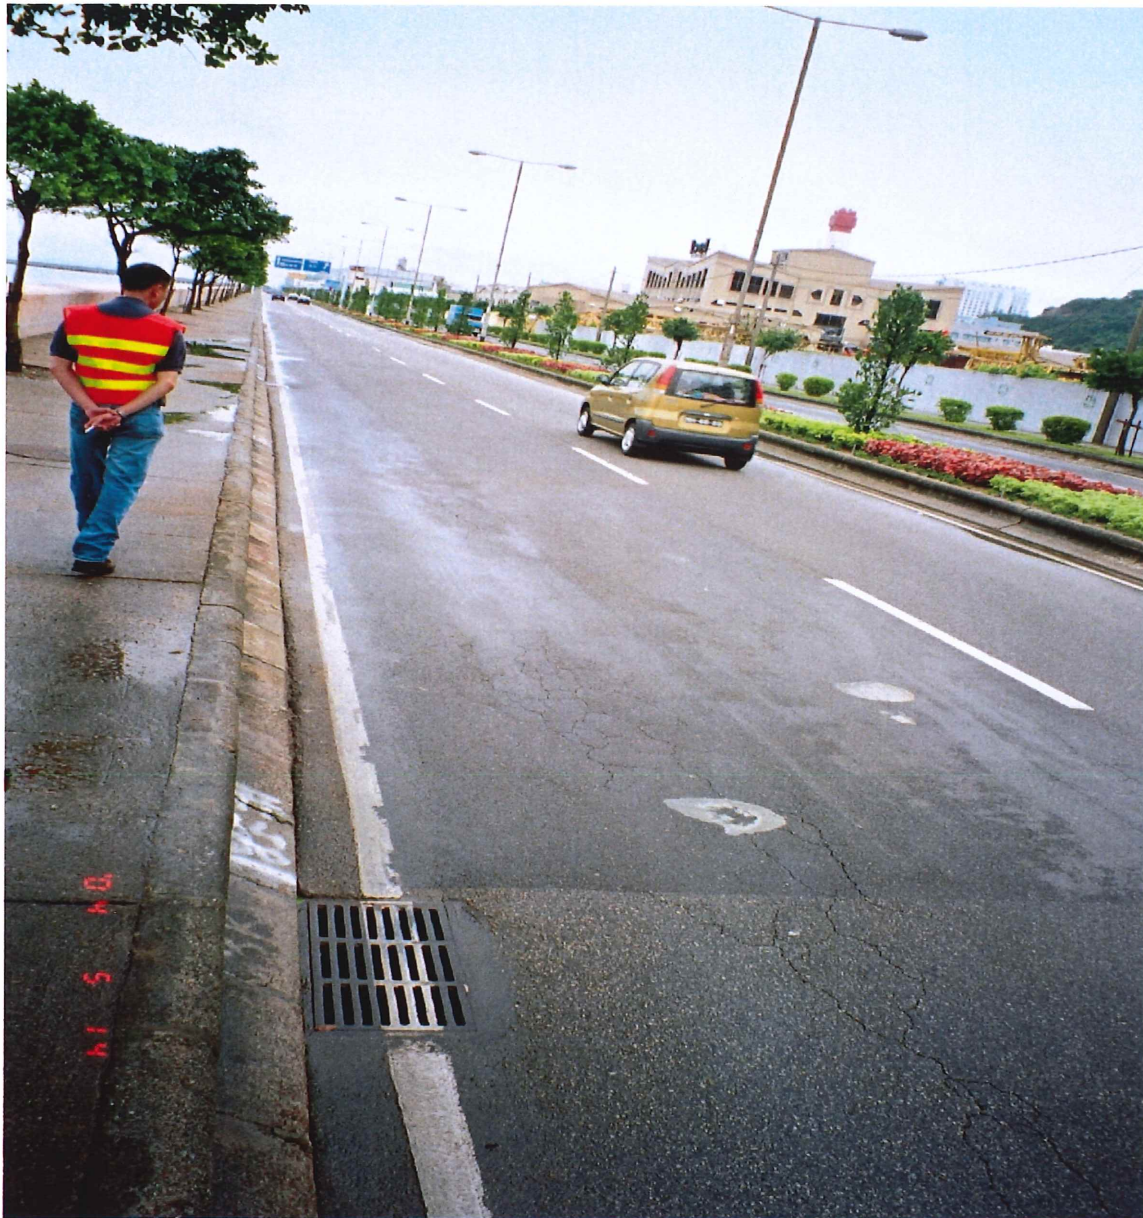
Figure 4.3 Inspection of Road -
Two Months After

The site was visited on May 10, 2004 around 2:00 pm and a difference

was readily perceived between the RJSeal™ treated section and the adjoining untreated portion. A screwdriver was used to dig two small holes in the asphalt pavement, to a depth of 3 centimetres, some 10 metres east of the start point (west end) of the demonstration (test) section, to determine the penetration of the RJSeal™. This was two months after the application of RJSeal™ and at these two locations the newly rejuvenated surface was evident, by the black resilient surface layer, which was now approximately 4 millimetre thick. Below that depth, the grey, oxidized layer of asphalt was evident. See figure 4.3 for details on the road on the inspection.

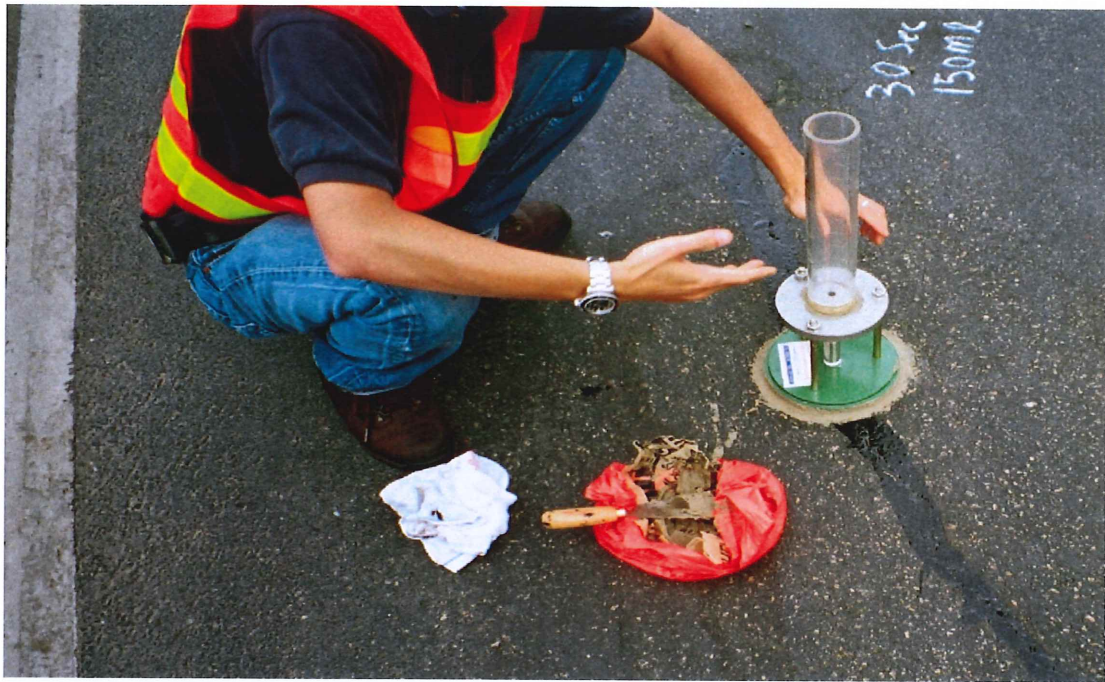
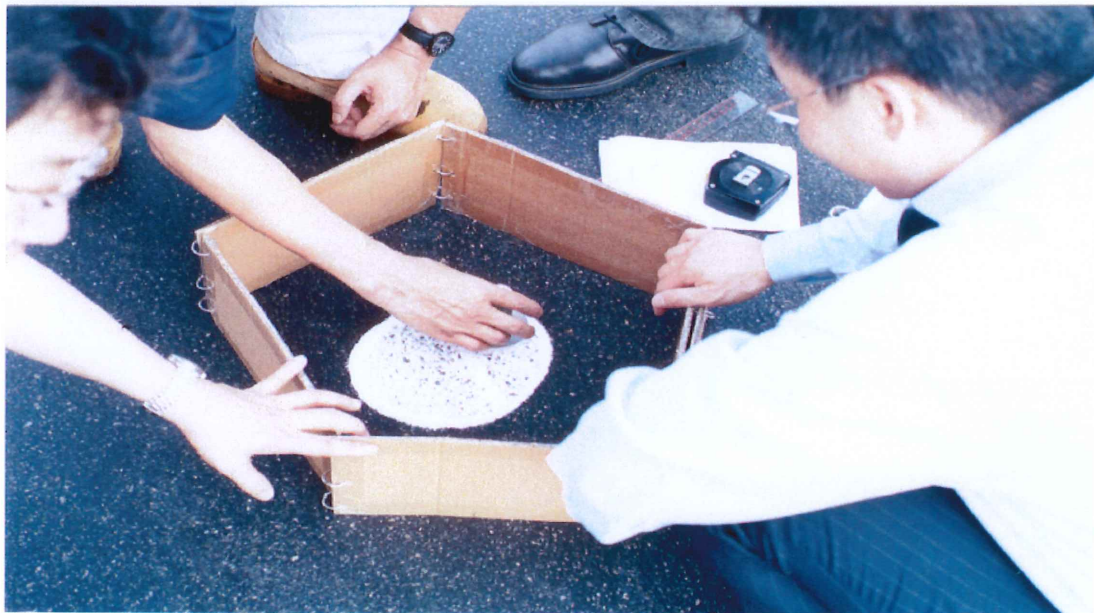
Figure 4.5 Water Penetration
& Sand Patch Test

Water Penetration Tests (China Testing Standard T 0730-2000) were undertaken at several locations on the RJSeal™ treated section and the adjoining untreated portion of the road, in close proximity to the Outflow meter tests on May 10, 2004. The results are shown in the following table.

Note: (1) Located on a "new" (i.e. since original RJS application on March 19, 2004) crack in pavement. Crack filler subsequently applied on May 14 and test (refer latter two tests) re-done with resulting "zero" inflow

The sand patch test (ASTM Standard E965-96 OR China Standard T 0961-95) was used to ascertain the Pavement Macrotexture Depth. Comparison was undertaken at several locations on both the untreated and RJSeal™ treated sections in close proximity to the Outflow meter tests. The results are as follows:
