**Demonstration of RJSeal™  
ShiDa Road, Hangzhou, ZheJiang,  
Peoples Republic of China**

**December 2005**

**TS² Consulting Inc.  
Lamma, Hong Kong**

Re: Inspection of RJSeal Demo Section – ShiDa Highway – Hangzhou, Zhejiang

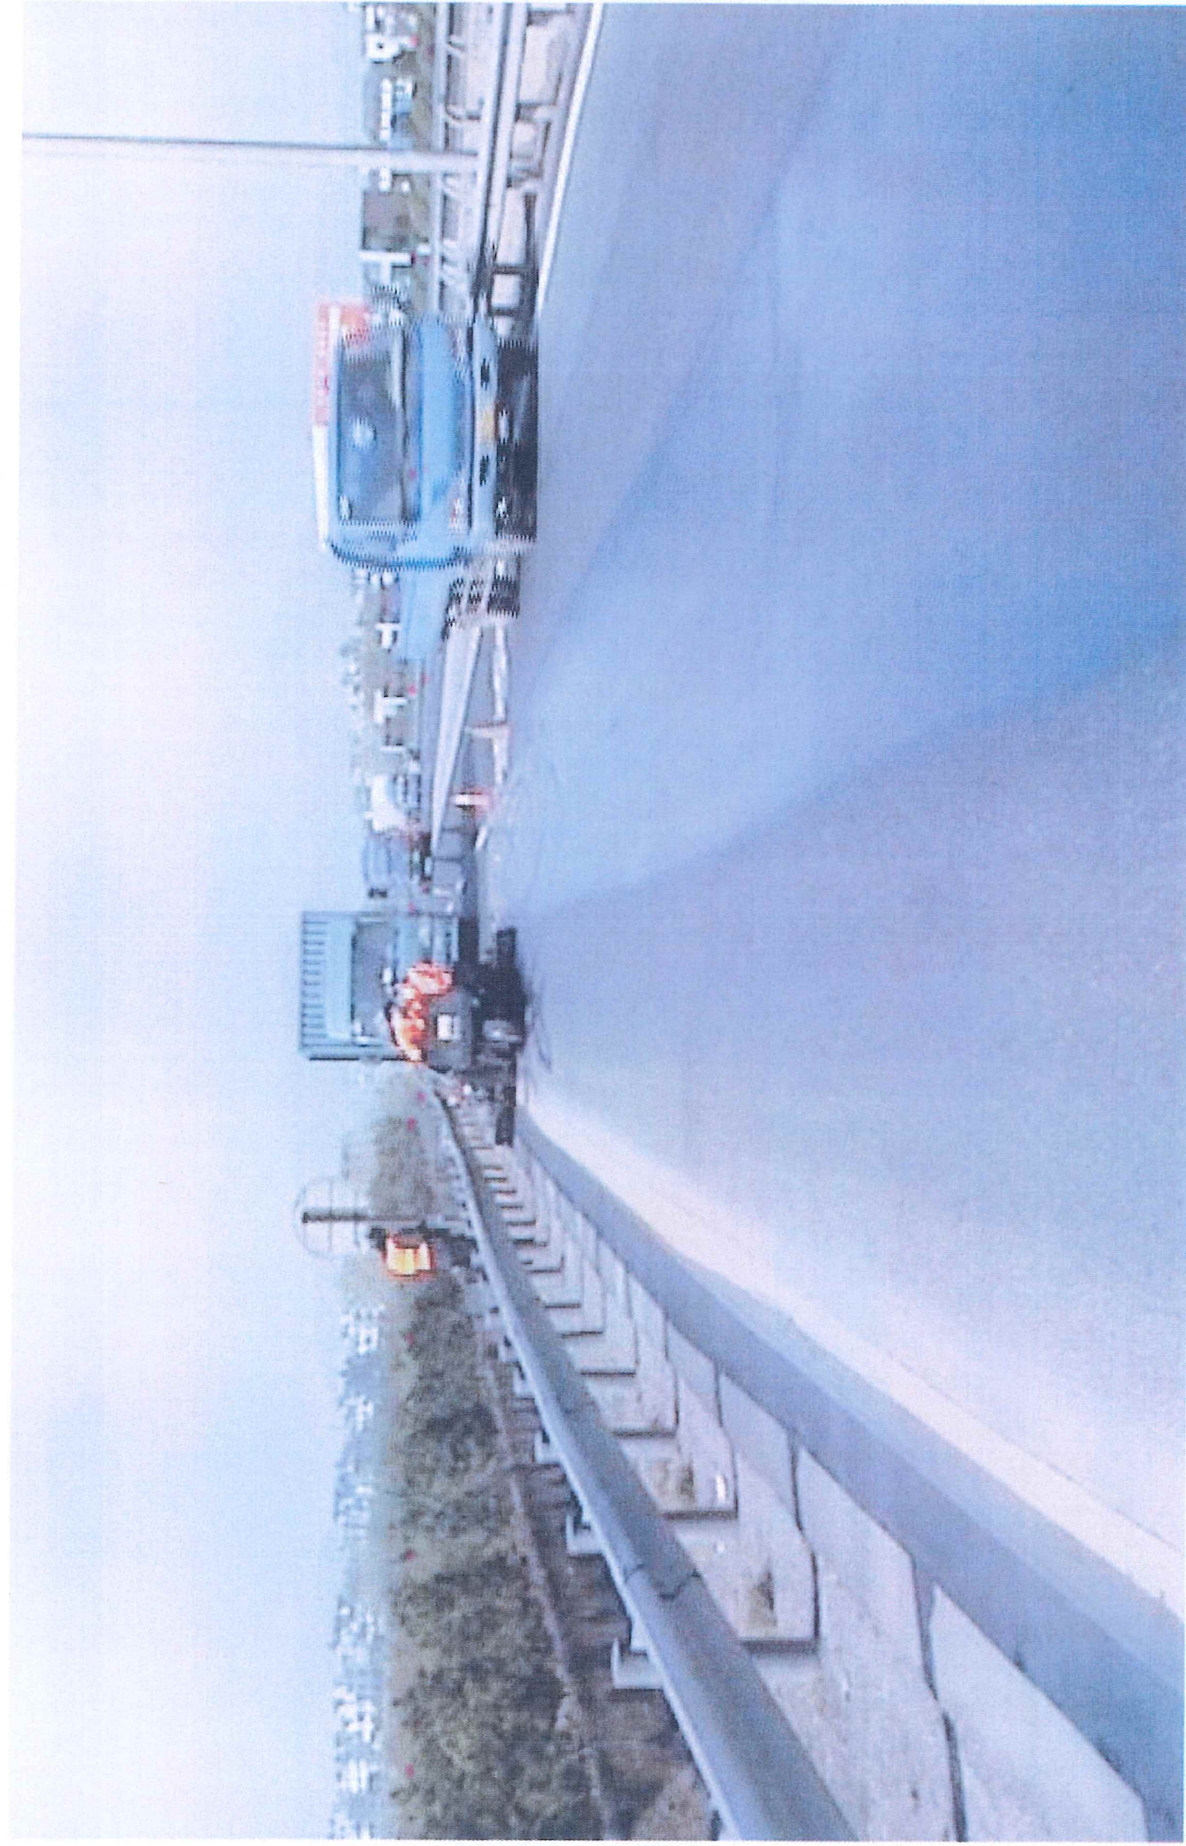
Figure 4.1 Test Strip at Application Site

This test patch showed that an application rate of 5.0 m<sup>2</sup>/kg would be appropriate for the road surface at this location. See figure 4.1, which follows, for a depiction of the general locale for the test strip.

The Test Strip undertaken on December 6 & 7, 2005 was 428 metres long and was located on the Eastbound exit ramp of the ShiDa Road onto the HuHan Expressway at the location shown in Table 4.2 which follows:

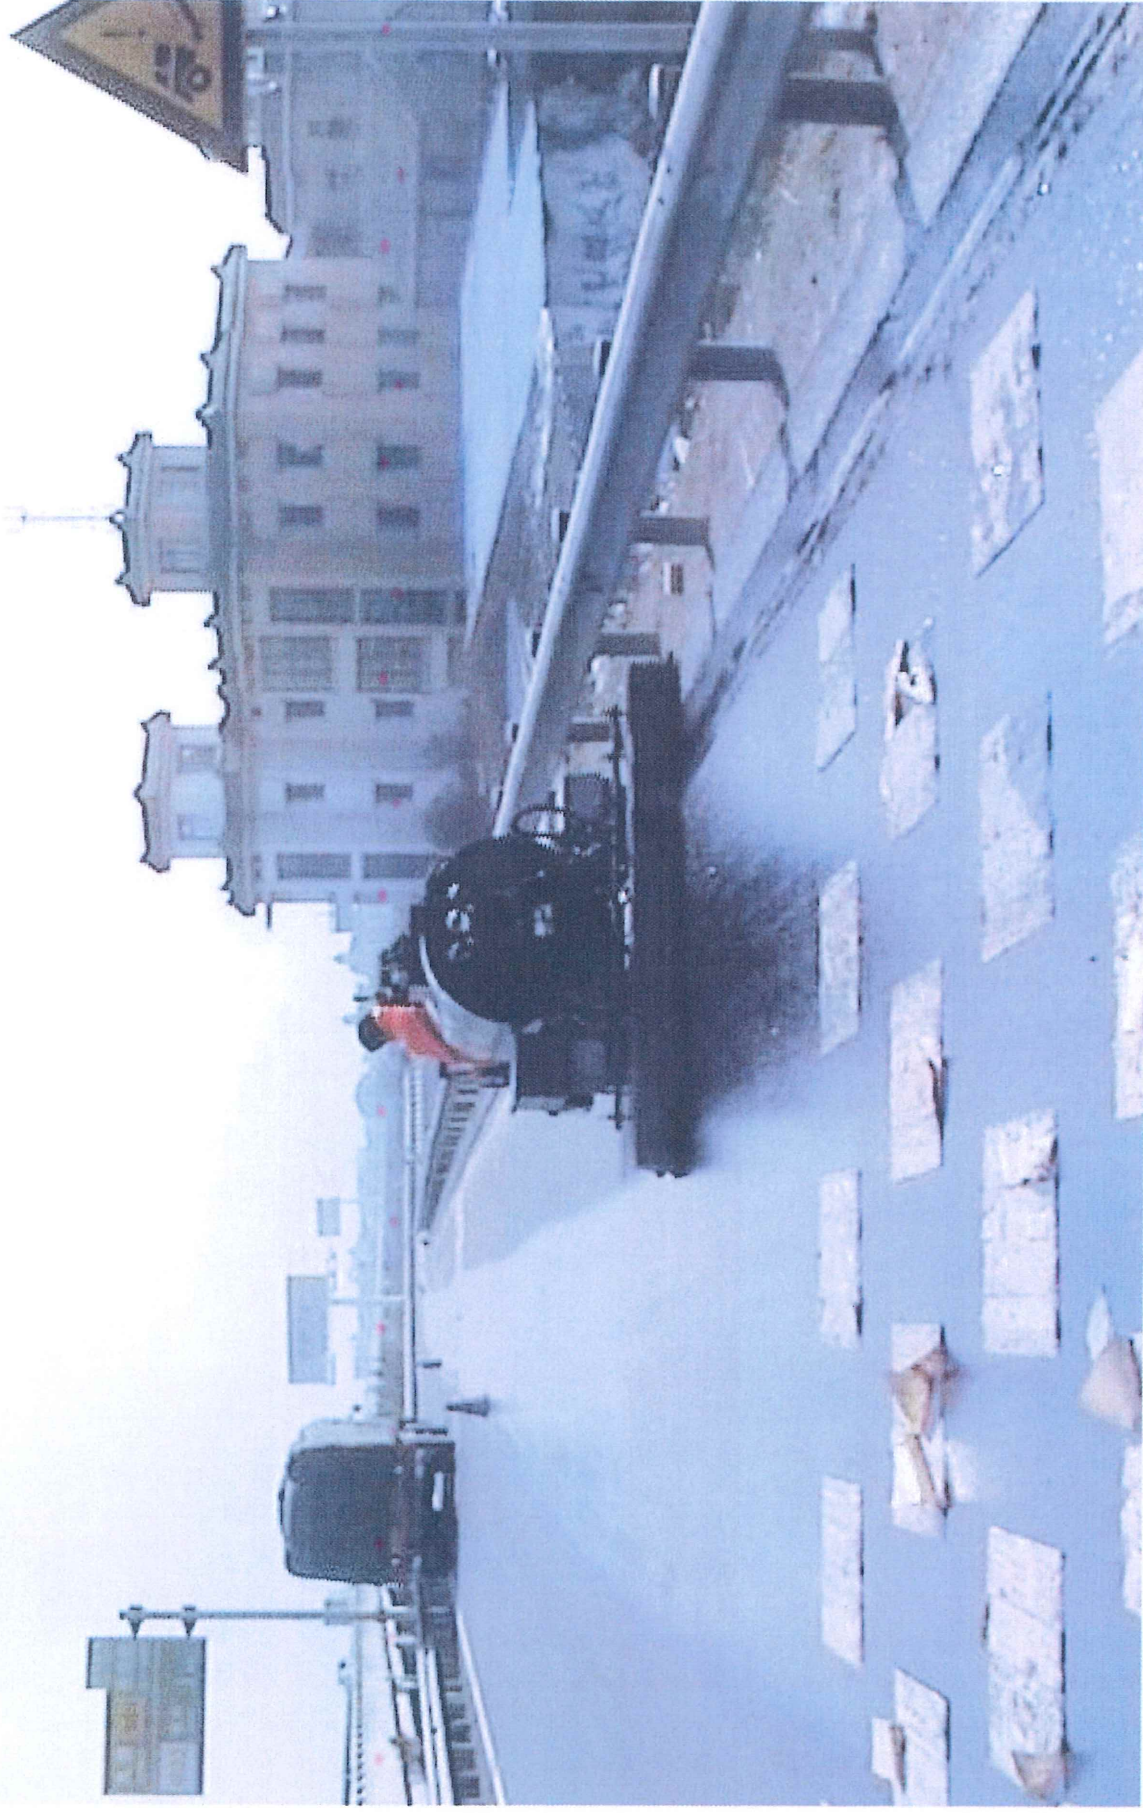
Figure 4.2 Typical Application Procedure

Photos showing the application of RJSeal™ follow in figures 4.2, 4.3 and 4.4 on the following pages. Copper slag was applied to improve the skid resistance, see figure 4.3 showing the application of the copper slag.

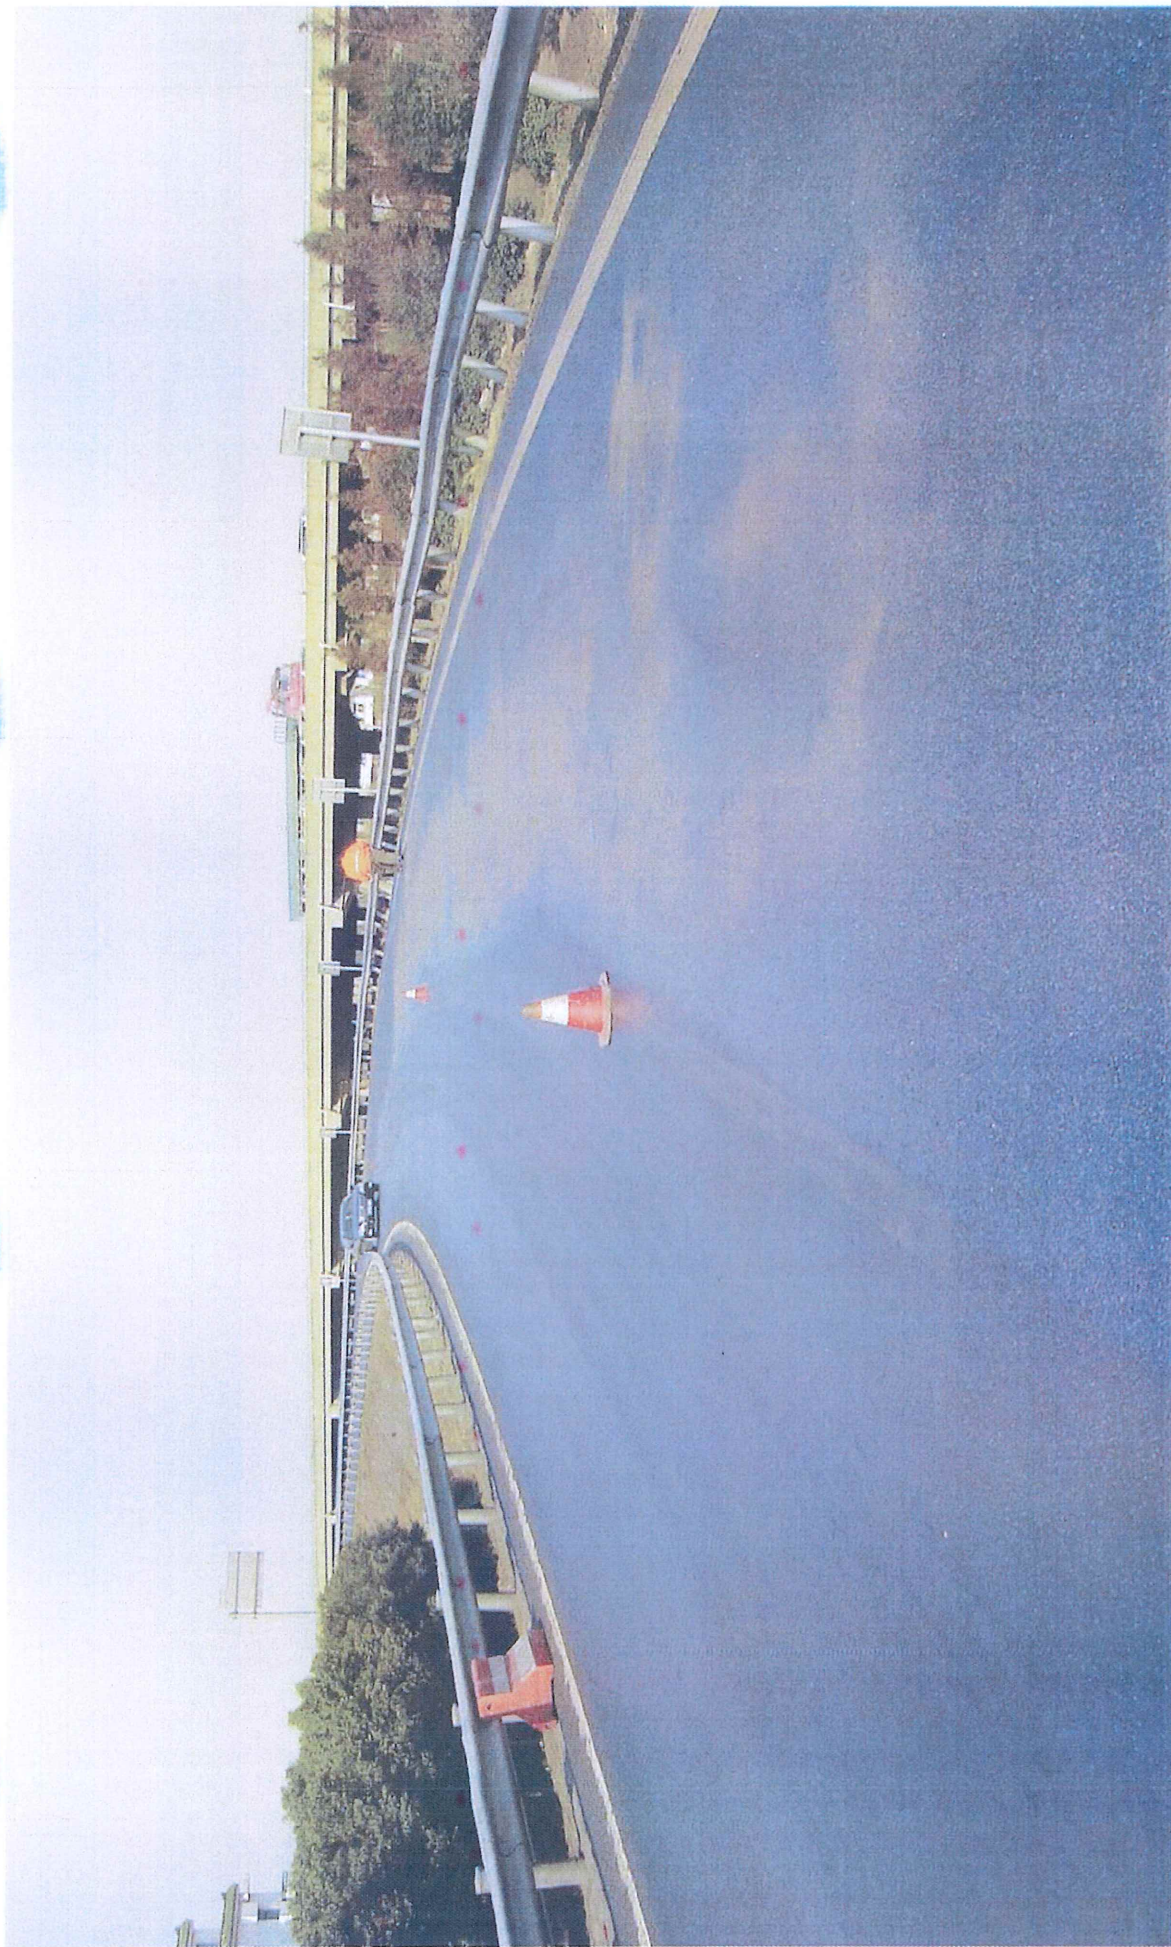
Figure 4.4 Finished Surface

The site was visited on December 8, 2004 around 10:00 am and a difference was readily perceived between the RJSeal™ treated sections and the untreated lane, just north of the test section.

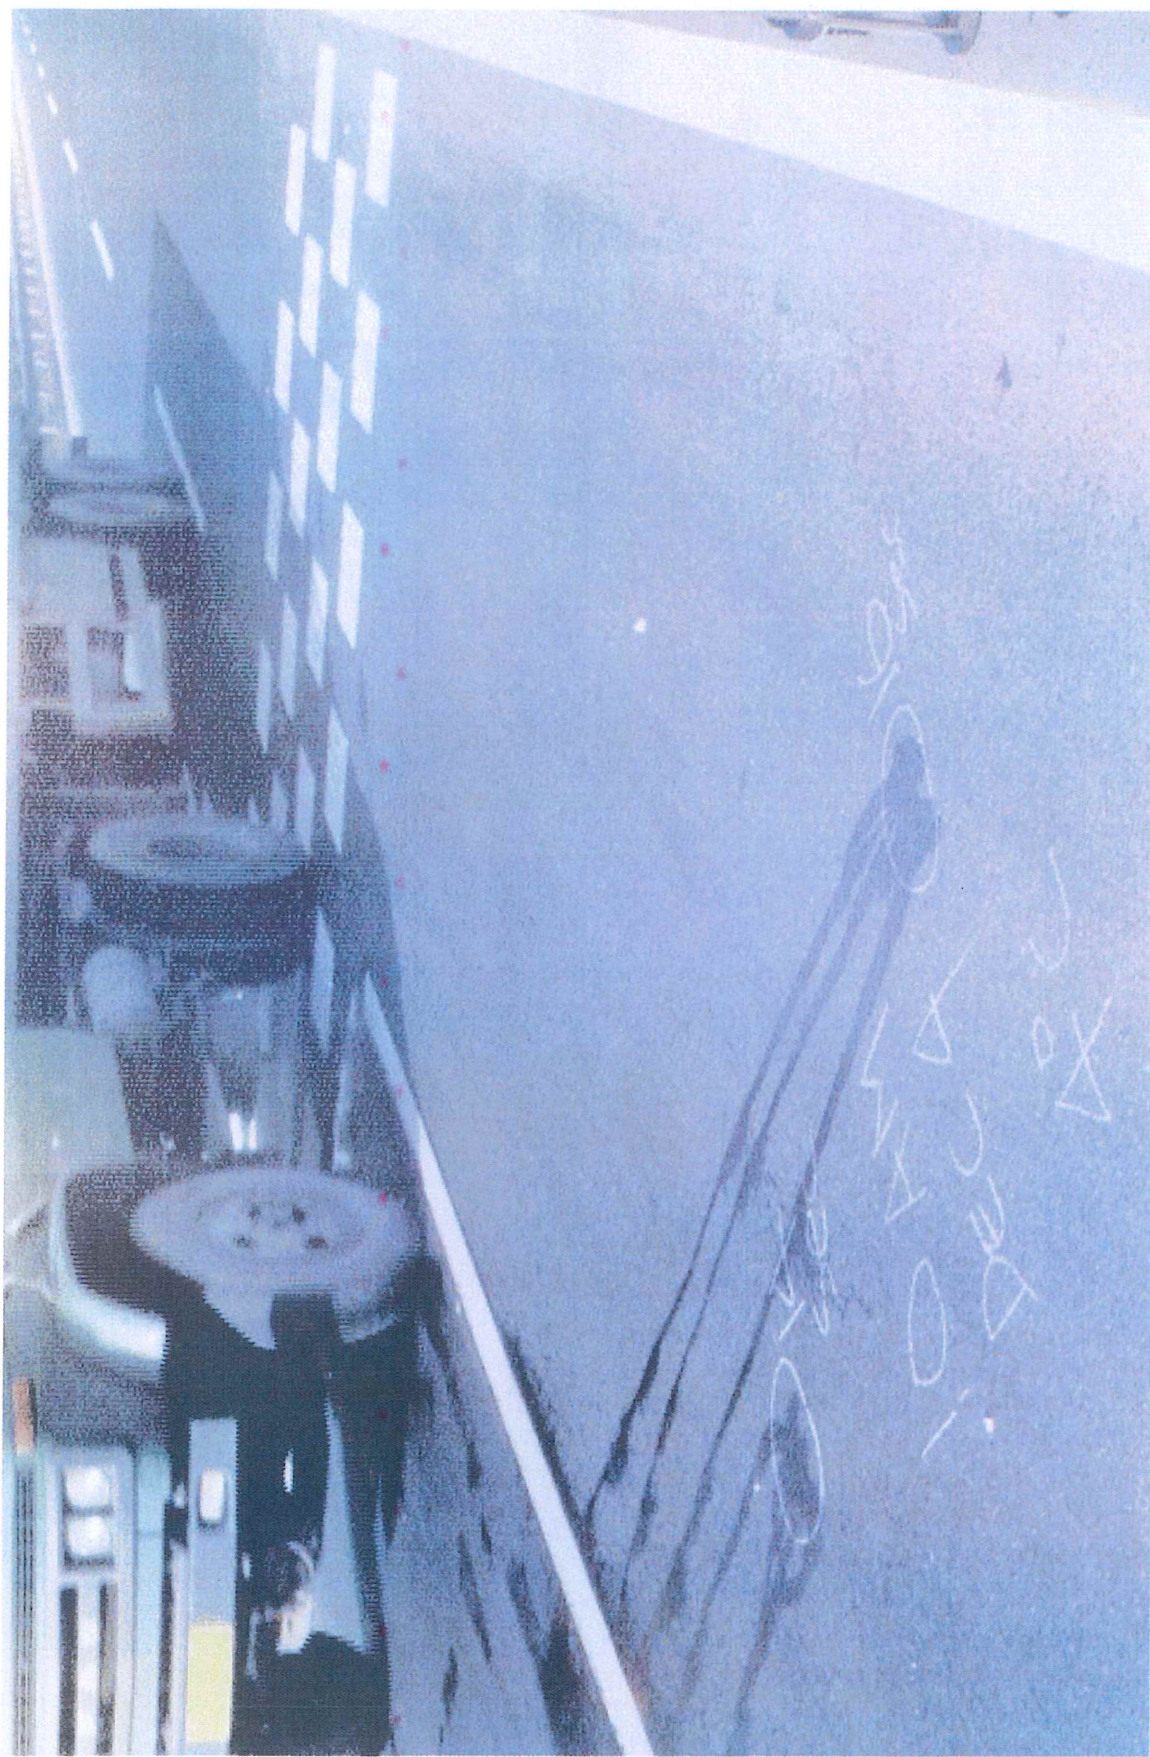
Figure 4.5 Outflow Meter Test

An "Outflow Meter" manufactured in the U.S.A. by Humble Equipment Company of Ruston, Louisiana and sold under the trademark "Outflow Meter" was used to measure the asphalt pavement's capability to dissipate water, as concern has been expressed about hydroplaning on the RJSeal™ treated surface, versus the untreated surface. The procedure is documented in the ASTM Standard E2380-05. The Outflow Meter gives readings in seconds for the dissipation of a known quantity of water. It is suggested that any readings between 3 and 10 seconds are satisfactory results for an asphalt pavement surface, if hydroplaning is to be minimized.

See figure 4.5 for a photo of the Outflow Meter in use at the demonstration site.

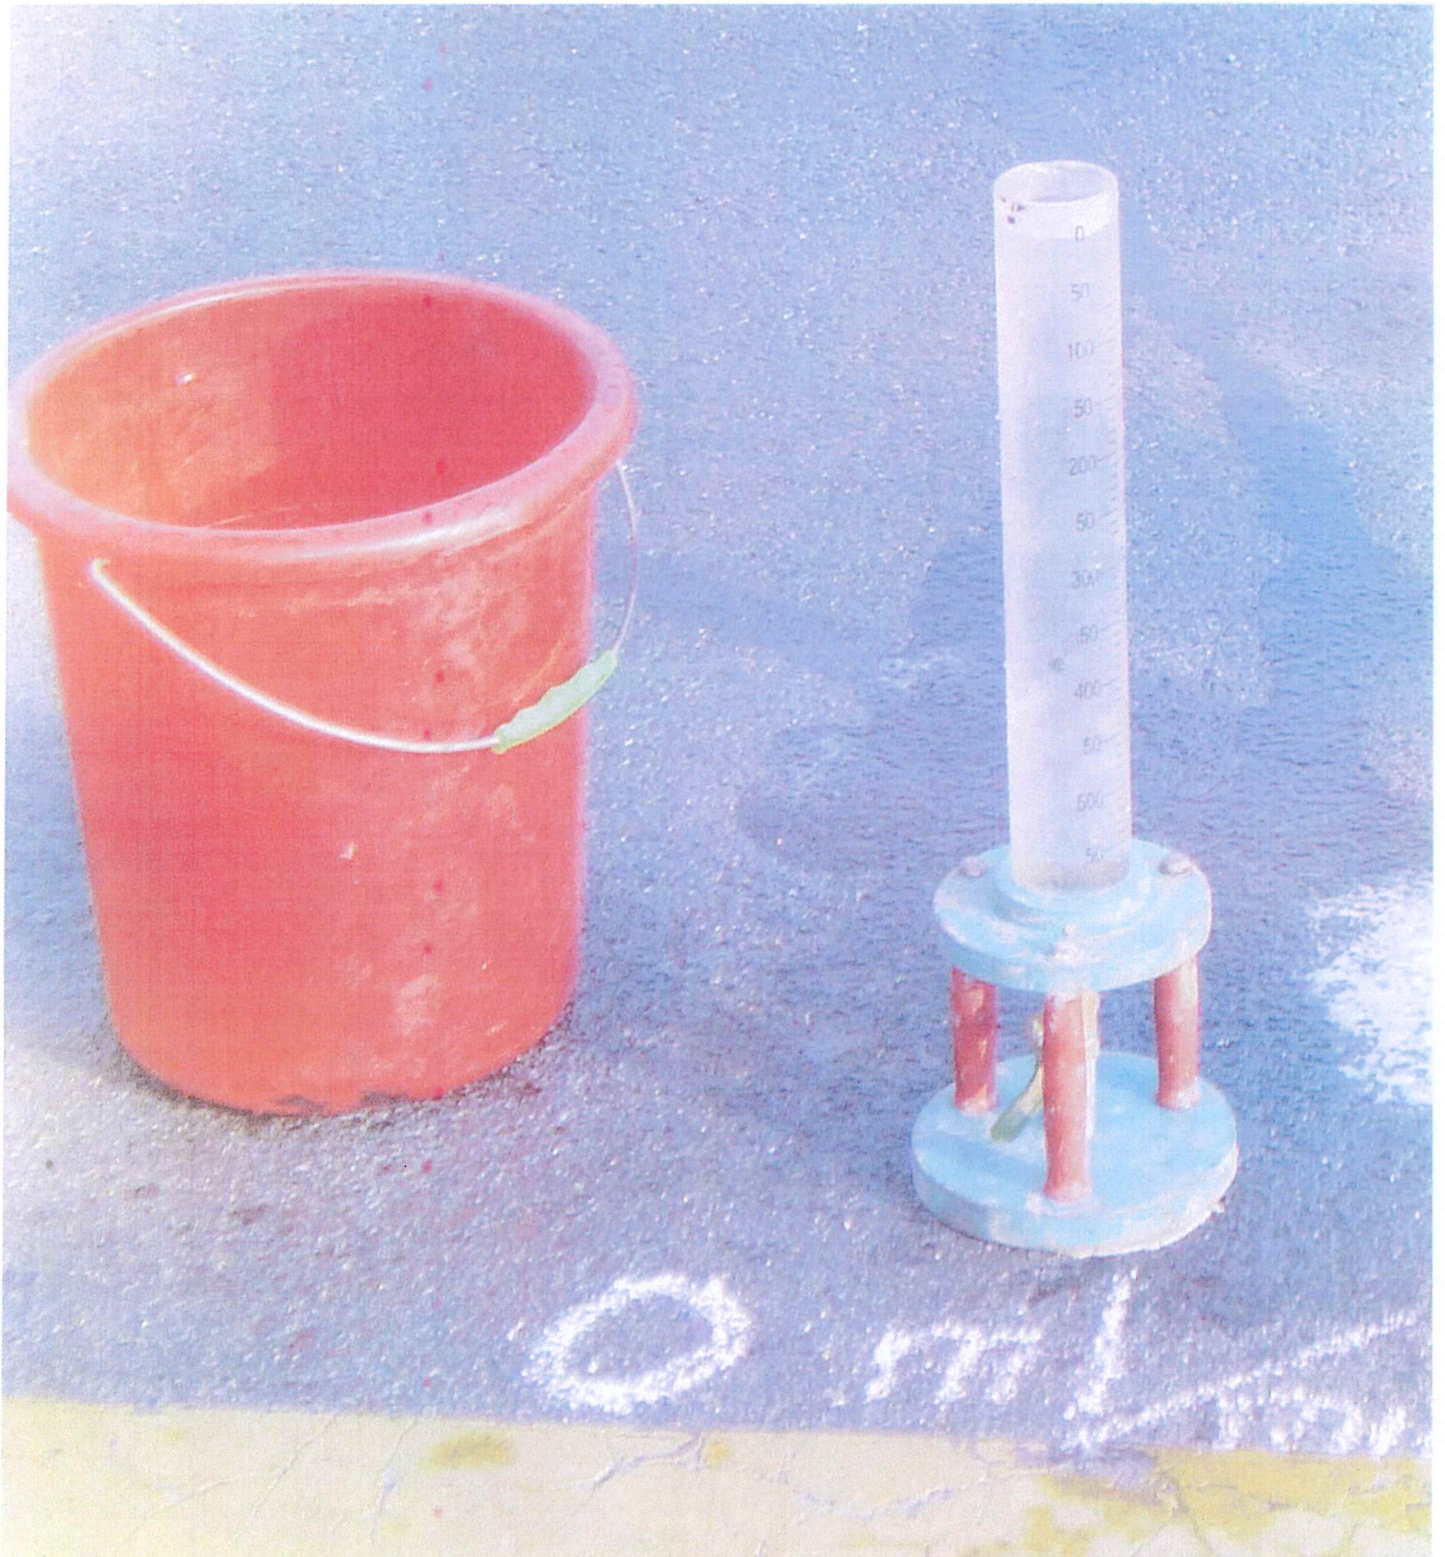
Figure 4.6 Water Penetration Test

Water penetration into the asphalt pavement is minimized by the application of RJSeal™. Water Penetration meter tests (China Testing Standard T 0730-2000) were undertaken on a section of the RJSeal™ treated section in close proximity to the Outflow meter test.

See figure 4.6 for a photo of the Water Penetration Meter in use at the demonstration site.

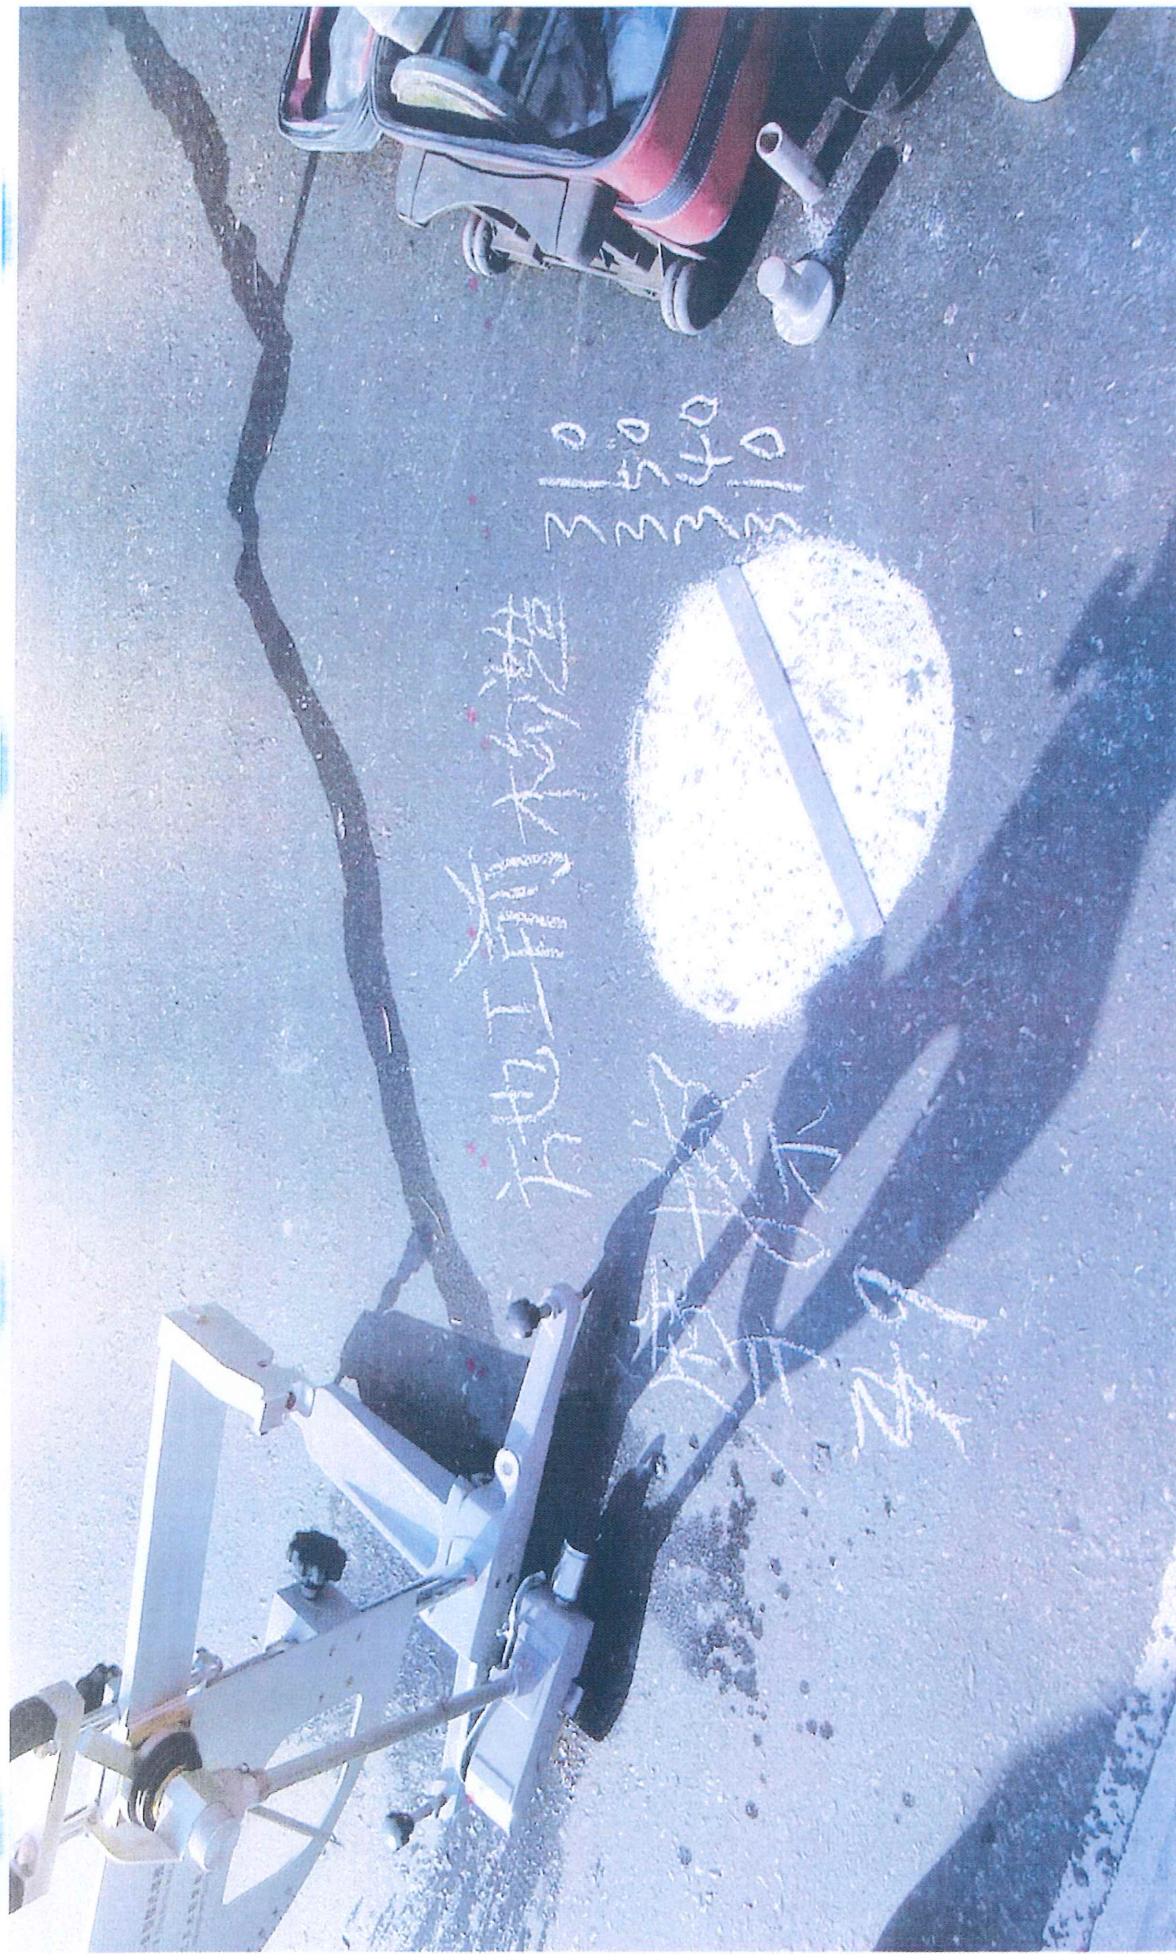
Figure 4.7 Sand Patch Test

The sand patch test (ASTM Standard E965-96 OR China Standard T 0961-95) was undertaken on several sections of the untreated and RJSeal™ treated sections in close proximity to the Outflow meter tests.

See figure 4.7 for a photo of the Sand Patch testing at the demonstration site.

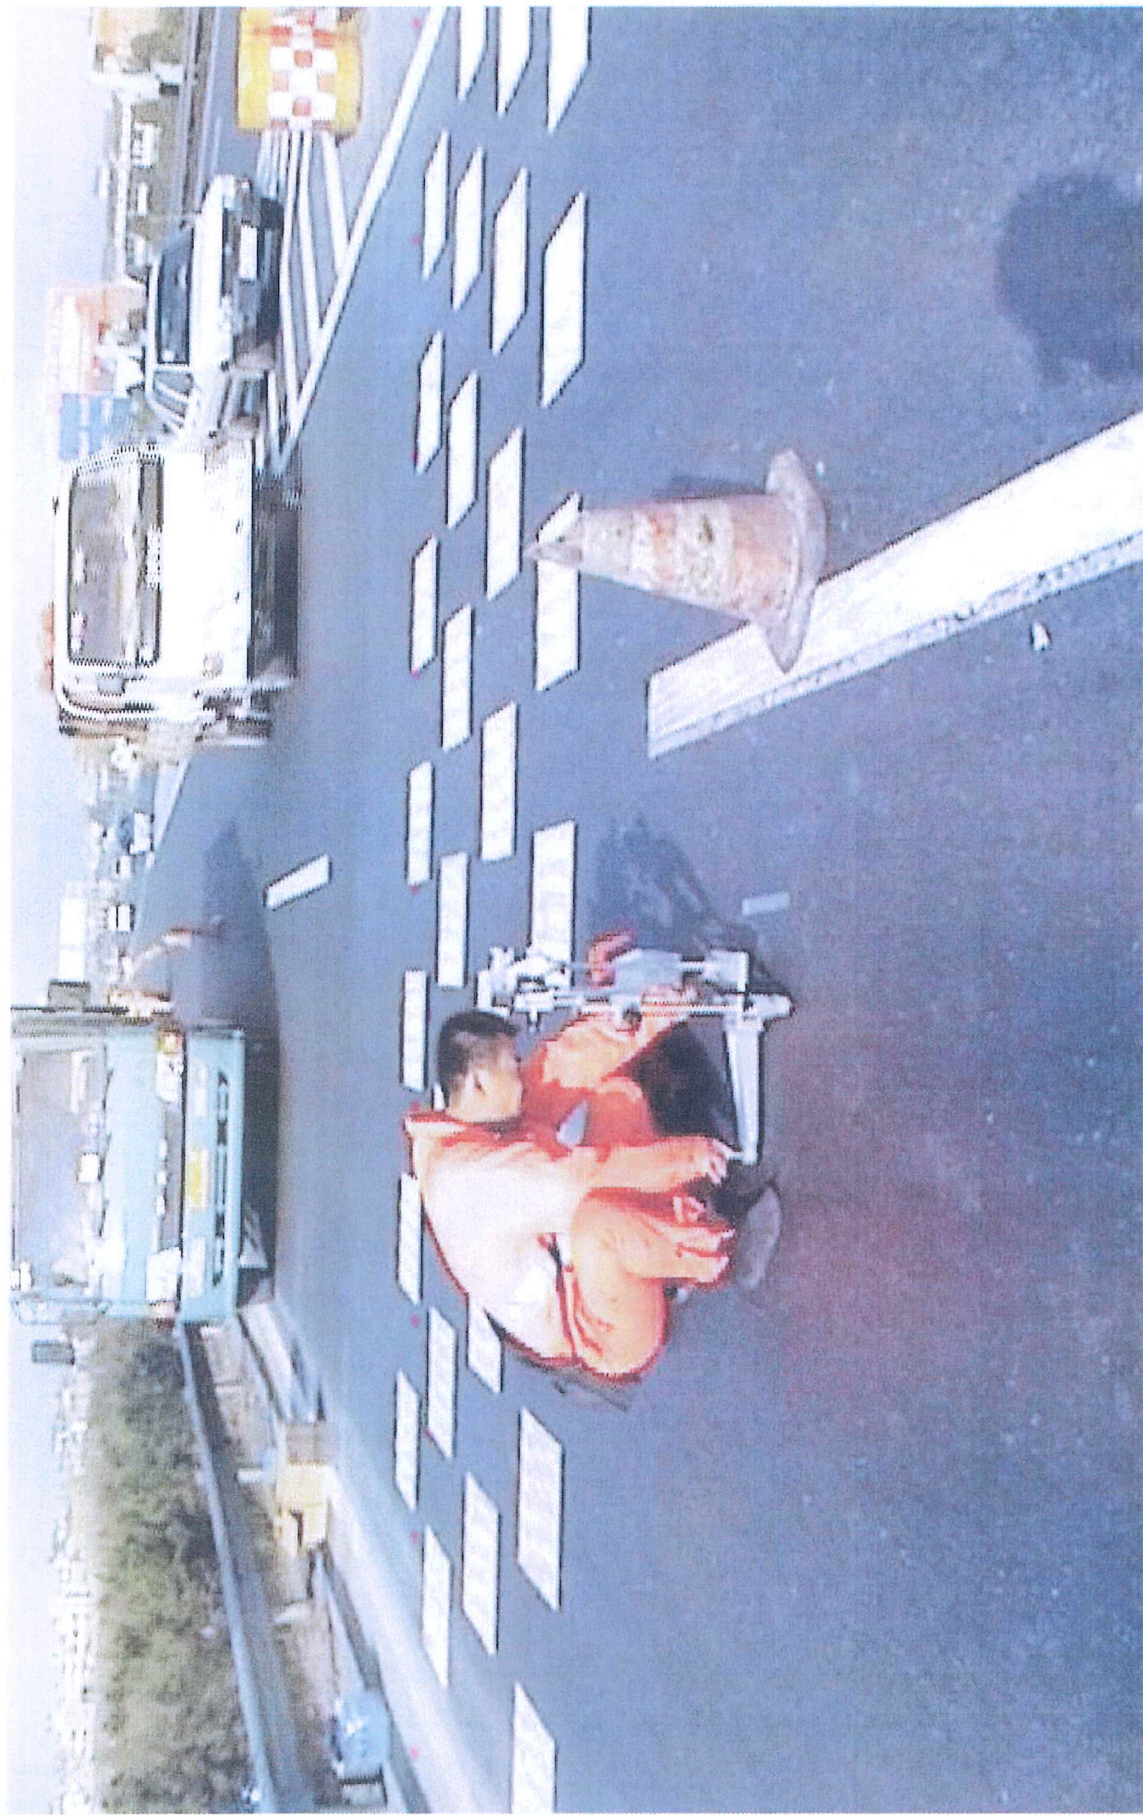
Figure 4.8 British Pendulum

A British Pendulum ASTM Standard E303-93 OR China Standard T 0964-95) was employed to determine the skid resistance of the road surface prior to the application of RJSeal™ and also after the application.

The test results from the British Pendulum are not directly correlatable with the sand patch test, or the Outflow Meter. A BPN of 42 is indicative of an acceptable road surface from a skid resistance point of view. Whereas a BPN of 26 infers that the road surface is unacceptable.

See figure 4.8 for a photo of the British Pendulum testing at the demonstration site
