**Demonstration of Rejuvaseal™
Guang-Quin Expressway, Guangzhou,
GuangDong Province,
Peoples Republic of China**

December 2001

Re: Demonstration of RejuvaSealTM on Guang-Quin Expressway, Guangdong

This is the final report on the demonstration of RejuvaSealTM on the Guang-Quin Expressway. A strip, 145.6 metres in length was completed in the outside, south bound lane of this four-lane divided expressway, in two phases. An initial 71.6 metres was completed on December 8th, 2001 and some 74.0 metres was completed during the second phase on December 14, 2001. I will submit a supplementary letter report on the follow up inspection that will be conducted in early 2002.

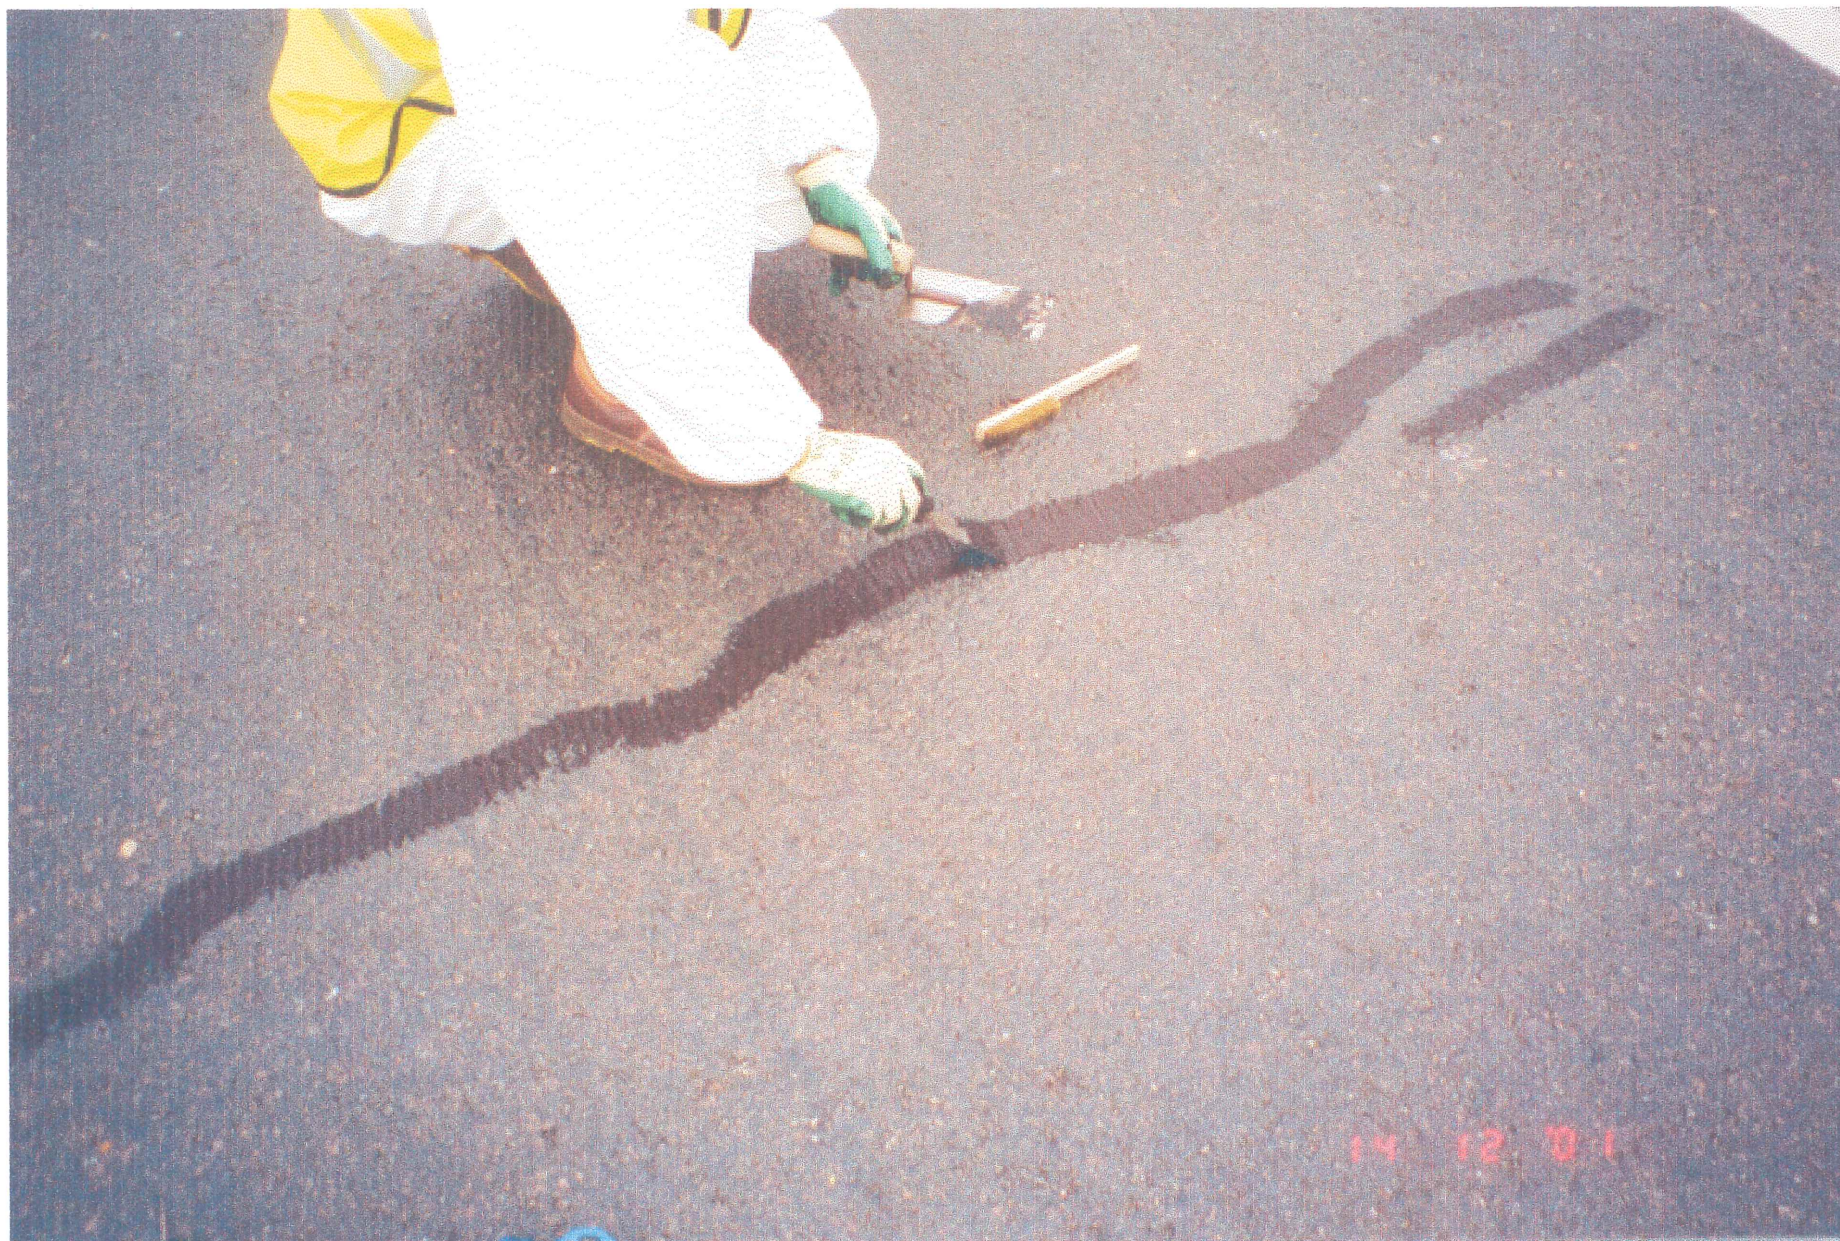
At the time of the visit on December 14, several cracks that were encountered in the Dec 8 test strip were filled with crack sealant. See figure 4.4 for a photographic record of the cracks that were filled with crack sealant. These cracks were in the range of 4 to 6 mm in width.

Figure 4.4: Cracks filled with crack sealant

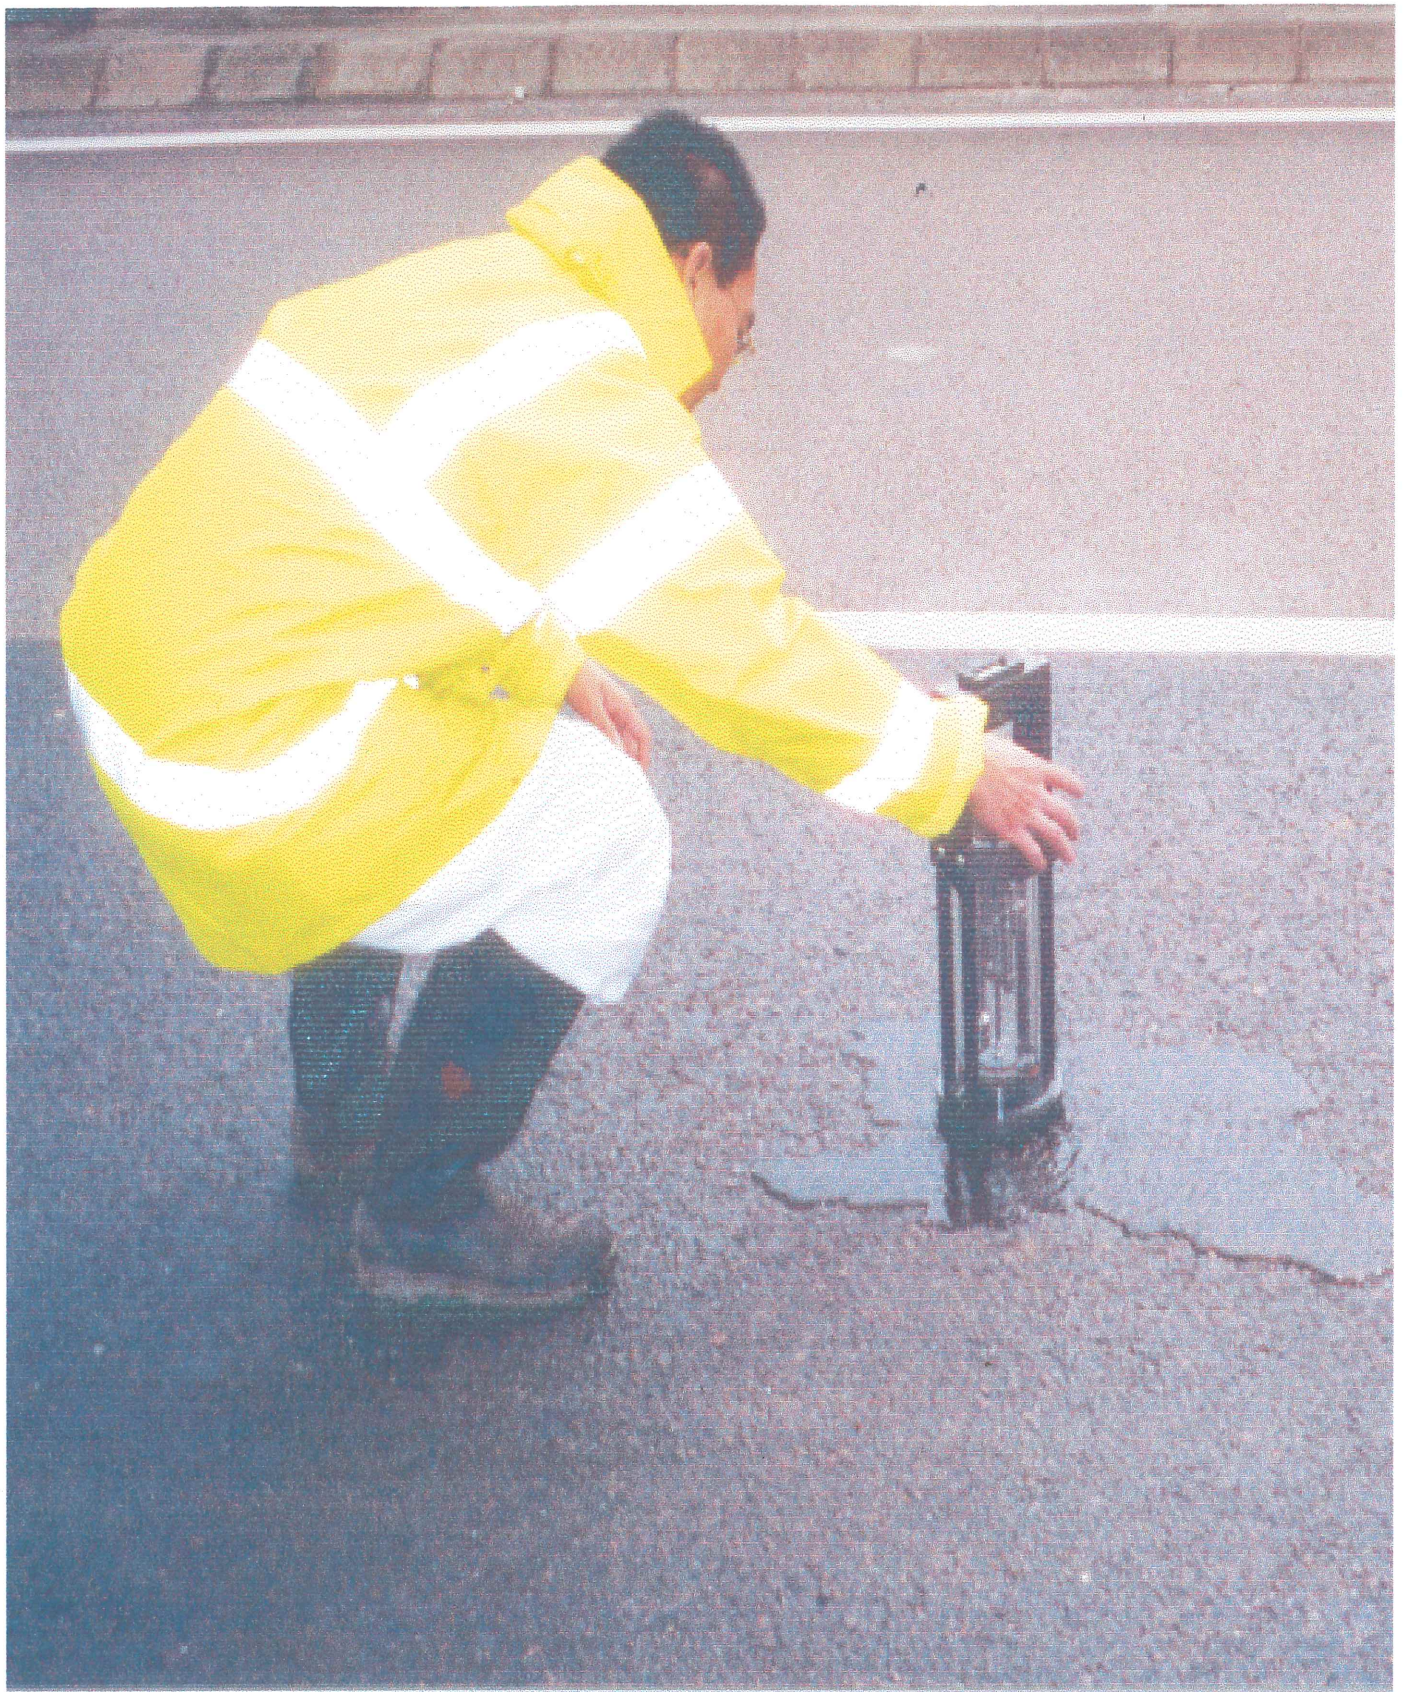
Figure 4.5: Humble Equipment Co. "Outflow Meter".

An "Outflow Meter" manufactured in the U.S.A. by Humble Equipment Company of Ruston, Louisiana and sold under the trademark "Outflow Meter" (see figure 4.5) was used to measure the asphalt pavement's capability to dissipate water, as concern has been expressed about hydroplaning on the RejuvaSeal™ treated surface, versus the untreated surface. The Outflow Meter gives readings in seconds for the dissipation of a known quantity of water. It is suggested that any readings between 3 and 10 seconds are satisfactory results for an asphalt surface, if hydroplaning is to be minimized.

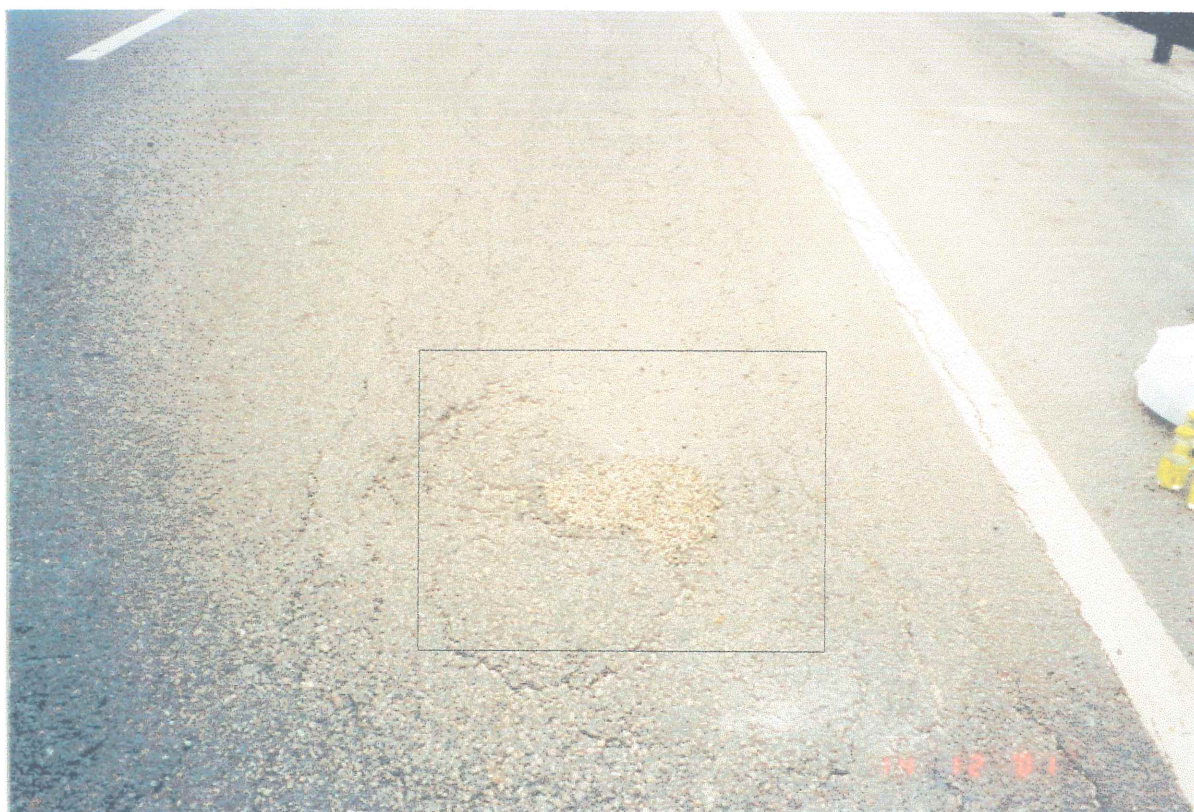
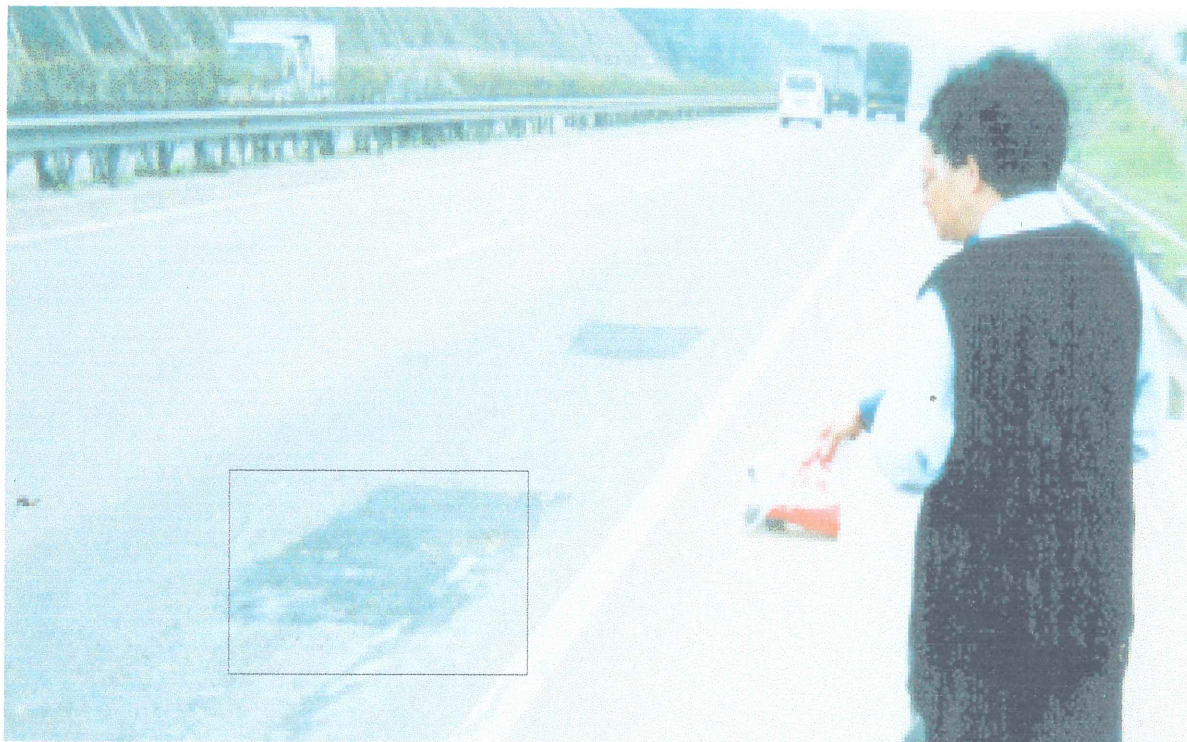
The pothole that was filled with the JEGEL pothole filler was still intact, although the surrounding area has suffered further structural damage, due to the fill for the highway continuing to settle across the gully the highway traverses at this point. In fact additional asphalt pavement has been added to fill in the ruts that lead up to the pothole.

Pothole filled with JEGEL Pothole Filler
Top Photo: December 14, 2001,
Bottom Photo: March 2, 2002

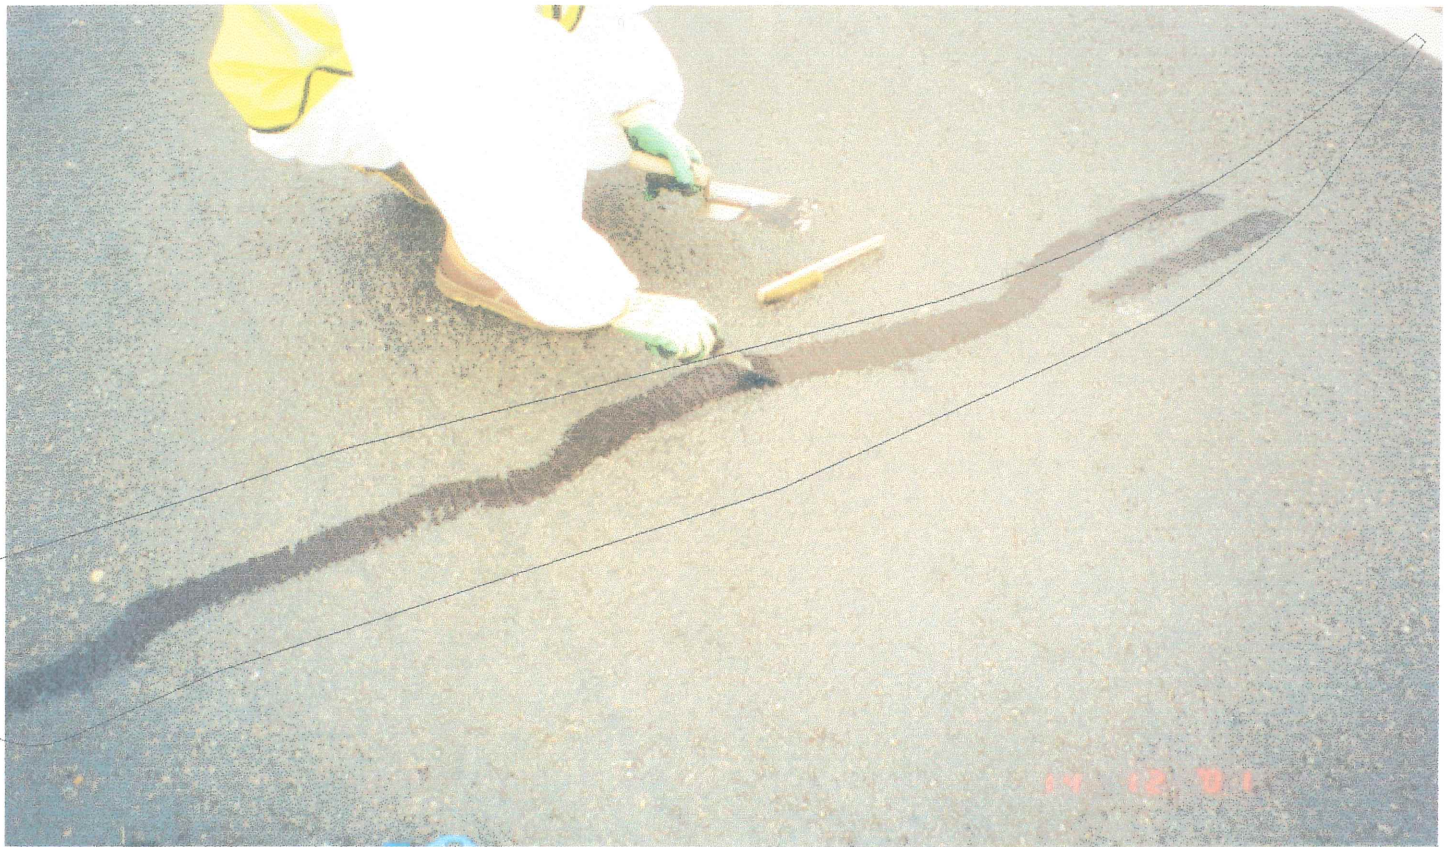
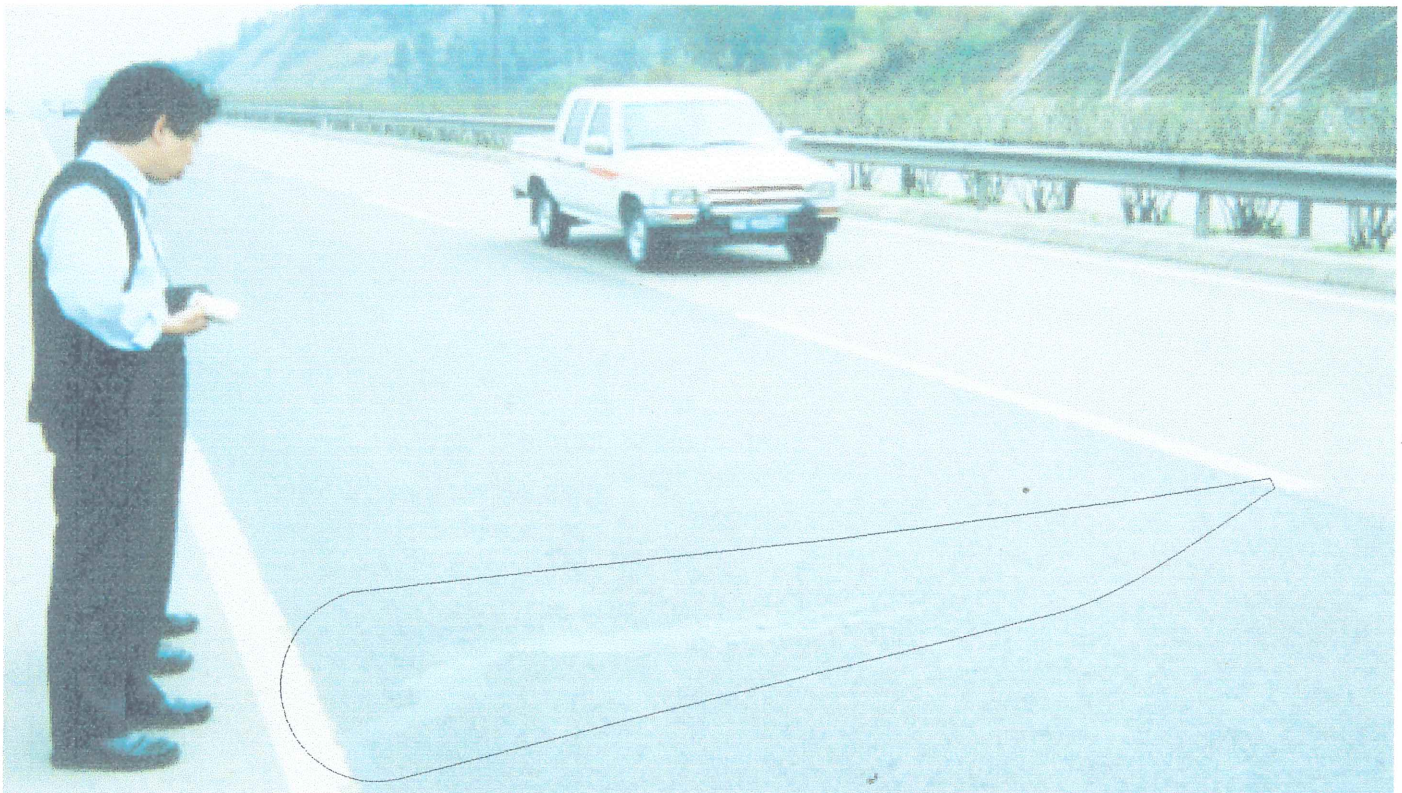
lateral crack that was treated with crack filler has now lost most of the immediate surface material, but water poured on the crack showed it was still impervious to water. However, another attempt should be made to apply crack filler, as part of the ongoing maintenance program.

Crack filled with crack sealant
Top: December 14, 2001, Bottom March 2, 2002
