**Demonstration of Rejuvaseal™
Highway G104, Cangzhou, Hebei,
Peoples Republic of China**

June 2002

Re: Inspection of RejuvaSeal Demonstration Strips near Bazhou and Cangzhou

Demonstration of RejuvaSeal Highway G104, Cangzhou, Hebei, Peoples Republic of China

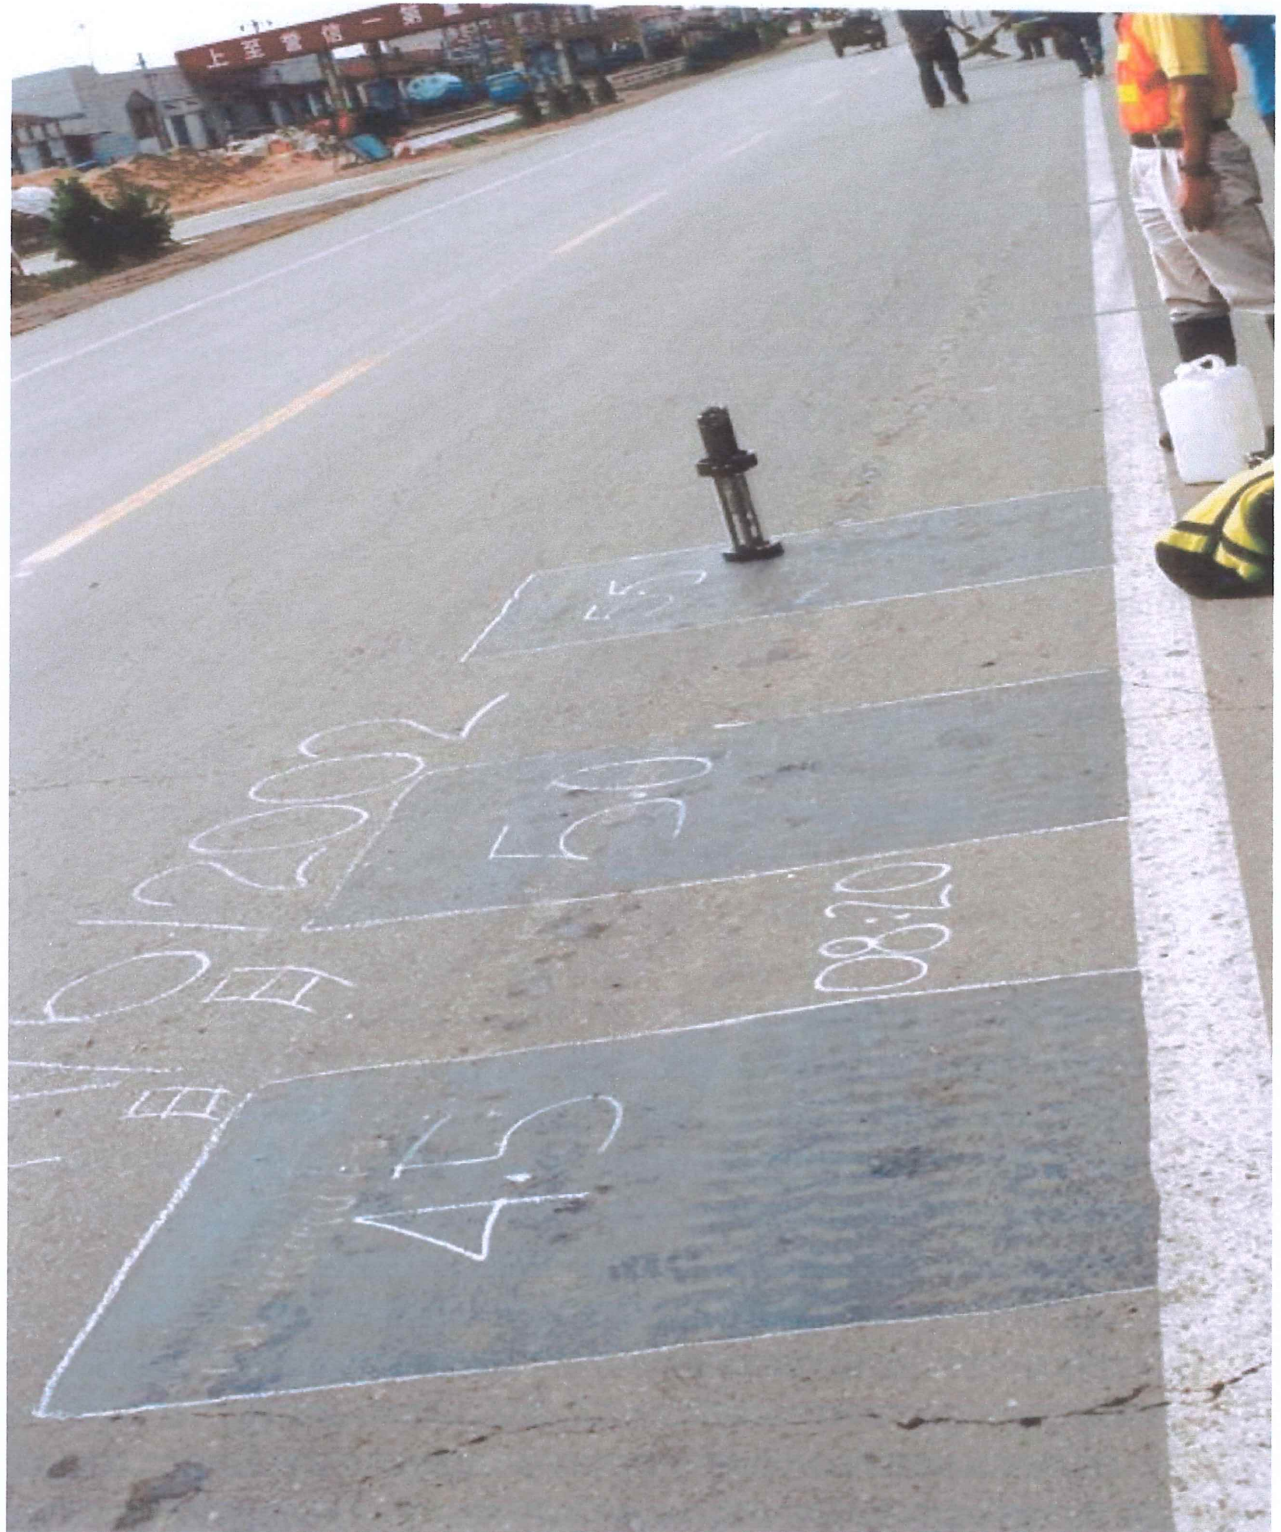
Figure 4.1
Test Patches at Demonstration Site.

See Figure No 4.1 for a photo showing the test patches as implemented. Particulars of the test patches are as follows:

Subsequent inspection of the test patches on June 14, showed that the application rate of 5.0 m²/kilogram (test patch three) was appropriate for the asphalt pavement at this location and could be used as a guide for other locations with similar physical characteristics.

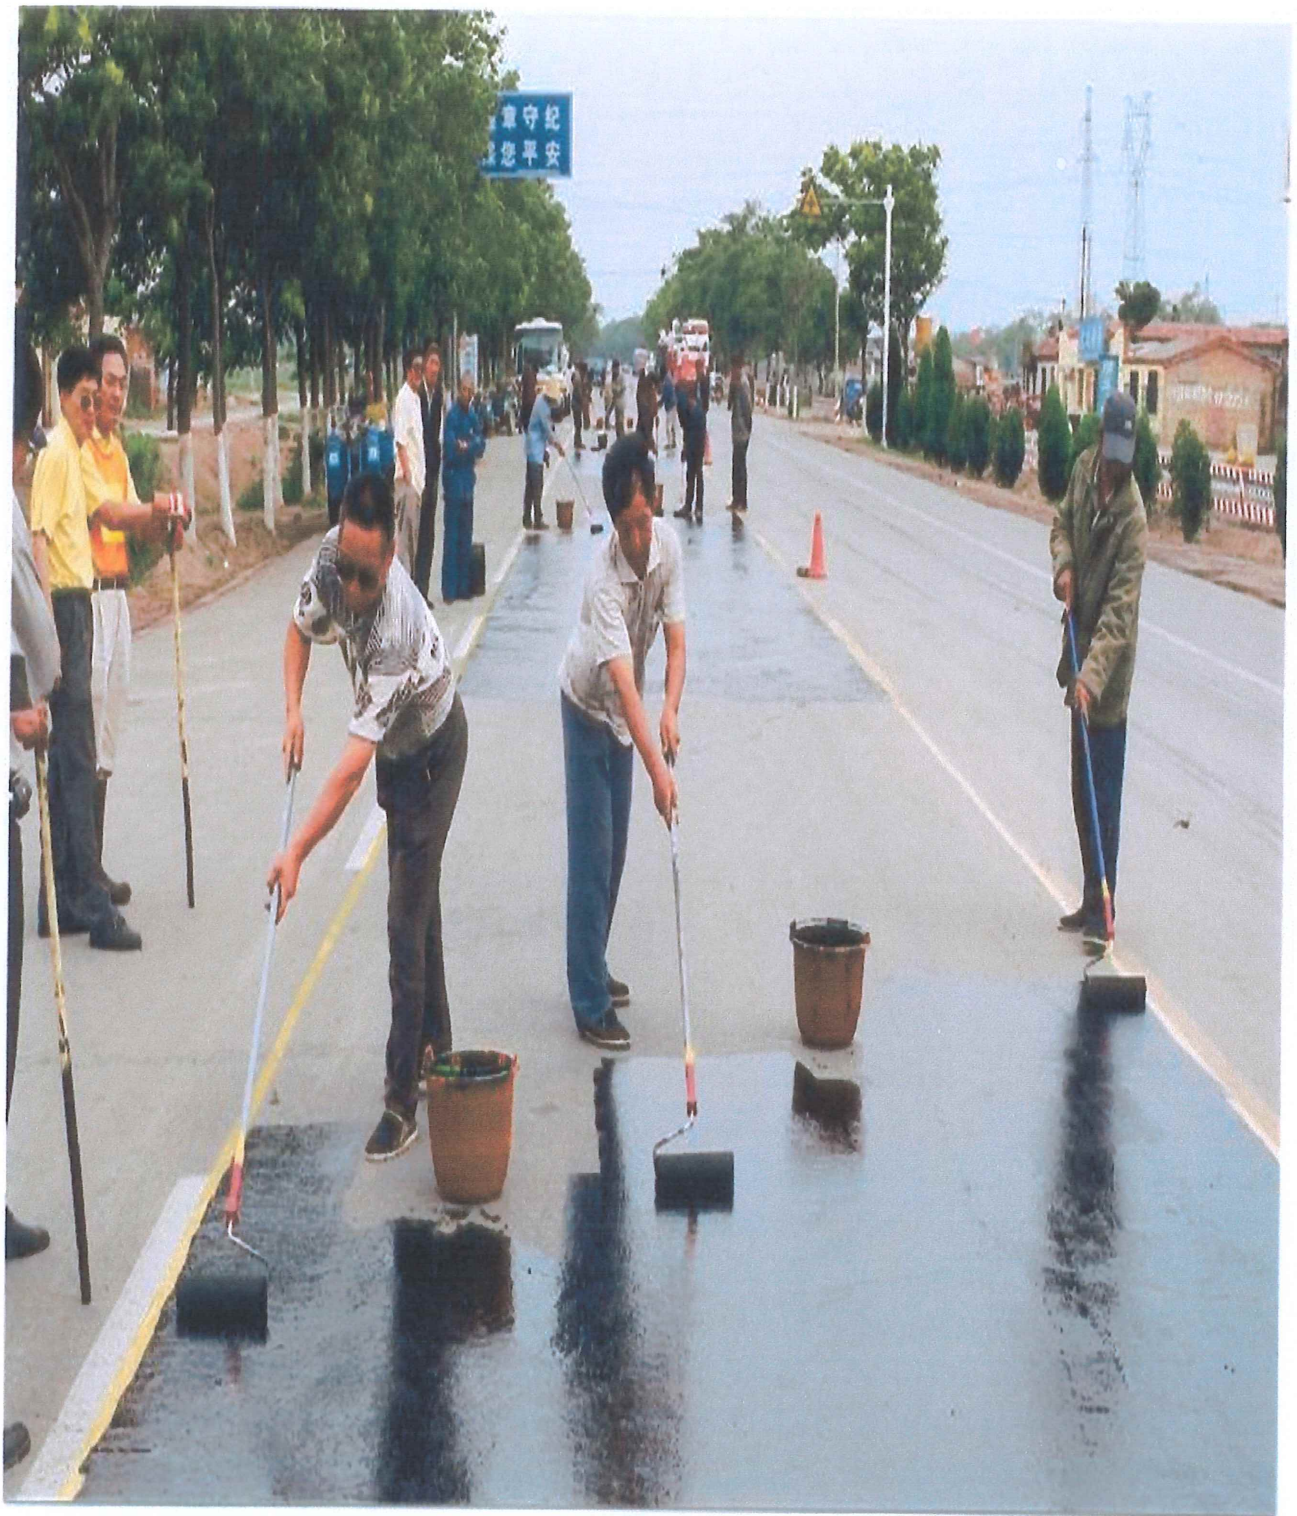
Figure 4.2
Typical Application Procedure.

On the morning of June 14, ten segments (panels), on the southbound lane were marked off in 32 metre increments. A final five panels of 29 metres was added to make the distance some 465 metres. The width of the lane is 3.6 metres between the painted centre line and the shoulder marker line, whilst the paved shoulder is 1.9 metres wide. A five U.S. gallon (17.9 litres) pail of RejuvaSeal™ was assigned to each panel. The RejuvaSeal™ was applied to each of the panels, excluding the paved shoulder, using paint rollers to ensure uniformity in the application.

Ambient temperatures at the time of the application were in the 24 to 27 degree Celsius range, with humidity in the 55% range. The application ceased at 10:55 pm and this southbound lane remained closed until 8 pm on June 14, when it was re-opened for traffic. Photos showing the test application of RejuvaSeal™ follow in figures 4.2, 4.3 and 4.4. on the following pages.

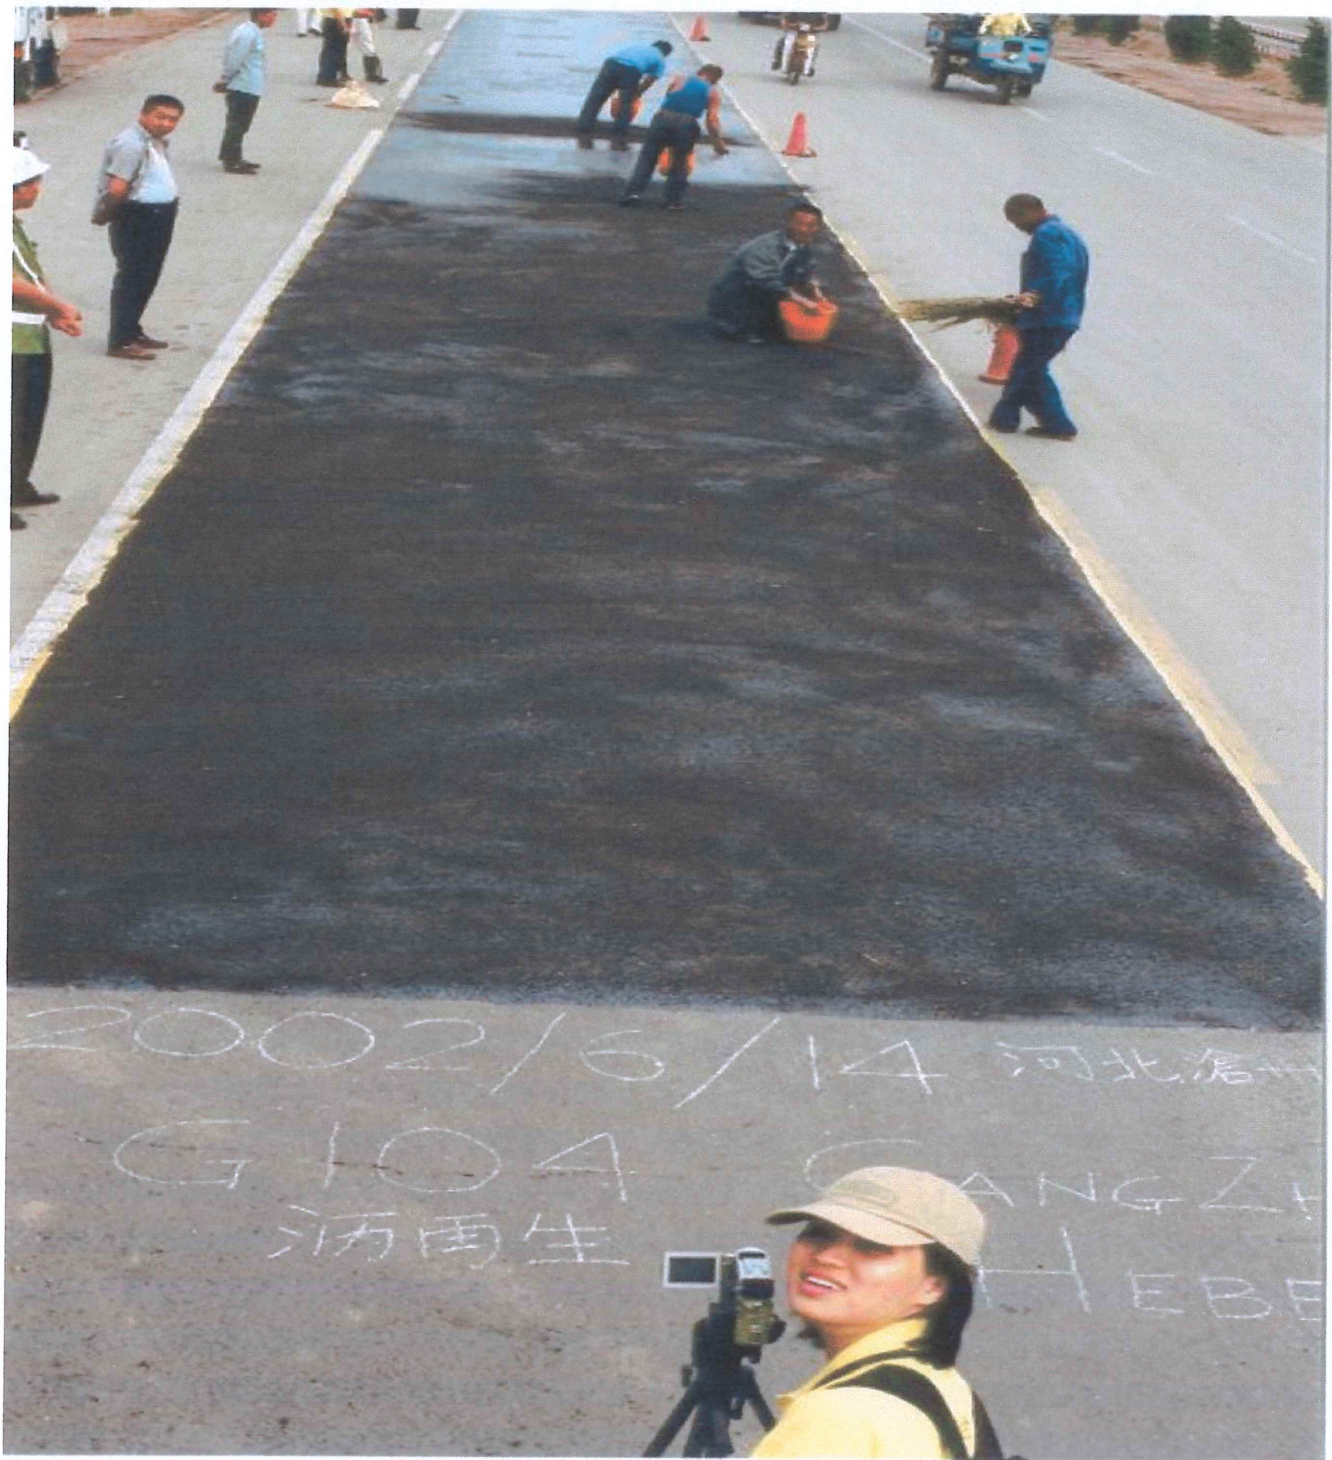
Figure 4.3 Application of Kunming Copper Slag to RejuvaSeal Surface.

In view of concern expressed by the QingXian Communications Department that the RejuvaSeal™ treated road gave the appearance of a slippery surface, Copper Slag from a smelter in Kunming was applied to the road surface immediately following the application of RejuvaSeal™. The application rate was approximately 0.52kgs/sq metre (1.0 lbs/sq yard). This was applied to the entire section treated. Further information on this copper slag is contained in technical data sheets in Appendix C. The approximate size consist for copper slag is as follows: >98% passing #8 mesh (2.5 mm) and <5% passing #30 mesh (0.5mm). A 15 tonne, pneumatic-tired roller was used following the slag application to roll the slag into the softened asphalt pavement surface

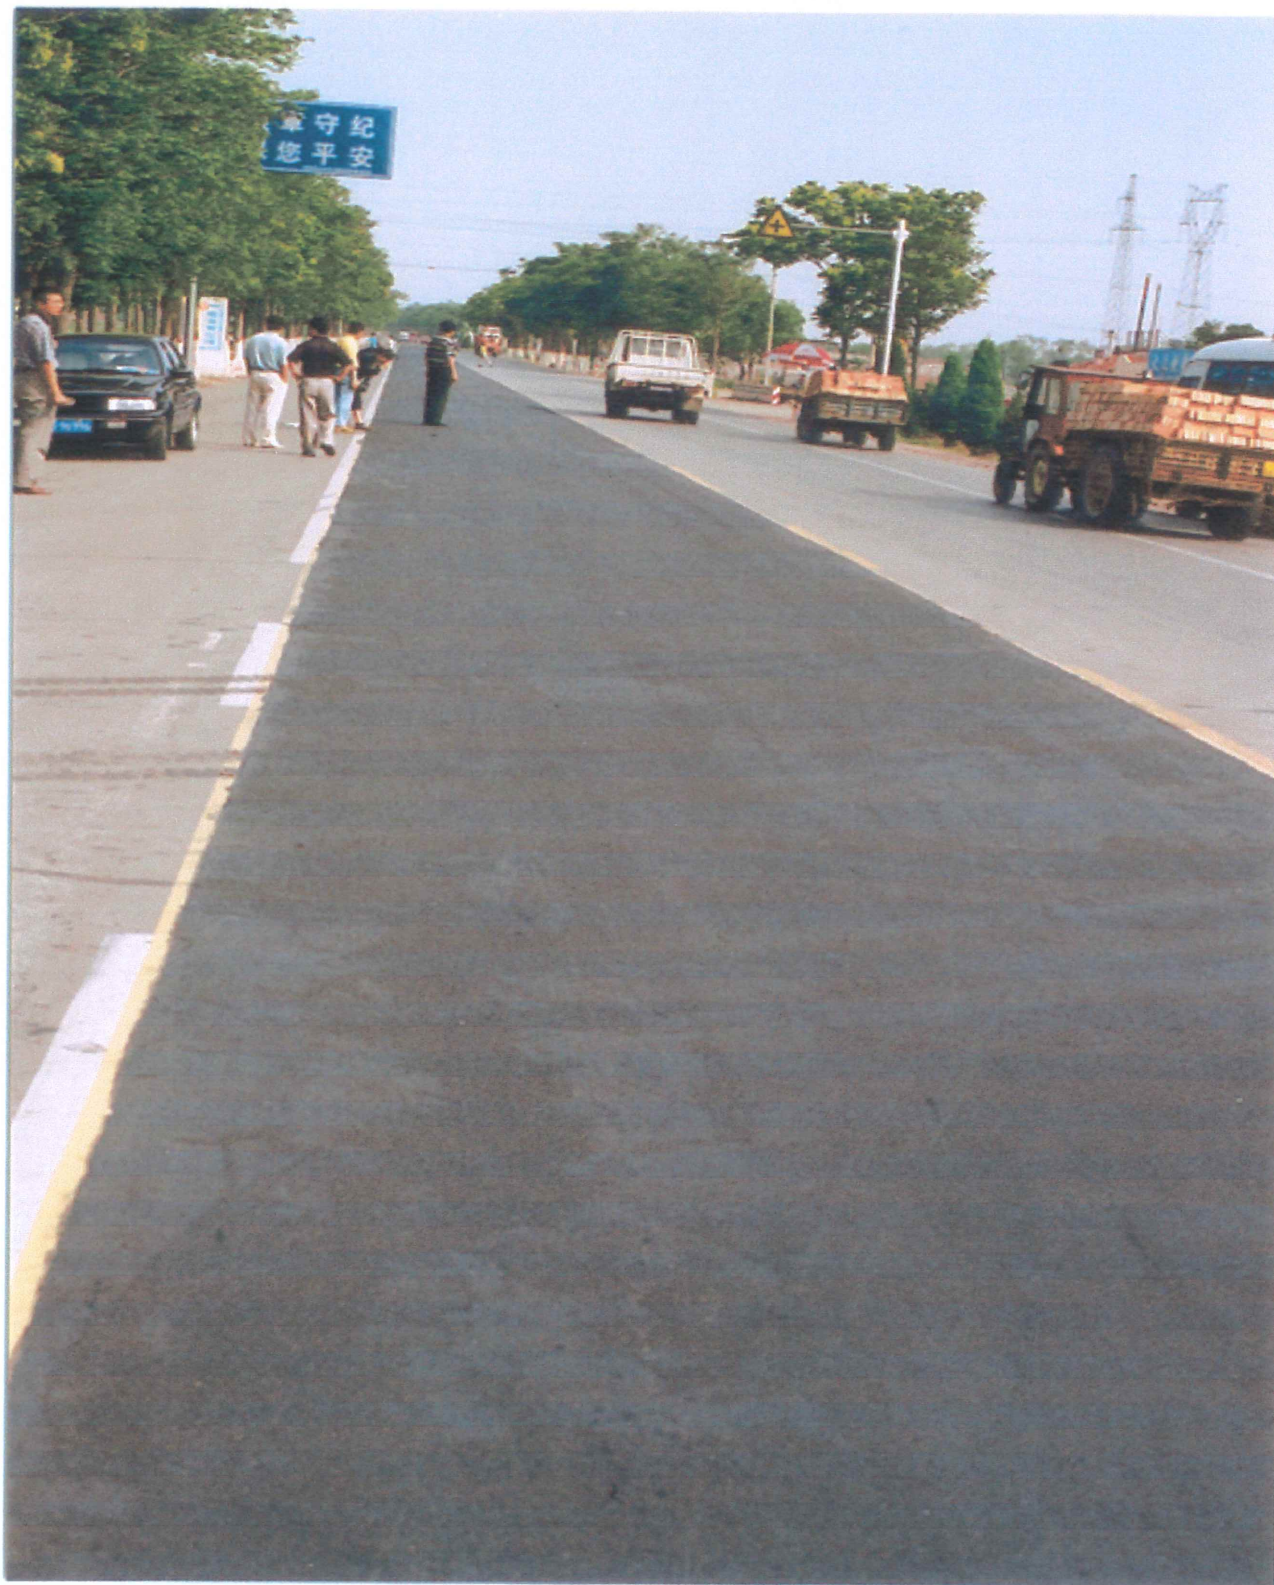
Figure 4.4 Finished Surface.

The site was visited on June 15 around 9:15 pm and a difference was readily perceived between the RejuvaSeal™ treated section and the adjoining untreated lanes. A screwdriver was used to dig two small holes in the asphalt pavement, to a depth of 3 centimetres, some 45 metres south of the extreme north end of the demonstration section, to determine the penetration of the RejuvaSeal™. This was one day after the application of RejuvaSeal™ and at these two locations the newly rejuvenated surface was evident, by the black resilient surface layer, which was now approximately 1 millimetre thick. Below that depth, the grey, oxidized layer of asphalt was evident. The copper slag was embedded in surface of the road, and most had become invisible. Little carryover of the RejuvaSeal™ was observed from vehicle tires at the south end of the southbound lane, so it can be presumed that the surface was dry shortly after the site was vacated at 8 pm on June 13.

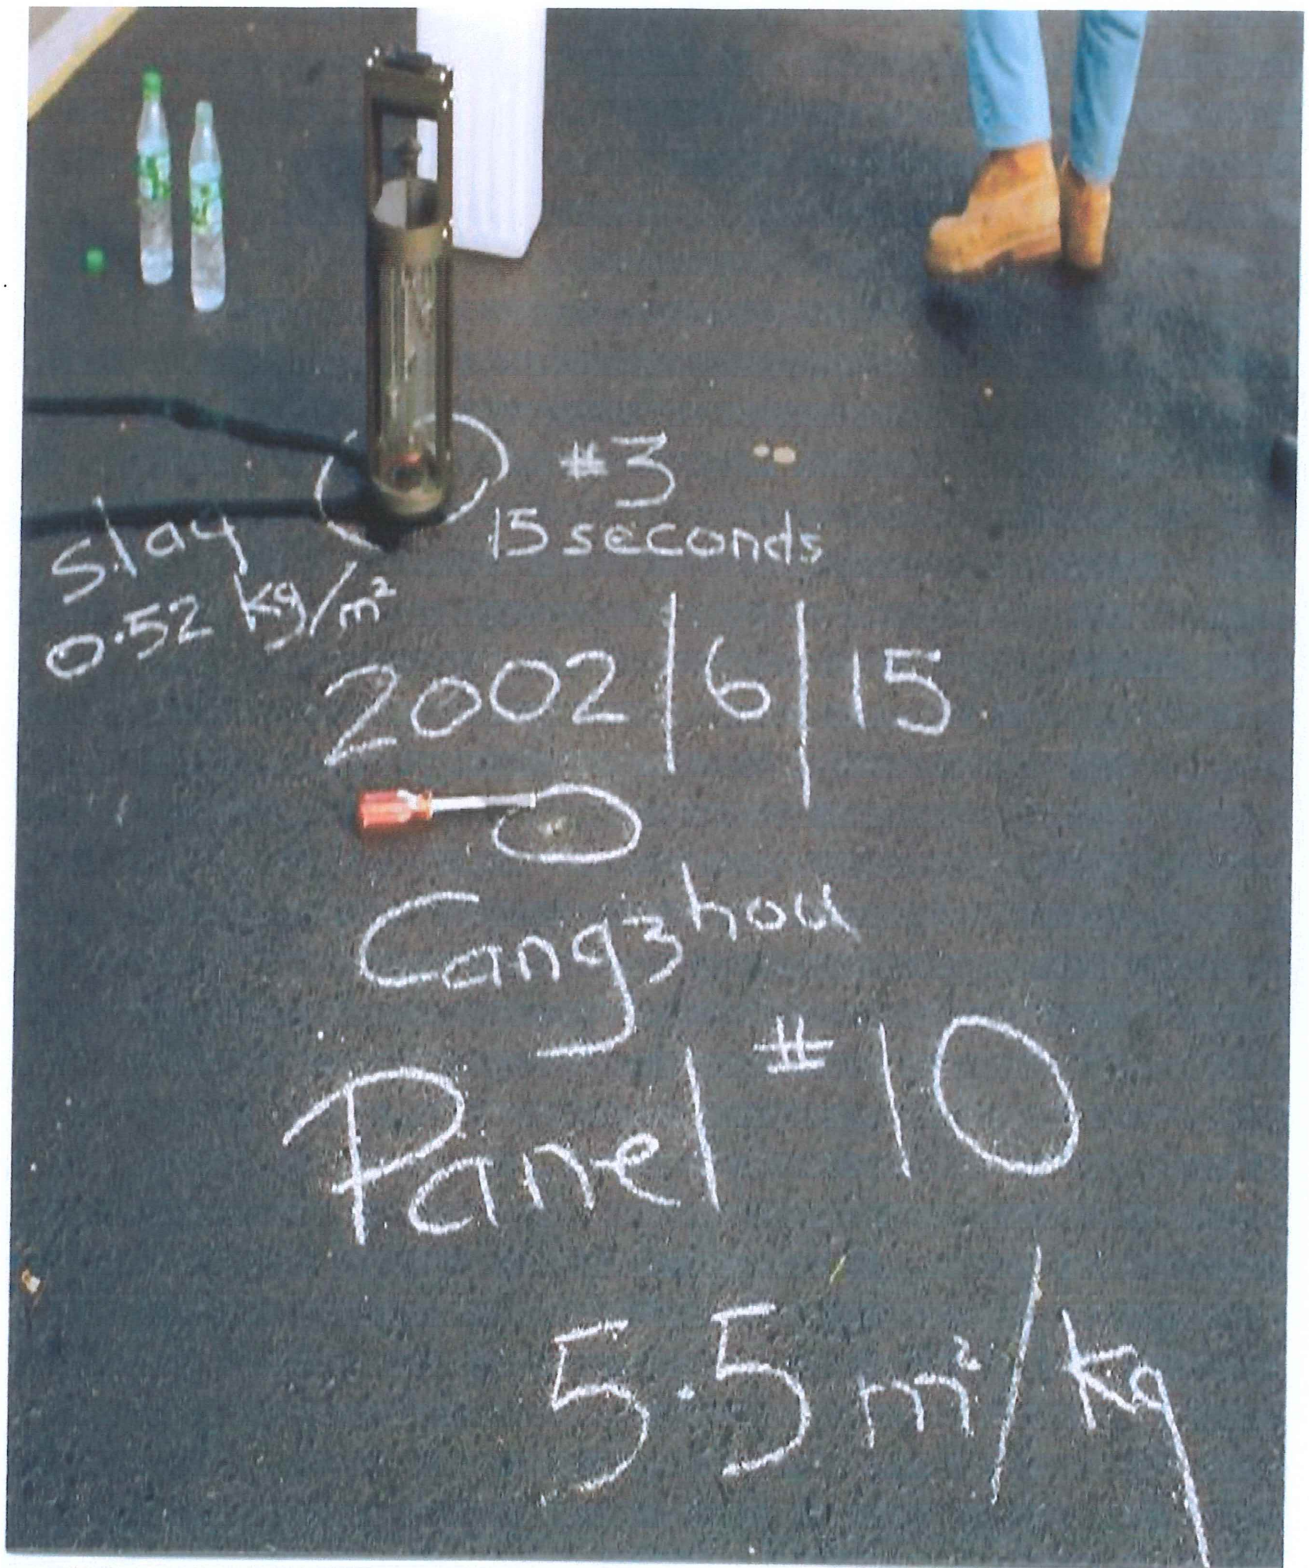
Figure 4.5
Humble Equipment Co. Outflow Meter

An "Outflow Meter" manufactured in the U.S.A. by Humble Equipment Company of Ruston, Louisiana and sold under the trademark "Outflow Meter" (see figure 4.5) was used to measure the asphalt pavement's capability to dissipate water, as concern has been expressed about hydroplaning on the RejuvaSeal™ treated surface, versus the untreated surface. The Outflow Meter gives readings in seconds for the dissipation of a known quantity of water. It is suggested that any readings between 3 and 10 seconds are satisfactory results for an asphalt surface, if hydroplaning is to be minimized. Initially readings were taken with this aforesaid Outflow Meter at four locations on the portion of the highway selected for the test, in proximity to the test patches. These initial readings were taken at 3:00 am on June 13,. A further two readings were taken when the site was revisited on June 14 at 8.30 pm and an additional 6 readings were taken on the morning of June 15 at 9:15 am. The results are shown in the table that follows:

Table 4.5		Outflow Meter Readings		
Test Date	Location relative to highway centerline	Location relative to south end of test section	Before RejuvaSeal™ (secs)	After RejuvaSea™ (secs)
June 13	2.6m w of centre	25 m north	35	n/a
June 13	1.6m w of center	25 m north	+150	n/a
June 13	1.8m w of center	24 m north	7	n/a
June 14	atop 5.5 m patch	25 m north	n/a	15
June 14	Between 5.0 m & 5.5 m patch	27 m north	n/a	13
June 15	3.0 m w of center	315 m north	n/a	5
June 15	2.0 m w of center	325 m north	n/a	7
June 15	1.0 m w of center	326 m north	n/a	15
