**Demonstration of Rejuvaseal™
Highway G112, Bazhou, Hebei,
Peoples Republic of China**

June 2002

Re: Demonstration of RejuvaSeal™ on Highway G112, Bazhou, Hebei.

Re: Inspection of RejuvaSeal Demonstration Strips near Bazhou and Cangzhou

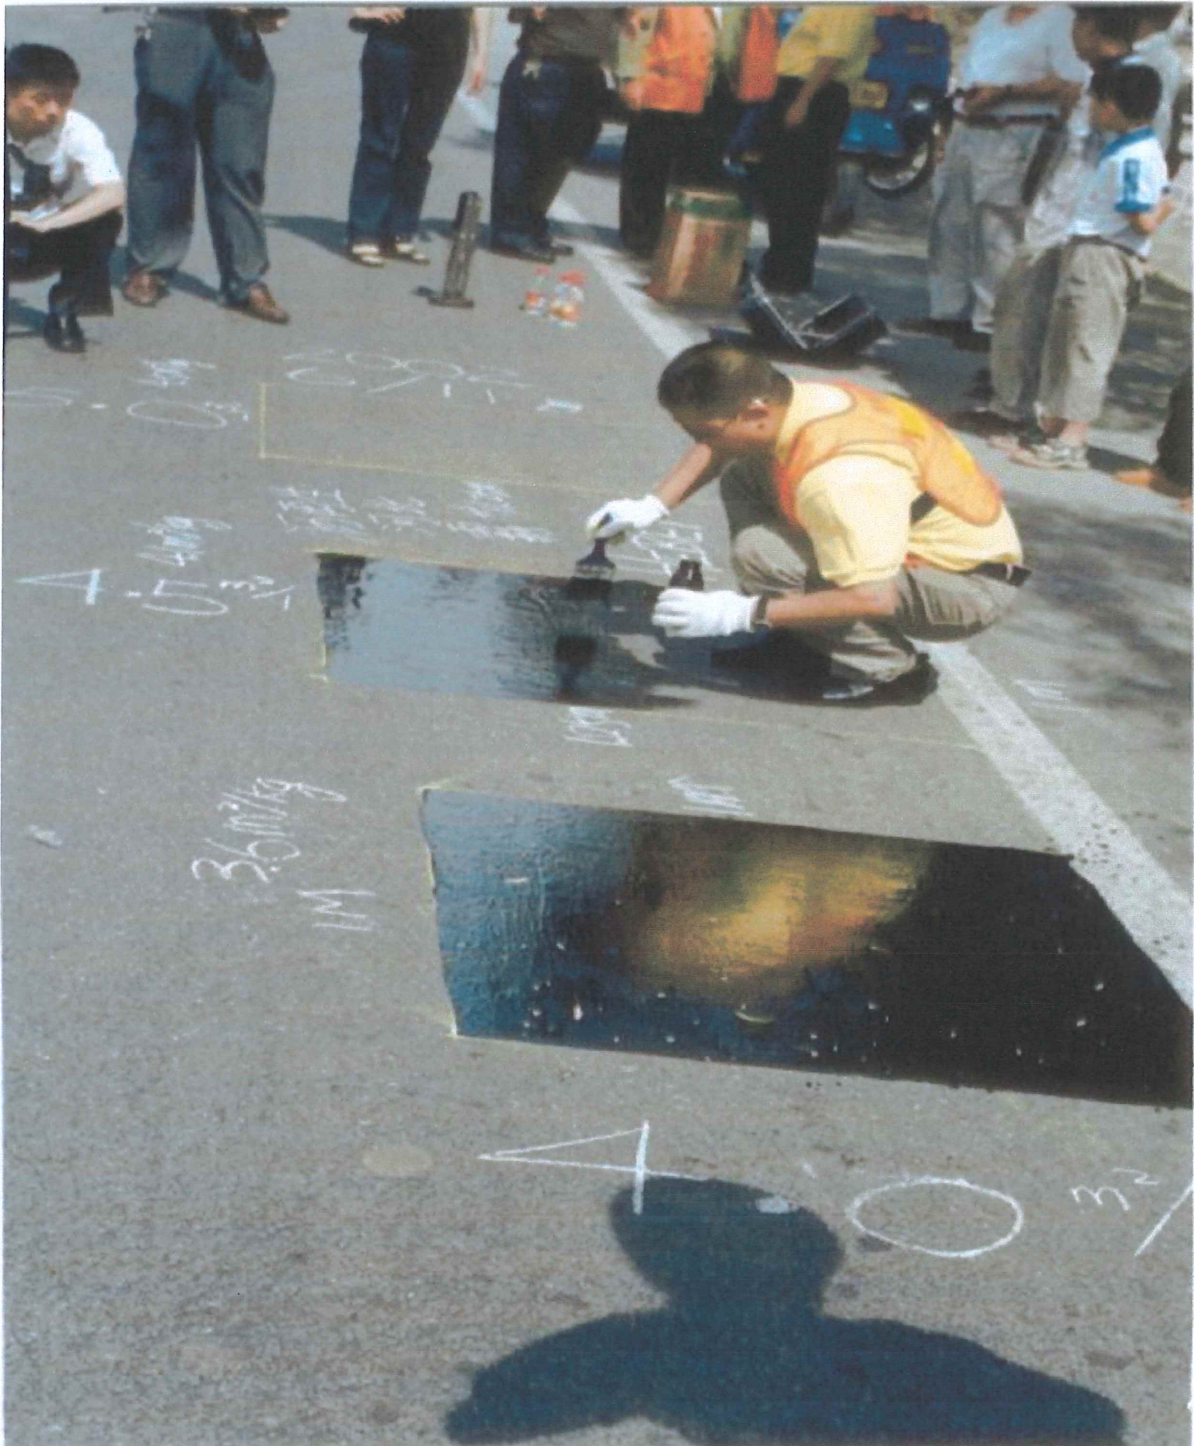
Figure 4.1
Test Patches at Demonstration Site.

See Figure No 4.1 for a photo showing the test patches as implemented. Particulars of the test patches are as follows:

Subsequent inspection of the test patches on June 12, showed that the application rate of 5.0 m²/litre (test patch three) was appropriate for the asphalt pavement at this location and could be used as a guide for other locations with similar physical characteristics.

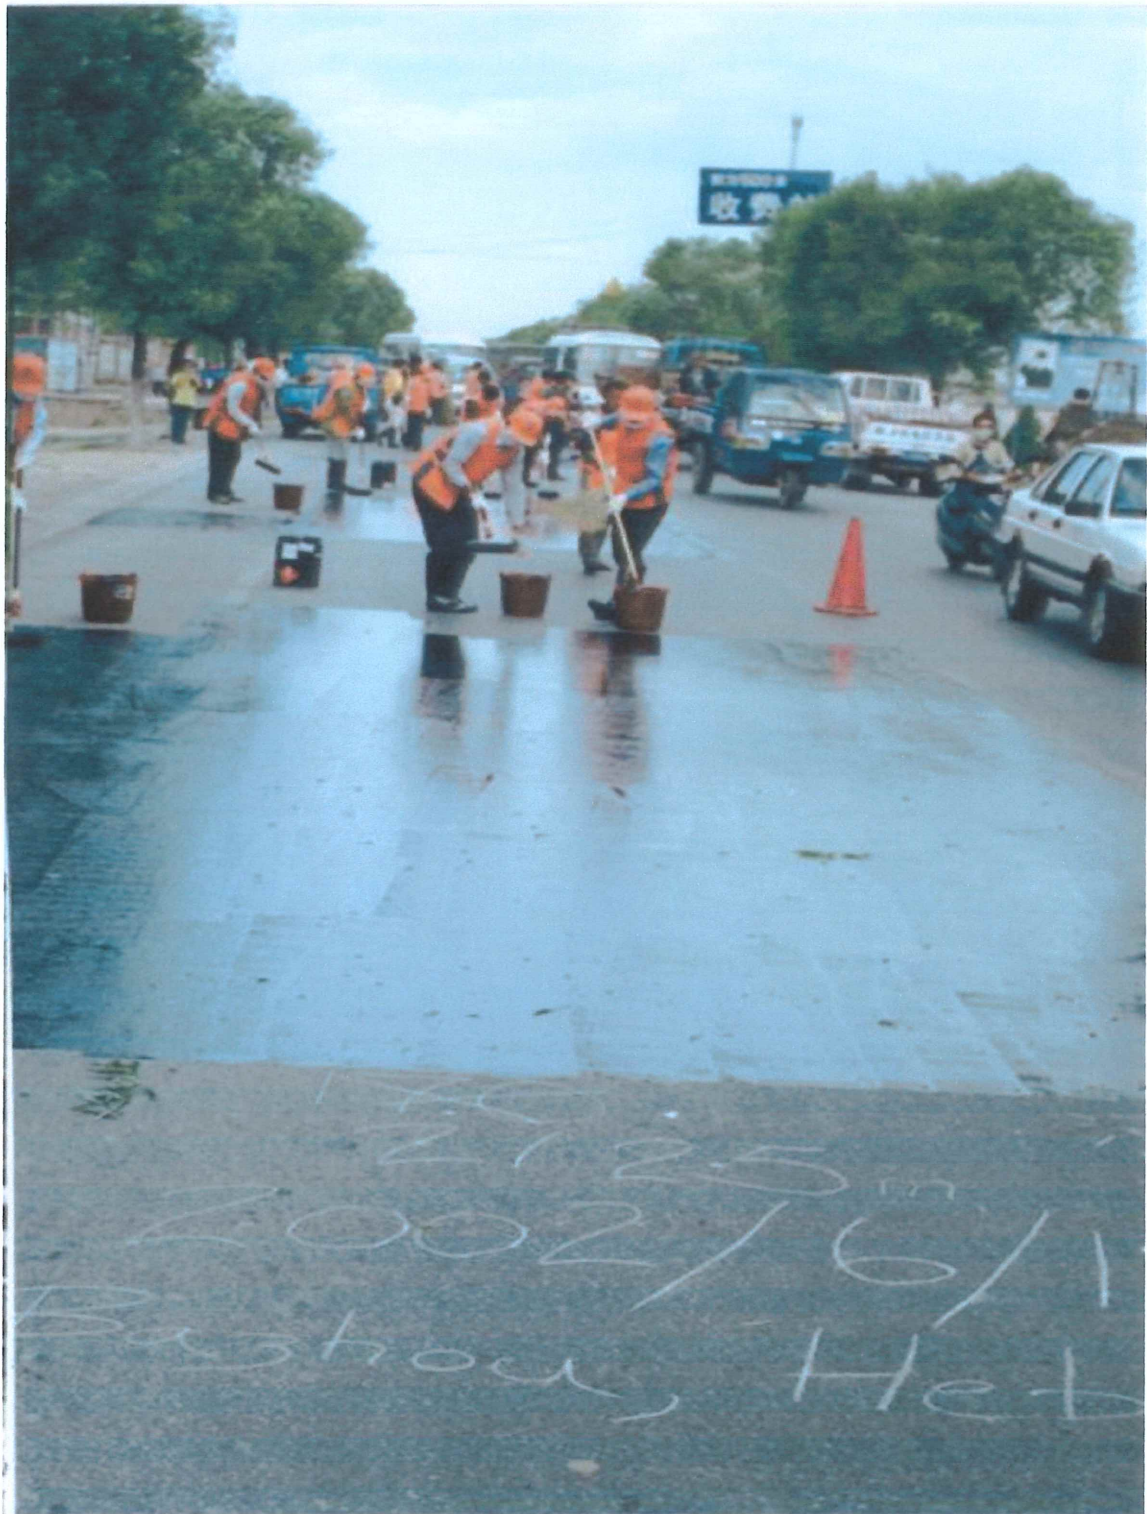
Figure 4.2
Typical Application Procedure.

On the morning of June 12, twelve segments (panels), on the eastbound lane were marked off in 17 metre increments. A final panel of 8.5 metres was added to make the distance some 212.5 metres. The width of the lane is 3.6 metres between the painted centre line and the shoulder marker line, whilst the paved shoulder is 1.9 metres wide. A five U.S. gallon (17.9 litres) pail of RejuvaSeal™ was assigned to each panel. The RejuvaSeal™ was applied to each of the panels, including the paved shoulder, using paint rollers to ensure uniformity in the application.

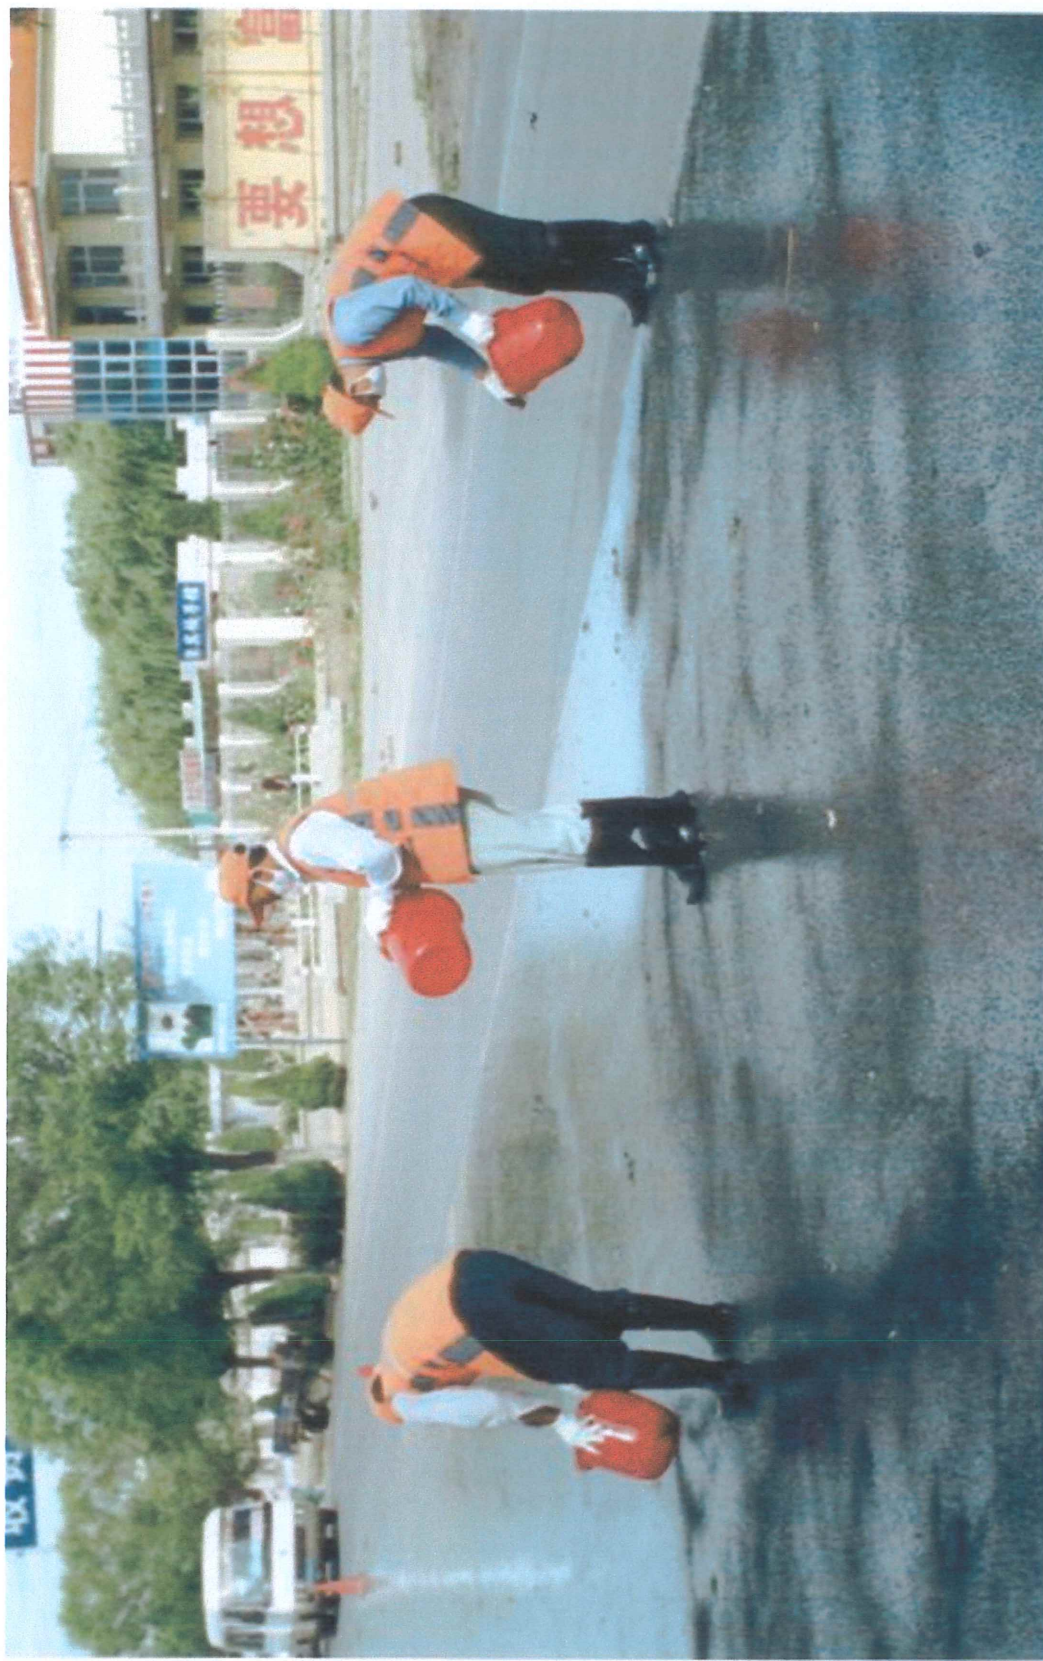
Figure 4.3 Application of Kunming Copper Slag to RejuvaSeal Surface.

In view of concern expressed by the Bazhou City Highway Department that the RejuvaSeal™ treated road gave the appearance of a slippery surface, Copper Slag from a smelter in Kunming was applied to the road surface immediately following the application of RejuvaSeal™. The application rate was approximately 0.46kgs/sq metre (1.0 lbs/sq yard). This was applied to the entire section treated. Further information on this copper slag is contained in technical data sheets in Appendix C. The approximate size consist for copper slag is as follows: >98% passing #8 mesh (2.5 mm) and <5% passing #30 mesh (0.5mm). A 14 tonne, pneumatic-tired roller was used following the slag application to roll the slag into the softened asphalt pavement surface

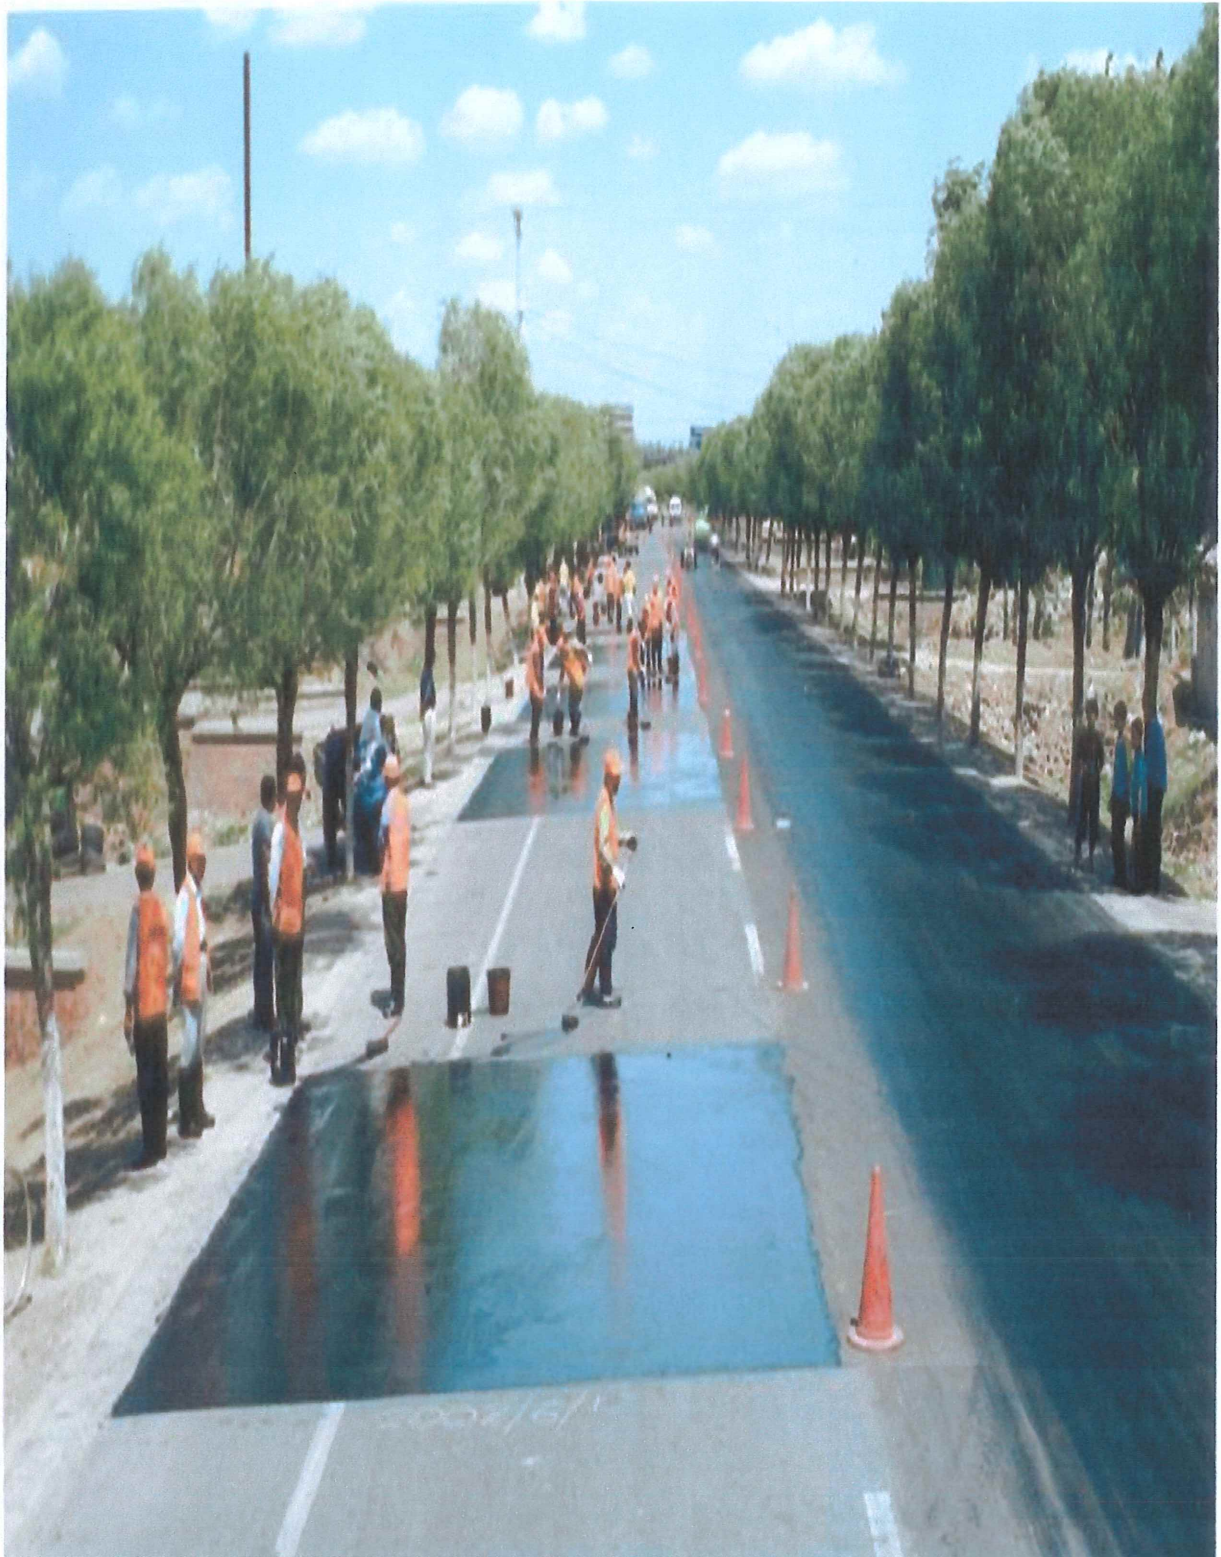
Figure 4.4 Finished Surface on Right Hand Side of Photo.

Ambient temperatures at the time of the application were in the 26 to 31 degree Celsius range, with humidity in the 55% range. The application ceased at 2:55 pm and the westbound lane remained closed until 8 pm on June 13, when it was re-opened for traffic. Photos showing the test application of RejuvaSeal™ follow in figures 4.2, 4.3 and 4.4. on the following pages.

The site was visited on June 13 around 9:14 pm and a difference was readily perceived between the RejuvaSeal™ treated section and the adjoining untreated lanes. A screwdriver was used to dig two small holes in the asphalt pavement, to a depth of 3 centimetres, some 45 metres west of the extreme east end of the demonstration section, to determine the penetration of the RejuvaSeal™. This was one day after the application of RejuvaSeal™ and at these two locations the newly rejuvenated surface was evident, by the black resilient surface layer, which was now approximately 1 millimetre thick. Below that depth, the grey, oxidized layer of asphalt was evident. The copper slag was embedded in surface of the road, and most had become invisible. Little carryover of the RejuvaSeal™ was observed from vehicle tires at the west end of the westbound lane, so it can be presumed that the surface was dry shortly after the site was vacated at 8 pm on June 13.

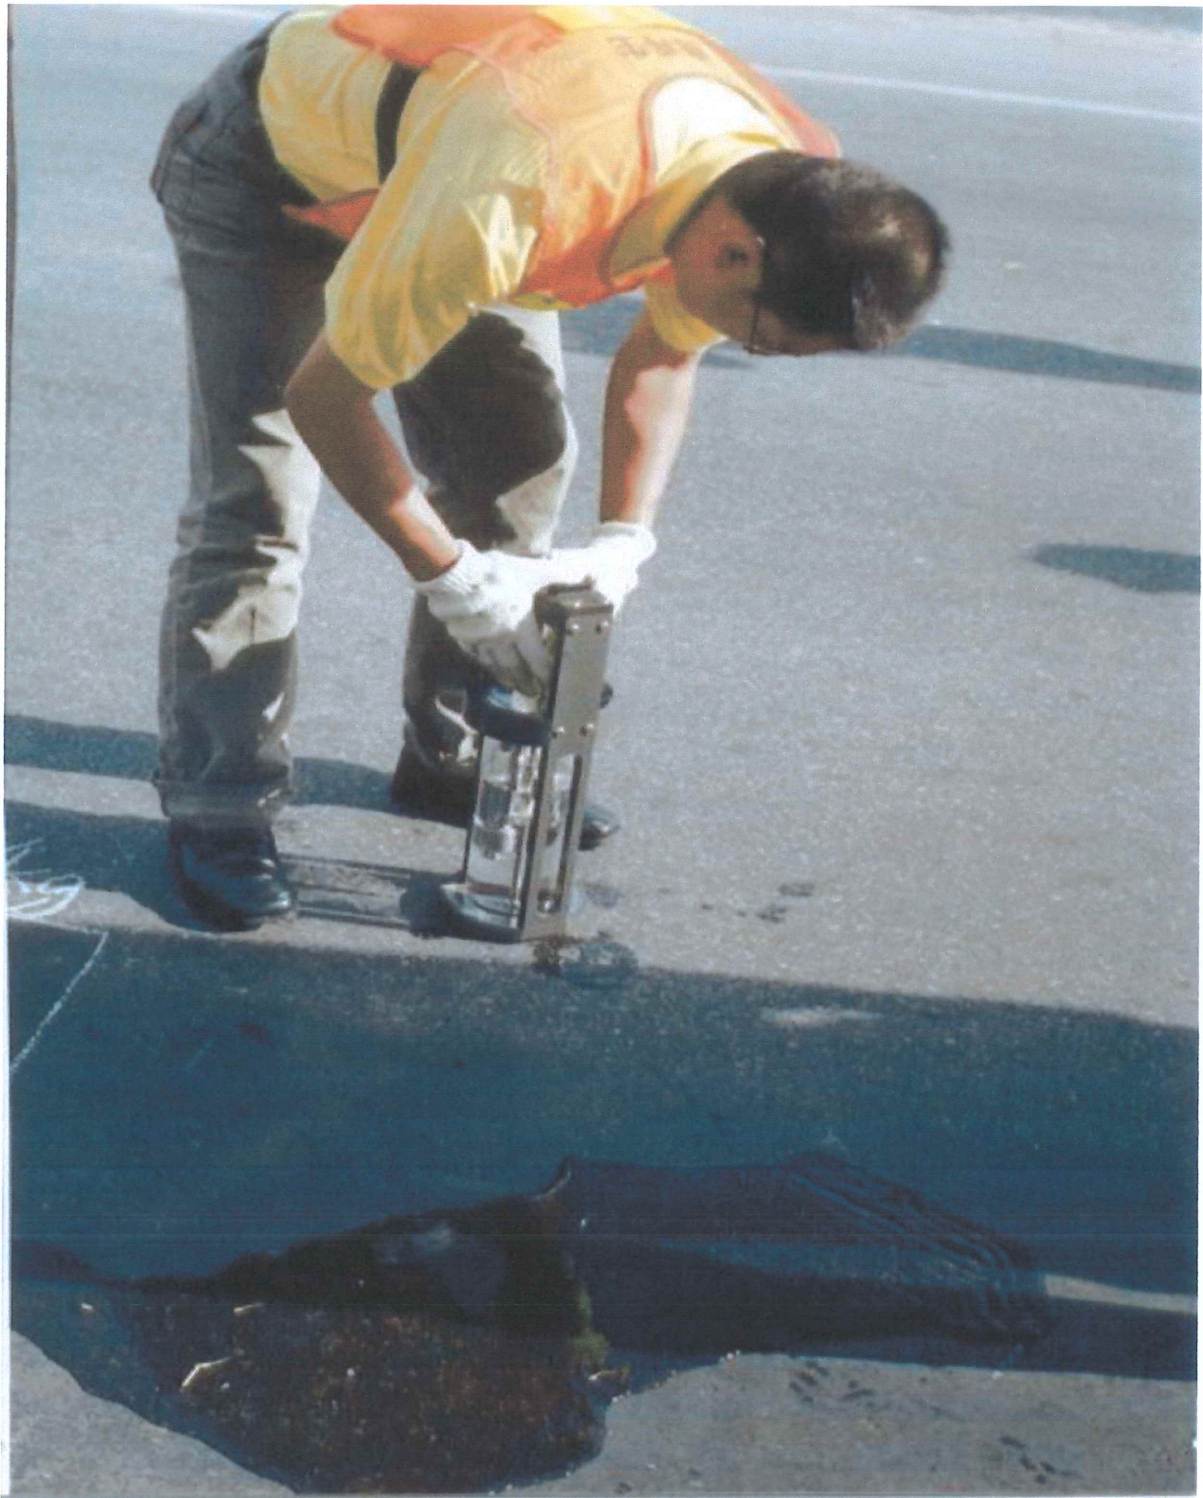
Figure 4.5
Humble Equipment Co. Outflow Meter

An “Outflow Meter” manufactured in the U.S.A. by Humble Equipment Company of Ruston, Louisiana and sold under the trademark “Outflow Meter” (see figure 4.5) was used to measure the asphalt pavement’s capability to dissipate water, as concern has been expressed about hydroplaning on the RejuvaSeal™ treated surface, versus the untreated surface. The Outflow Meter gives readings in seconds for the dissipation of a known quantity of water. It is suggested that any readings between 3 and 10 seconds are satisfactory results for an asphalt surface, if hydroplaning is to be minimized. Initially readings were taken with this aforesaid Outflow Meter at four locations on the portion of the highway selected for the test, in proximity to the test patches. These initial readings were taken at 4:00 am on June 12,. A further two readings were taken when the site was revisited on June 13 at 8.30 pm and an additional 6 readings were taken on the morning of June 14 at 8:45 am. The results are shown in the table that follows:

Table 4.5		Outflow Meter Readings		
Test Date	Location relative to highway centerline	Location relative to west end of test section	Before RejuvaSeal™ (secs)	After RejuvaSea™ (secs)
June 11	2.6m s of centre	5 metres west	11	n/a
June 11	1.1m s of center	4 metres west	50	n/a
June 11	4.6m s of center	2 metres west	11	n/a
June 12	atop 5.0 m patch	4 metres west	n/a	9
June 12	atop 5.0 m patch	4 metres west	n/a	9
June 12	1m east of patch	3 metres east	+50	n/a
June 12	atop 4.0 m patch	9 metres west	n/a	21
June 13	1 metre north	160 m east	n/a	37
June 13	1 metre north	161 m east	n/a	24
June 13	1 metre north	162 m east	n/a	28
June 13	1 metre north	162 m east	n/a	28
June 13	2.5 metre south	165 m east	n/a	28
June 13	2.5 metre south	166 m east	n/a	28
