# Demonstration of Rejuvaseal<sup>™</sup> Wei-Lai Expressway, WeiFang, ShanDong, Peoples Republic of China

**June 2002**

TS<sup>2</sup> Consulting Inc. Lamma, Hong Kong

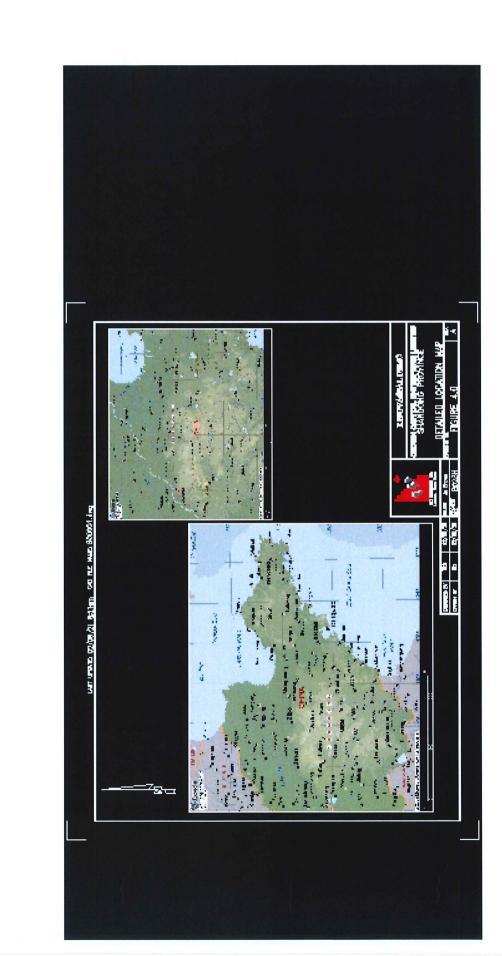
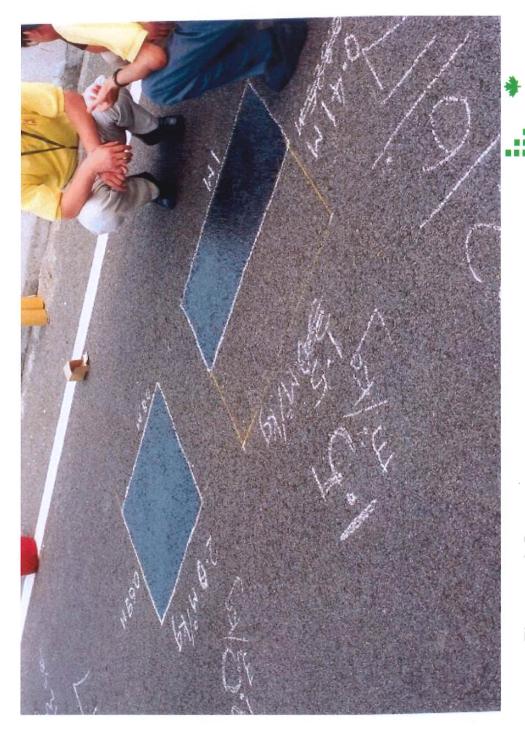
Figure 4.1 Test Patches at Demonstration Site.

See Figure No 4.1 for a photo showing the test patches as implemented. Particulars of the test patches are as follows:

Subsequent inspection of the test patches on June 18, showed that the application rate of 2.0 m<sup>2</sup>/Kg (test patch one) was appropriate for the asphalt

pavement at this location and could be used as a guide for other locations with similar physical characteristics.

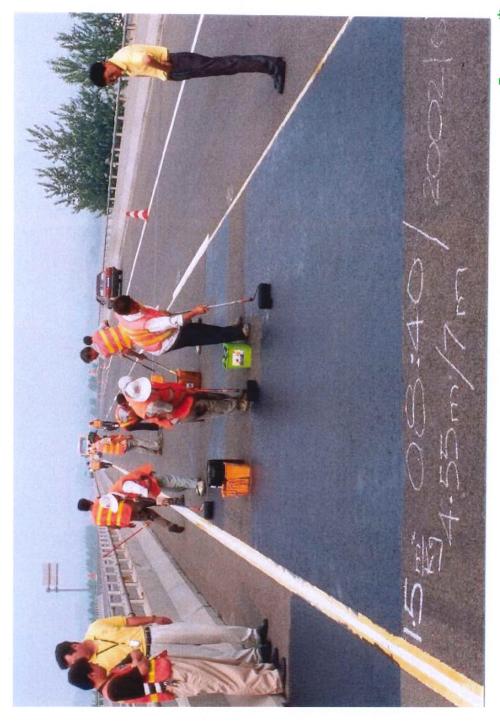
Figure 4.2 Typical Application Procedure.

On June 18, segments (panels) were marked off in 7 metre increments, the full width of the inside lane. The width of the lane is 4.55 metres between the bridge guardrail and the dividing line. A five U.S. gallon (17.9 litres) pail of RejuvaSeal<sup>TM</sup> was assigned to each panel. The RejuvaSeal<sup>TM</sup> was applied to each of the panels, using paint rollers and paint roller pans, to ensure uniformity in the application. The last panel was completed at 10:05 am.

Ambient temperatures at the time of the application were in the 31 to 34 degree Celsius range, with humidity in the 85% range. The application ceased at 10:50 pm and the pneumatic roller worked until 12:50 pm. The lane remained closed until 7 pm on June 18, when it was re-opened for traffic. Photos showing the test application of RejuvaSeal<sup>TM</sup> follow in figures 4.2 and 4.3. on the following pages.

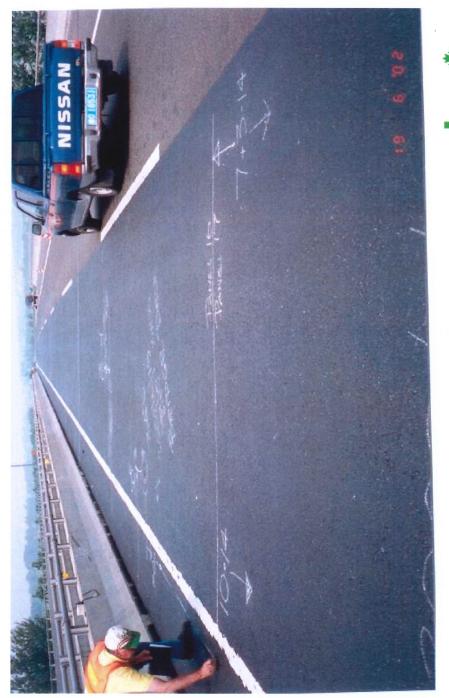
The site was visited on June 19 around 9:20 pm and a difference was readily perceived between the RejuvaSeal<sup>TM</sup> treated section and the adjoining untreated lanes. A screwdriver was used to dig two small holes in the asphalt pavement, to a depth of 3 centimetres, some 45 metres west of the extreme east end of the demonstration section, to determine the penetration of the RejuvaSeal<sup>TM</sup>. This was one day after the application of RejuvaSeal<sup>TM</sup> and at these two locations the newly rejuvenated surface was evident, by the black resilient surface layer, which was now approximately 1 millimetre thick. Below that depth, the grey, oxidized layer of asphalt was evident. The copper slag remained embedded in surface of the road, and most had cemented to the RejuvaSeal<sup>TM</sup>. No carryover of the RejuvaSeal<sup>TM</sup> was observed from vehicle tires at the east end of the demonstration strip, so it can be presumed that the surface was dry when the site was vacated at 7 pm on June 18.

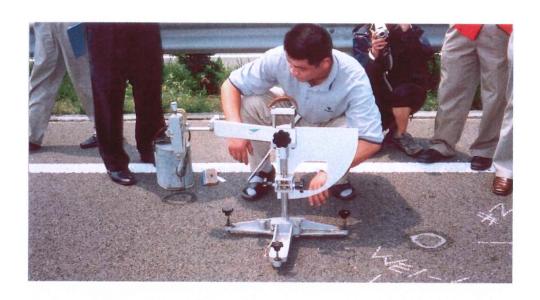
Figure 4.4 British pendulum Test (top)
Sand Patch Test (lower left)
Water Infusion Test (lower right)

The Shandong Highway Research Department brought additional testing equipment to the site on June 19, for comparison on a more disciplined, objective basis and to this end, the following tests were undertaken.

- Sand Patch Test
- British Pendulum Test
- Water Infusion Test.

These will be reported separately in a report compiled by the Shandong Highway Research Department. See Figure 4.4 that follows, showing the testing equipment utilized by the Shandong Highway Research Department.

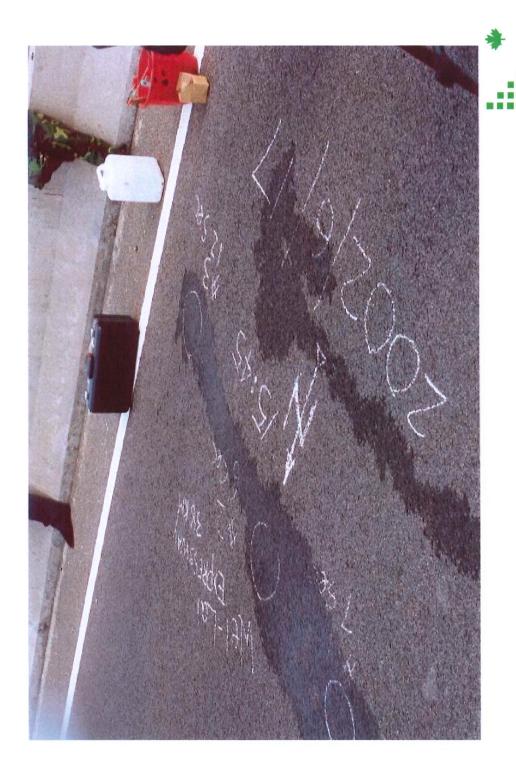
Figure 4.5 Humble Equipment Co. Oufflow Meter

An "Outflow Meter" manufactured in the U.S.A. by Humble Equipment Company of Ruston, Louisiana and sold under the trademark "Outflow Meter" (see figure 4.5) was used to measure the asphalt pavement's capability to dissipate water, as concern has been expressed about hydroplaning on the RejuvaSeal<sup>TM</sup> treated surface, versus the untreated surface. The Outflow Meter gives readings in seconds for the dissipation of a known quantity of water. It is suggested that any readings between 3 and 10 seconds are satisfactory results for an asphalt surface, if hydroplaning is to be minimized.

Readings were taken with this aforesaid Outflow Meter at three locations on the portion of the bridge selected for the test. These readings were taken at 9:30 am on June 17. The results are shown in the table that follows:

• Readings in the 3 to 10 second range are quite acceptable from a skid resistance viewpoint.
