**CROWN CAPITAL ENTERPRISE
LIMITED**

**Demonstration of Rejuvaseal™
West Second Road, DaQing, Heilongjiang,
Peoples Republic of China**

August 2002

**TS² Consulting Inc.
Lamma, Hong Kong**

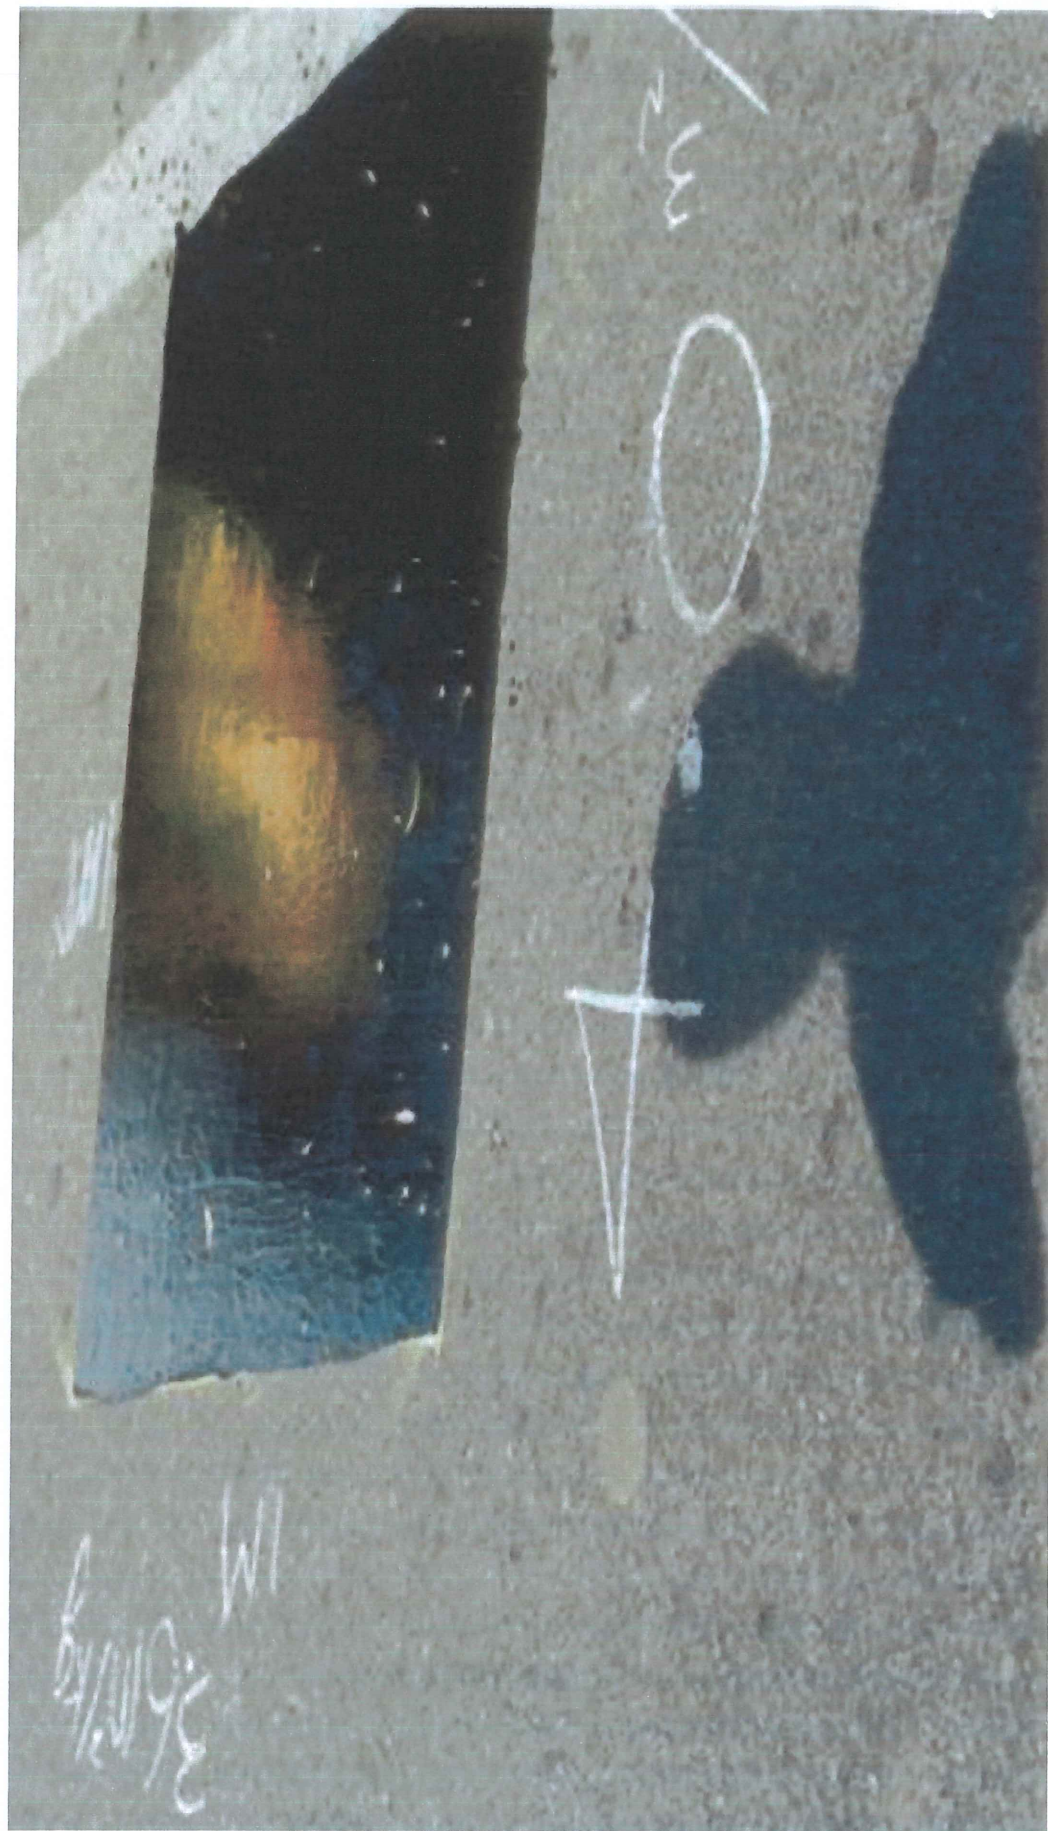
Figure 4.1 Test Patch at Demonstration Site.

On July 15, 2002 a test patch in the northbound lane of West Second Road (two lane highway with no paved shoulders) was treated with RejuvaSeal™. The test patch was at the following geographic location:

Subsequent inspection of the test patches on August 9, showed that the application rate of 4.0 m²/kg was more than adequate for the asphalt

pavement at this location and a slightly lower application rate of 4.76 metres/kg was selected.

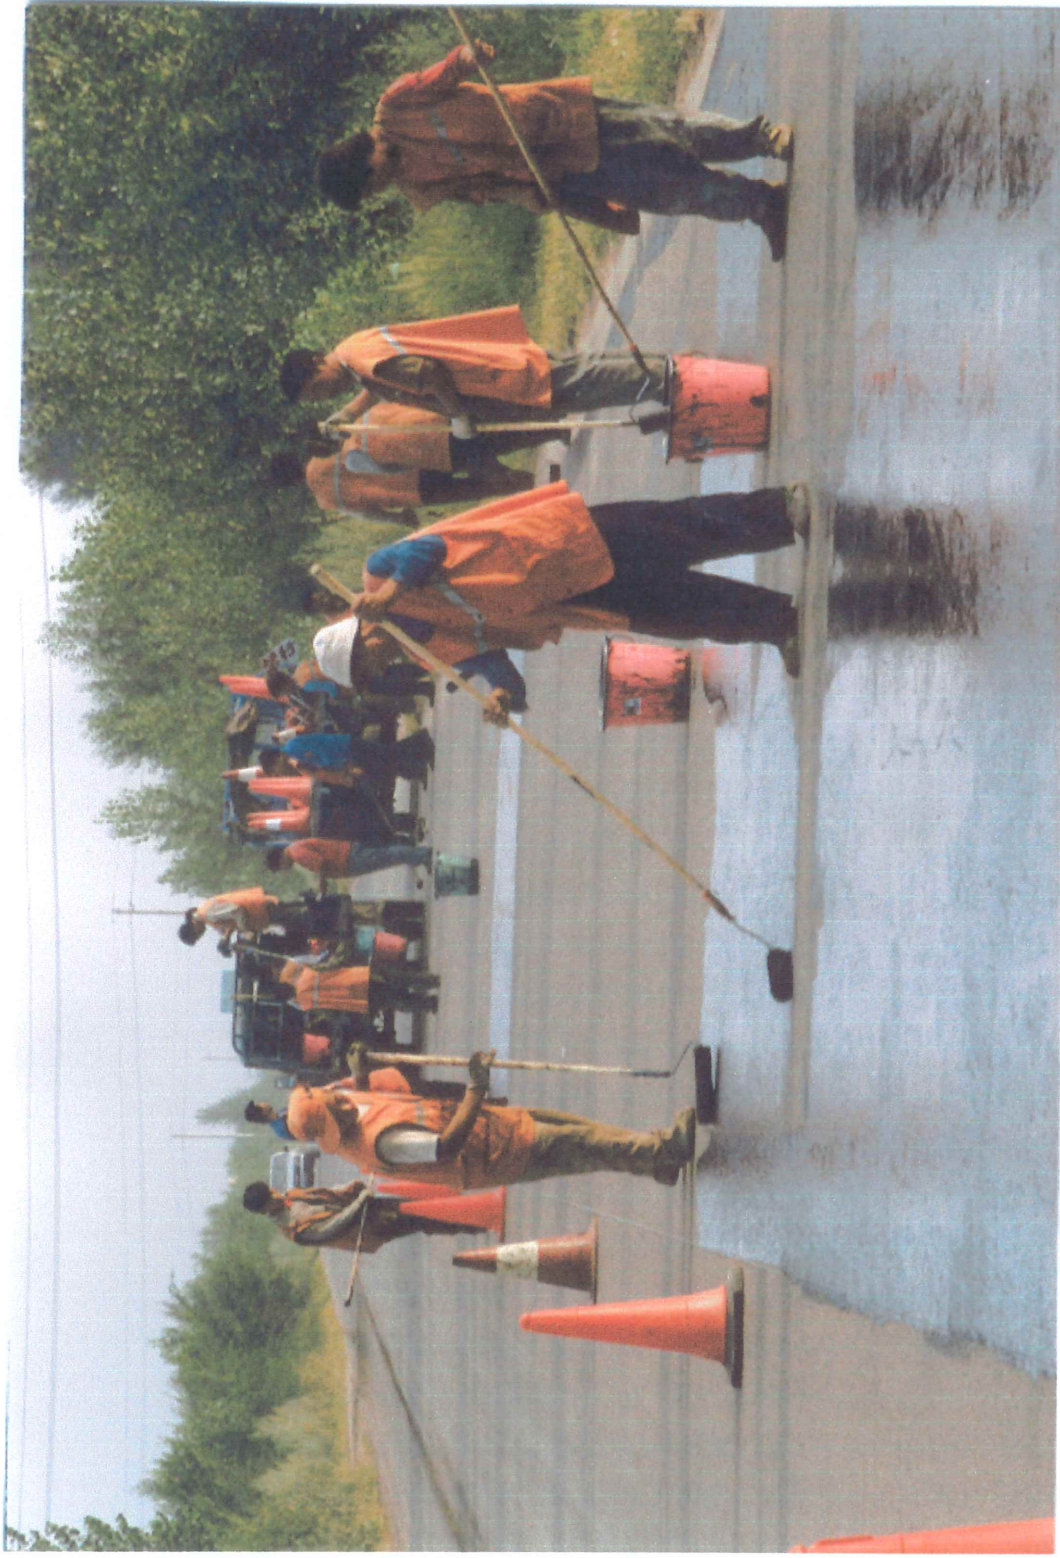
Figure 4.2 Typical Application Procedure.

Ambient temperatures at the time of the application on August 12 were in the 26 to 31 degree Celsius range, with humidity in the 55% range. Photos showing the test application of RejuvaSeal™ follow in figures 4.2, 4.3 and 4.4. on the following pages.

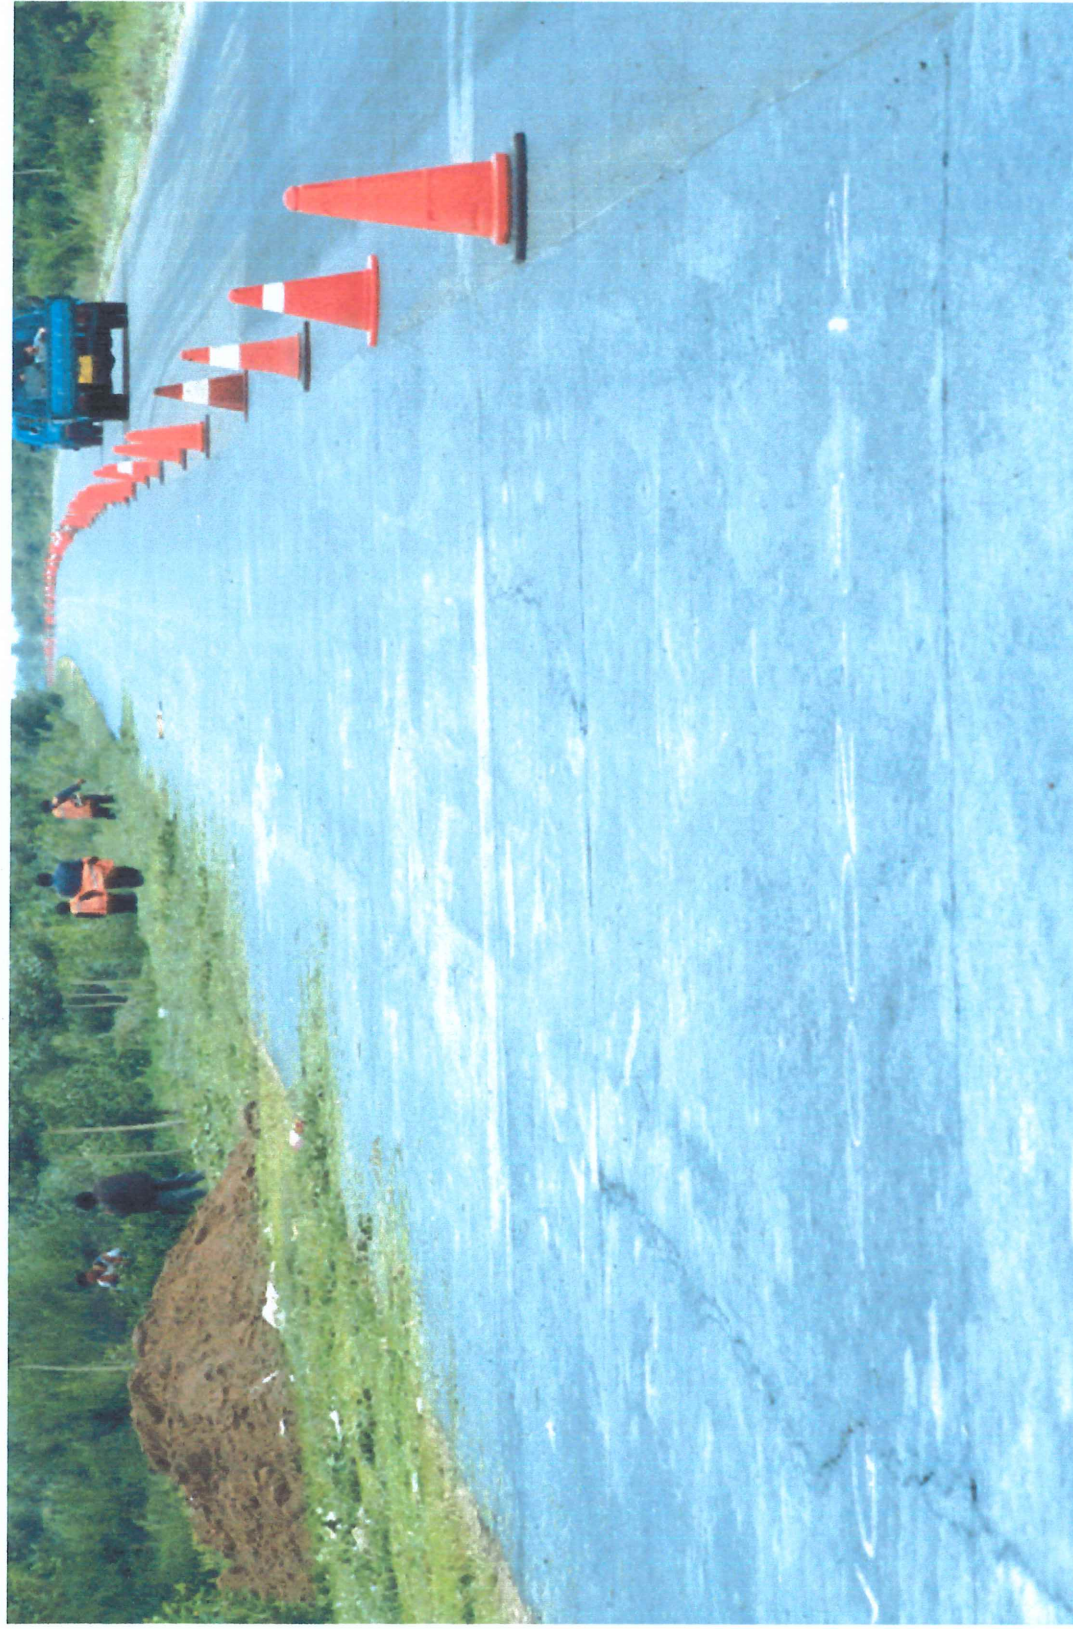
Figure 4.3 Finished Surface.

The site was visited on August 13 around 7:00 am and a difference was readily perceived between the RejuvaSeal™ treated section and the adjoining untreated lanes. A screwdriver was used to dig two small holes in the asphalt pavement, to a depth of 3 centimetres, some 700 metres north of the extreme south end of the demonstration section, to determine the penetration of the RejuvaSeal™. This was one day after the application of RejuvaSeal™ and at these two locations the newly rejuvenated surface was evident, by the black resilient surface layer, which was now approximately 1 millimetre thick. Below that depth, the grey, oxidized layer of asphalt was evident.

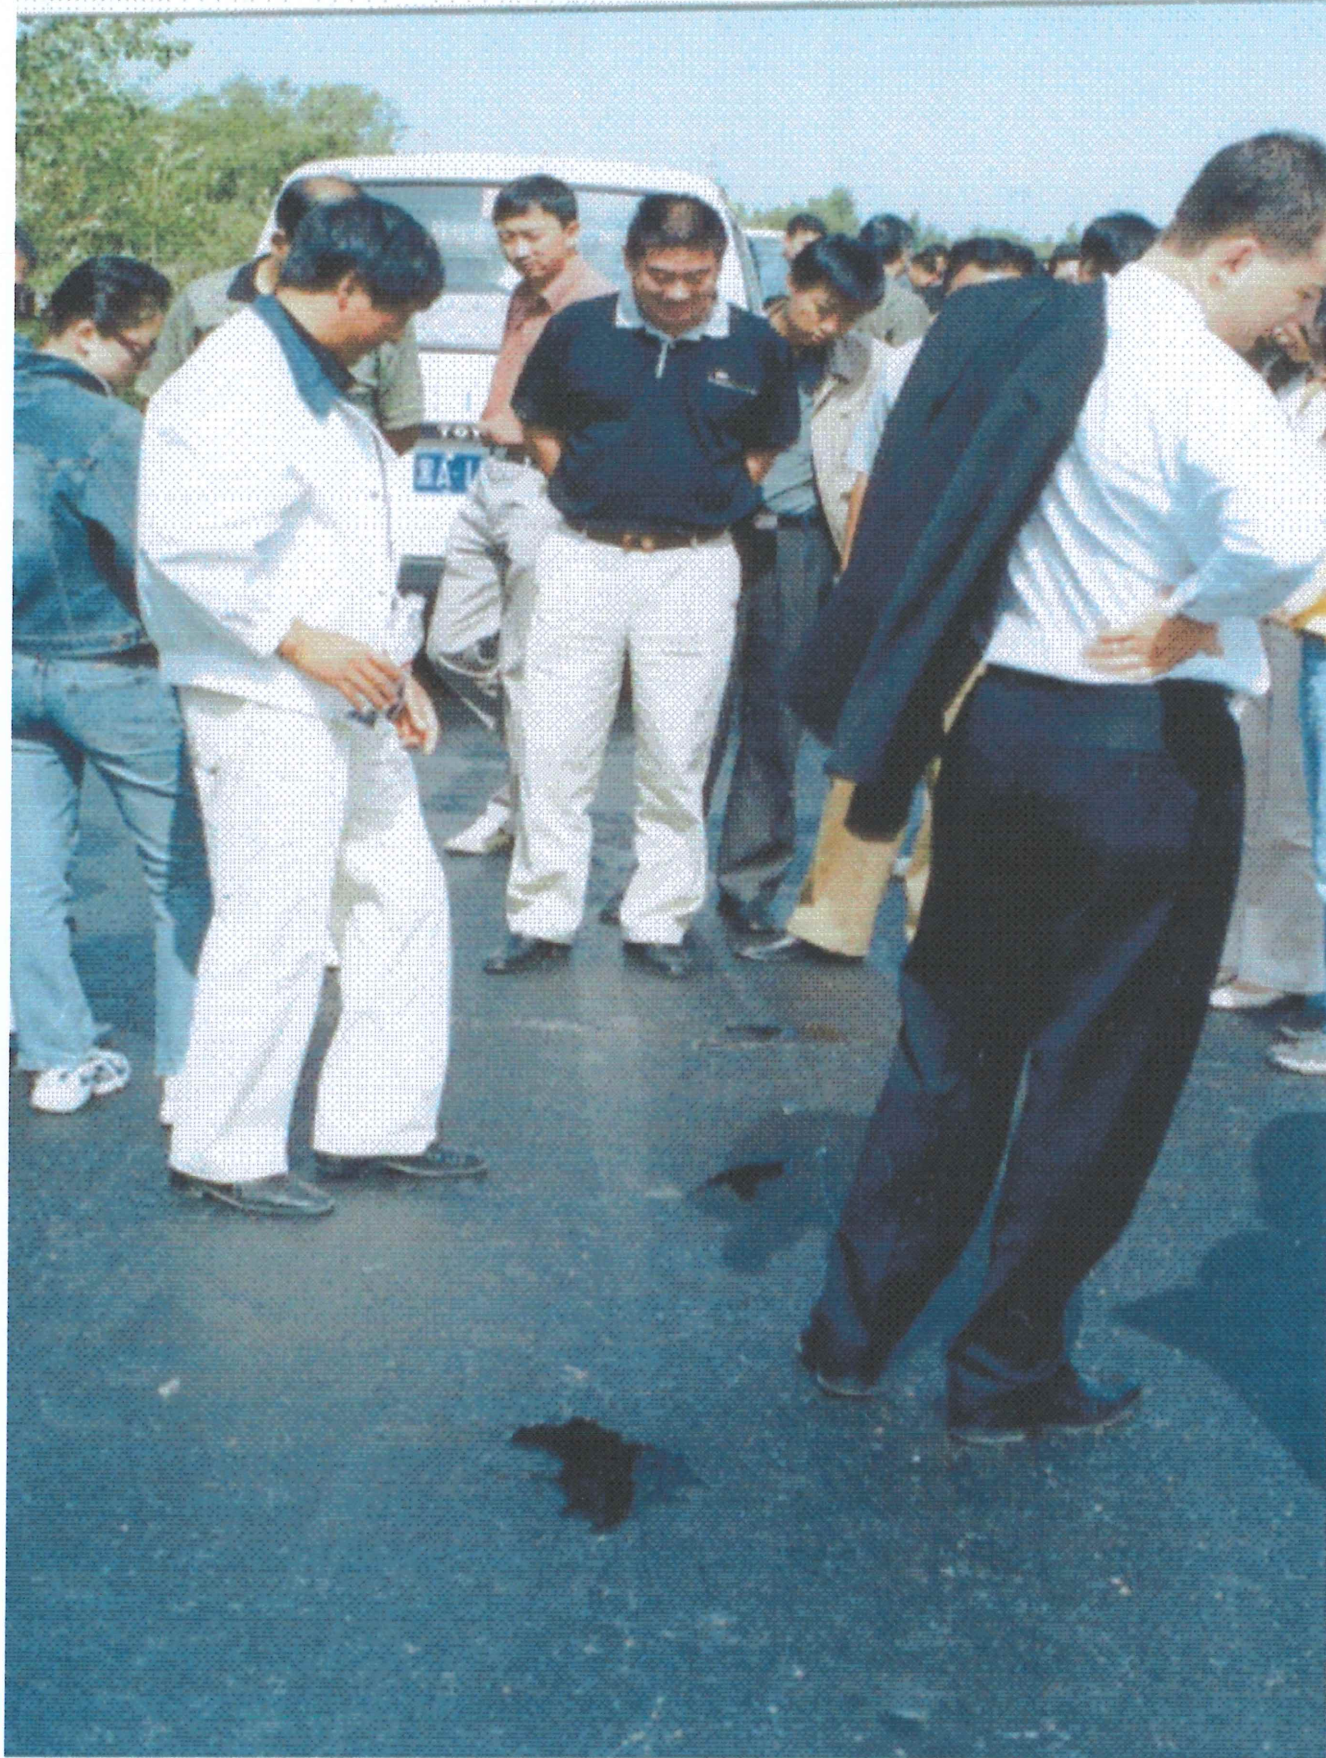
Figure 4.4 Site visit - One Month following application

On the morning of August 12, work recommenced on the demonstration section at 6:00 am on a further 1100 metres of the northbound lane. Panels were again marked off in 20 metre increments. A pail which holds 19 kilograms of RejuvaSeal™ was assigned to each panel. The RejuvaSeal™ was applied to each of the panels, using paint rollers to ensure uniformity in the application. Further application of RejuvaSeal on the remainder of the 3.65 kilometre test section were undertaken over the next three weeks, culminating in completion of both the north bound lane and the south bound lane. A site visit on September 6 was made to check the entire test section and evaluate the penetration of the RejuvaSeal. This is graphically shown in Figure 4.4 that follows.

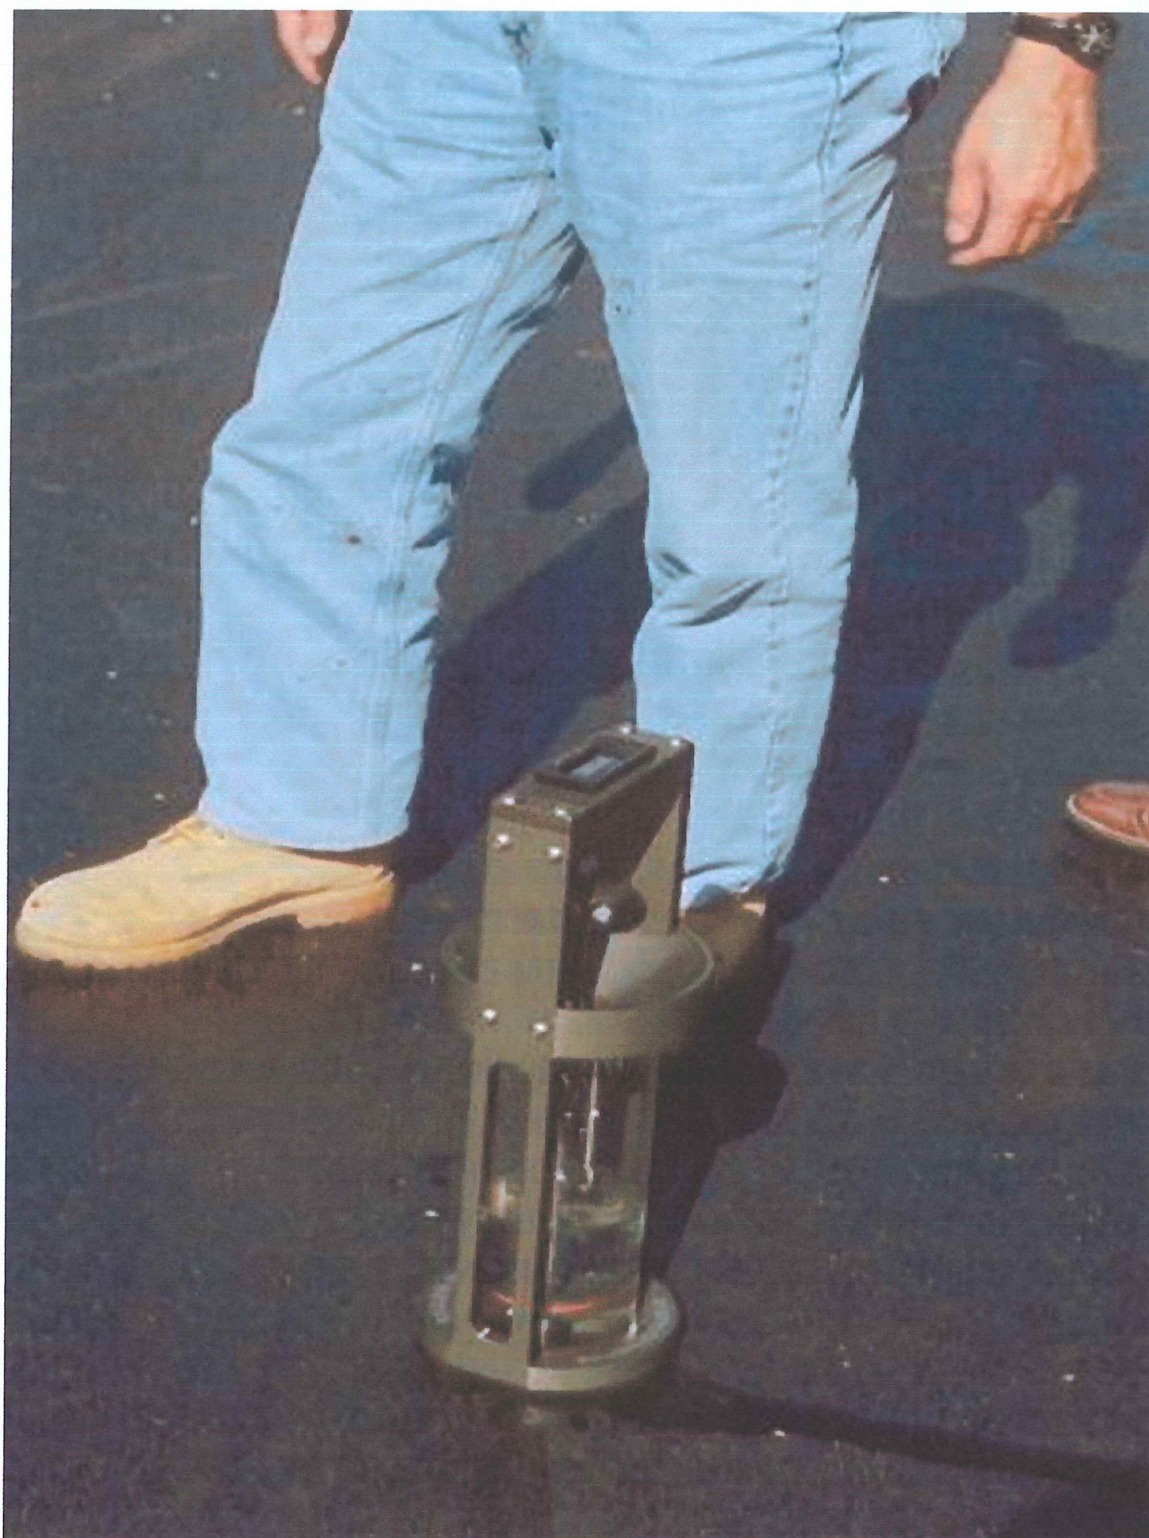
Figure 4.5
Humble Equipment Co. Outflow Meter

An “Outflow Meter” manufactured in the U.S.A. by Humble Equipment Company of Ruston, Louisiana and sold under the trademark “Outflow Meter” (see figure 4.5) was used to measure the asphalt pavement’s capability to dissipate water, as concern has been expressed about hydroplaning on the RejuvaSeal™ treated surface, versus the untreated surface. The Outflow Meter gives readings in seconds for the dissipation of a known quantity of water. It is suggested that any readings between 3 and 10 seconds are satisfactory results for an asphalt surface, if hydroplaning is to be minimized. Initially readings were taken with this aforesaid Outflow Meter at four locations on the portion of the highway selected for the test, in proximity to the test patch. These initial readings were taken at 8:00 am on August 11.

Table 4.5		Outflow Meter Readings		
Test Date	Location relative to highway centerline	Location relative to south end of test section	Before RejuvaSeal™ (secs)	After RejuvaSea™ (secs)
Aug 11	2.6m w of centre	50 m north	32	n/a
Aug 11	center	50 m north	6	n/a
Aug 11	2.6m e of center	50 m north	10	n/a
