Demonstration of Rejuvaseal[™] ChangPing Expressway, ChangChun, Jilin, Peoples Republic of China

September 2002

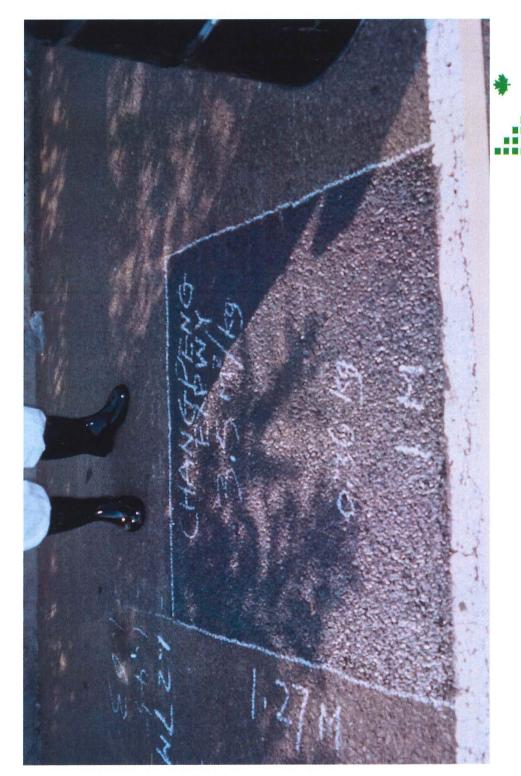
Figure 4.1 Test Patch at Demonstration Site.

See Figure No 4.1 for a photo showing the test patch as implemented. Particulars of the test patch are as follows:

Subsequent inspection of the test patches on September 16, showed that the application rate of 3.5 m²/kg was more than adequate for the asphalt pavement at this location and a slightly lower application rate of 3.34 m²/kg was selected.

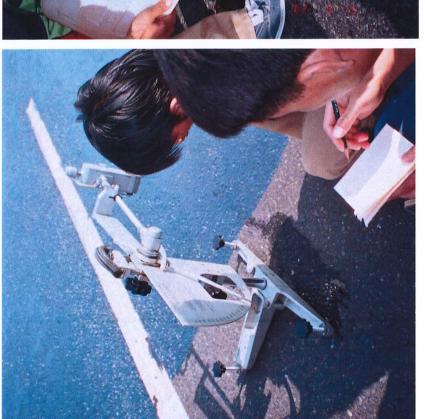
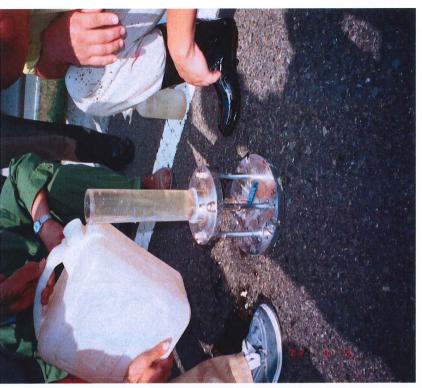
Figure 4.4 British pendulum Test (left) Water Infusion Test (right)

A site visit on September 17 was made to check to entire test section and evaluate the penetration of the RejuvaSeal. This is graphically shown in Figure 4.4 that follows.

The site was visited on September 17 around 7:00 am and a difference was readily perceived between the RejuvaSealTM treated section and the adjoining untreated lanes. A screwdriver was used to dig two small holes in the asphalt pavement, to a depth of 3 centimetres, some 10 metres south of the extreme north end of the demonstration section, to determine the penetration of the RejuvaSealTM. This was one day after the application of RejuvaSealTM and at these two locations the newly rejuvenated surface was evident, by the black resilient surface layer, which was now approximately 1 millimetre thick. Below that depth, the grey, oxidized layer of asphalt was evident.
