Demonstration of Rejuvaseal[™] ShengLi Beijie, Shijiazhuang, Hebei, Peoples Republic of China

September 2002

Re: Demonstration of RejuvaSealTM on ShengLi Beijie, Shijiazhuang,

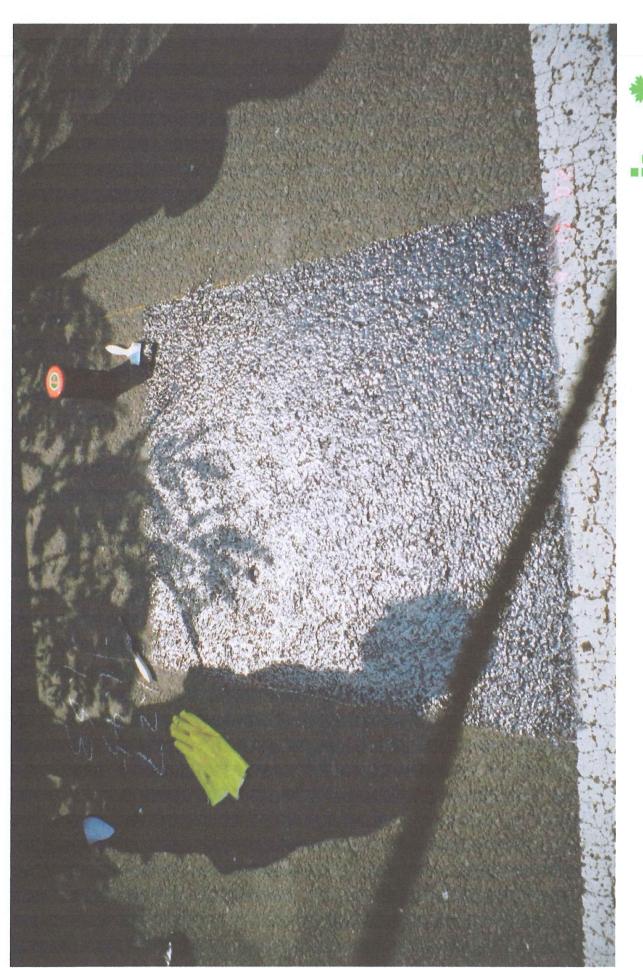
Figure 4.1 Test Patch at Demonstration Site.

See Figure No 4.1 for a photo showing the test patches as implemented. Particulars of the test patch are as follows:

Subsequent inspection of the test patch on September 16, showed that the application rate of 4.55 m²/kilogram was appropriate for the asphalt pavement at this location and could be used as a guide for other locations with similar physical characteristics.

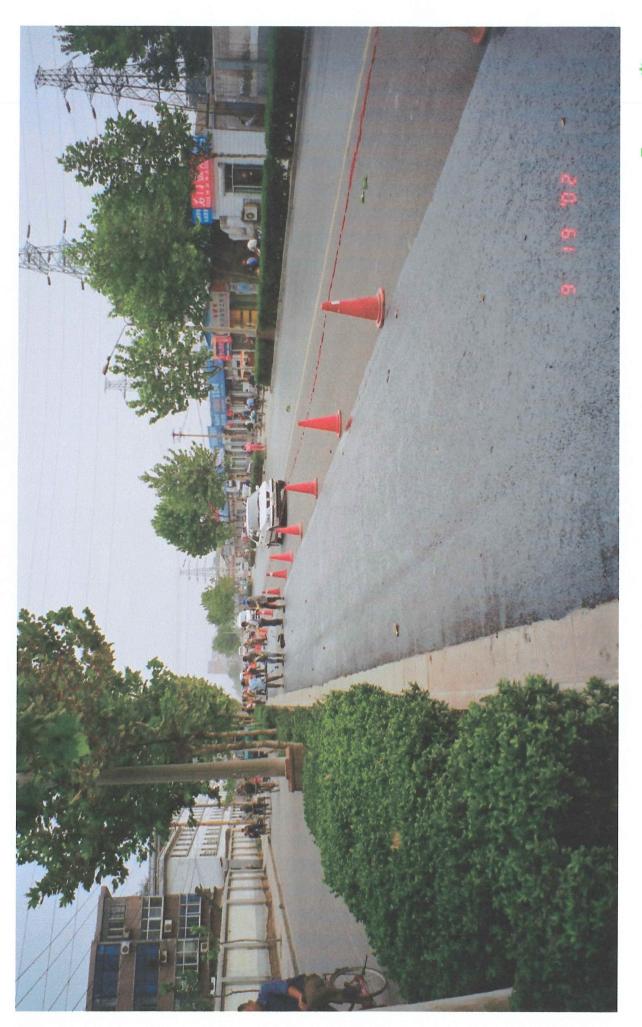
Figure 4.4 Finished Surface. Southbound, Curb Lane Segment

The site was visited on September 19 around 9:15 am and a difference was readily perceived between the RejuvaSealTM treated sections and the adjoining untreated lanes. A screwdriver was used to dig two small holes in the asphalt pavement, to a depth of 3 centimetres, some 100 metres south of the extreme north end of the demonstration section, to determine the penetration of the RejuvaSealTM. This was one day after the application of RejuvaSealTM and at this location, the newly rejuvenated surface was evident, by the black resilient surface layer, which was now approximately 1 millimetre thick. Below that depth, the grey, oxidized layer of asphalt was evident.
