Demonstration of Rejuvaseal[™] Li-Wen Expressway, Ying Tan, JiangXi, Peoples Republic of China

January 2003

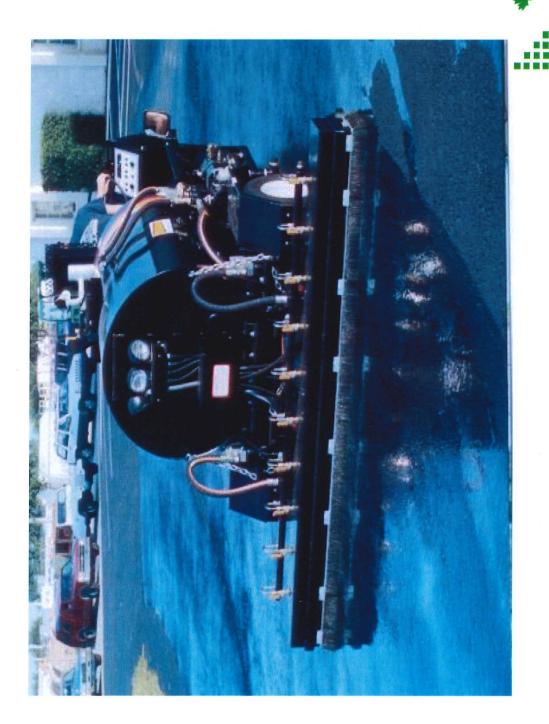
Figure 4.2 RejuvaSeal Application using Desco D200 Sprayer

On January 24, the Desco D200 Sprayer was filled with 3.5 barrels of RejuvaSeal. The widths of the lanes are 3.75 metres between the painted lane dividing line and the shoulder marker line. An inside shoulder, nominally 0.5 metres occurs and an outside shoulder of 1.3 metres exists. RejuvaSeal was applied, using a Desco D200 Sprayer, to ensure uniformity in the application. The initial test strip was completed in two passes and work on this initial test strip finished at 12:20 pm.

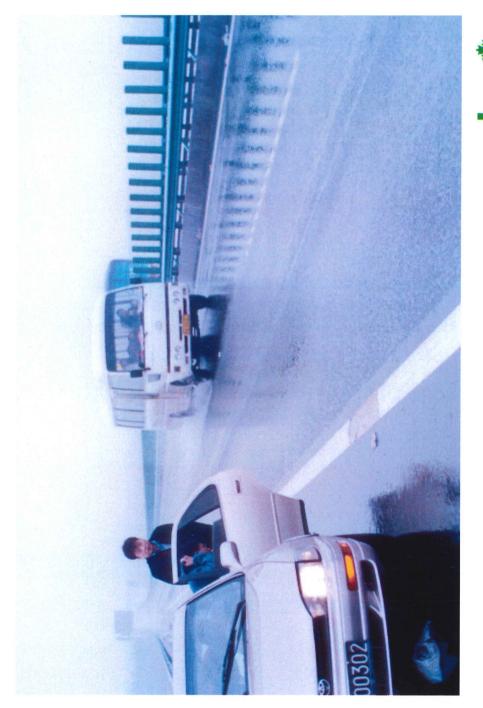
The site was visited on January 25 around 10:20 pm and a difference was readily perceived between the RejuvaSealTM treated section and the adjoining untreated lanes. This was one day after the application of RejuvaSealTM and at this location the newly treated surface was evident, as the black resilient surface layer, which was now approximately 1millimetre thick, did not allow water to puddle on the surface, as it immediately ran off. . No carryover of the RejuvaSealTM was observed from vehicle tires at the east end of the demonstration strip, so it can be presumed that the surface was dry

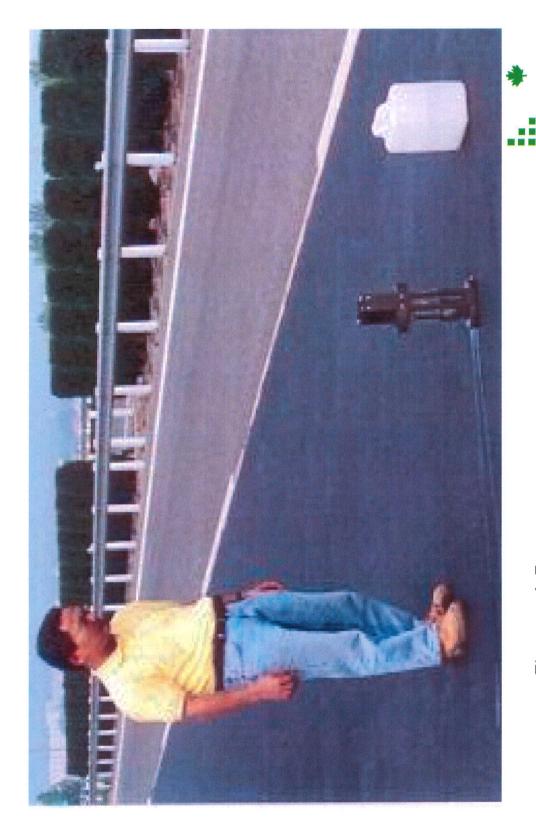
Figure 4.5 Humble Equipment Co. Oufflow Meter

An "Outflow Meter" manufactured in the U.S.A. by Humble Equipment Company of Ruston, Louisiana and sold under the trademark "Outflow Meter" (see figure 4.5) was used to measure the asphalt pavement's capability to dissipate water, as concern has been expressed about hydroplaning on the RejuvaSealTM treated surface, versus the untreated surface. The Outflow Meter gives readings in seconds for the dissipation of a known quantity of water. It is suggested that any readings between 3 and 10 seconds are satisfactory results for an asphalt surface, if hydroplaning is to be minimized.

Readings in the 3 to 10 second range are quite acceptable from a skid resistance viewpoint.
