RJSeal[™] Application Century Street, DaQing, HeilongJiang, Peoples Republic of China

June 2003

Re: Commercial Application of RJSealTM on Century Street, DaQing.

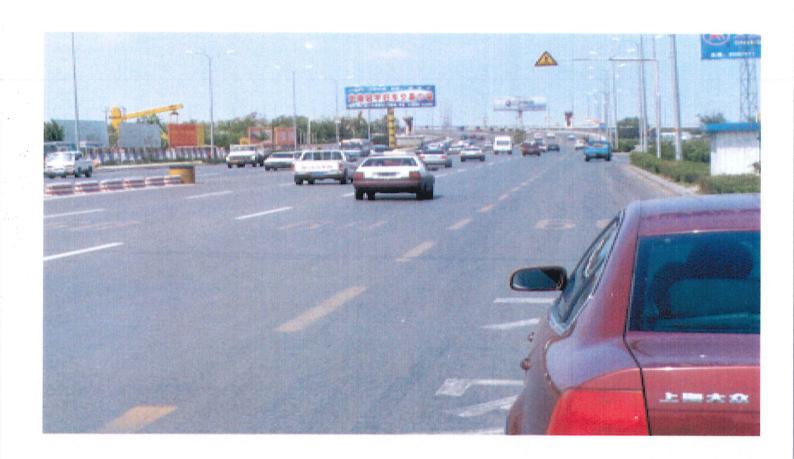
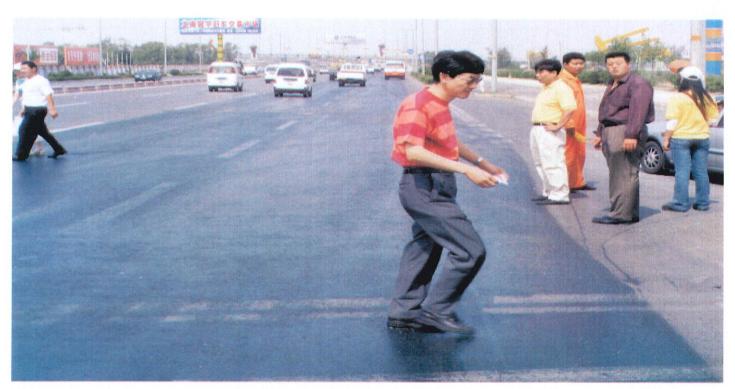
Subsequent inspection of the test strips on June 25, showed that the application rate of 5.5 m²/kg was adequate for the asphalt pavement at this location

Figure 4.1 Test Strips on Century Street. Top Photo - Before, Bottom Photo - After

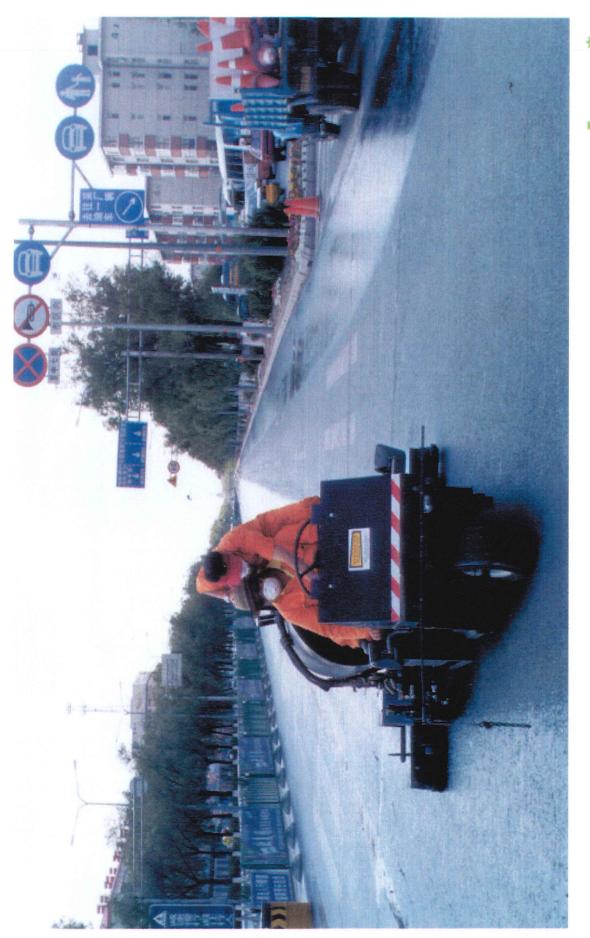
Figure 4.2 Typical Application Procedure.

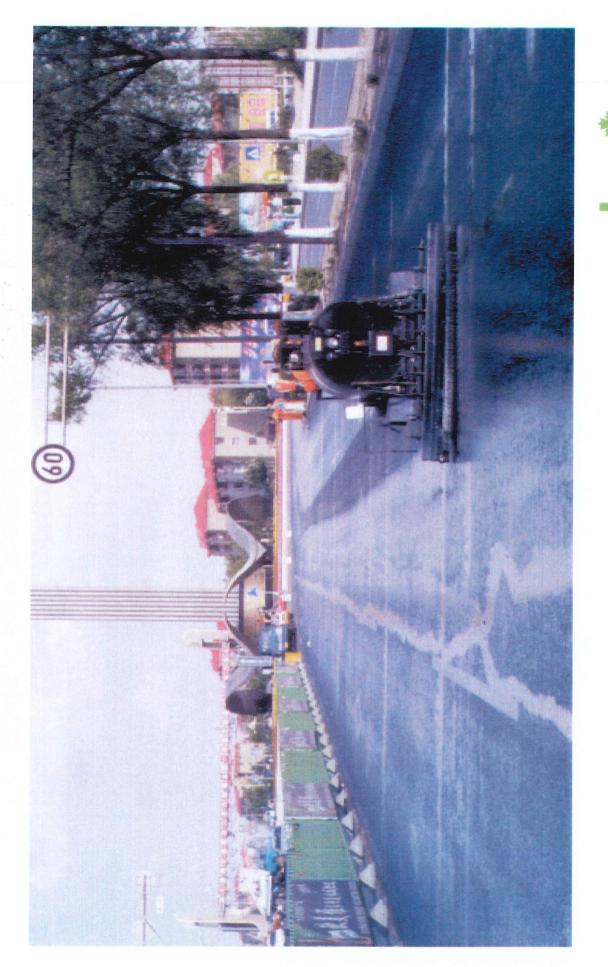
The site was visited on June 27 thru July 1 inclusive and a difference was readily perceived between the RJSealTM treated sections and the adjoining untreated lanes. A screwdriver was used to dig several small holes in the asphalt pavement, to a depth of 3 centimetres, to determine the penetration of the RJSealTM. At these locations the newly rejuvenated surface was evident, by the black resilient surface layer, which was now approximately 1 millimetre thick. Below that depth, the grey, oxidized layer of asphalt was evident.

Figure 4.3 Finished Surface.

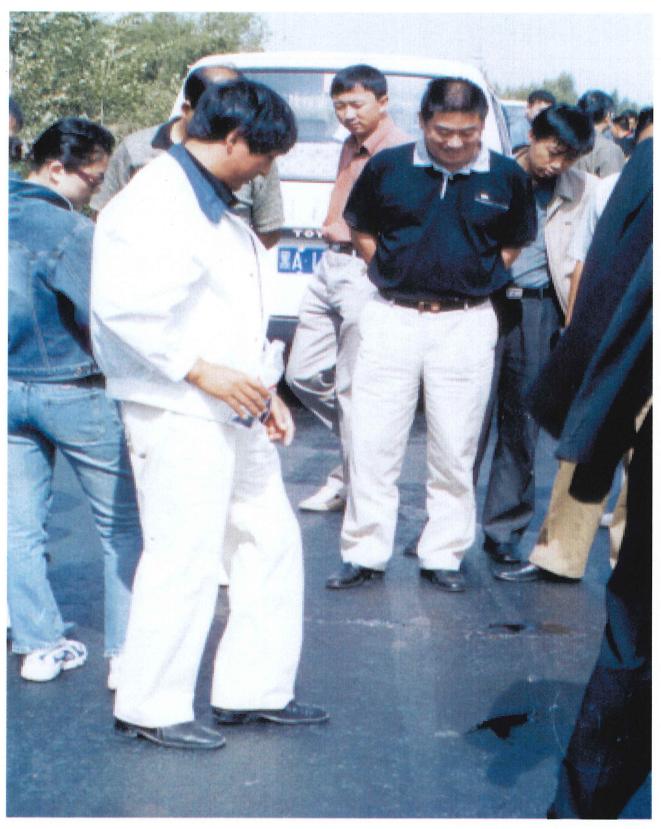
Figure 4.4 Site visit - following application

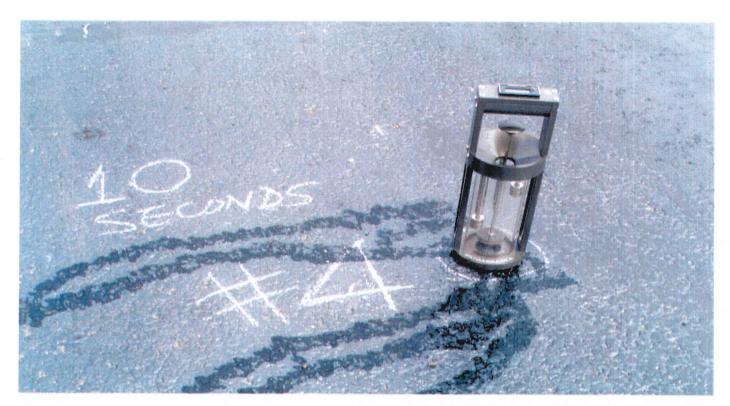
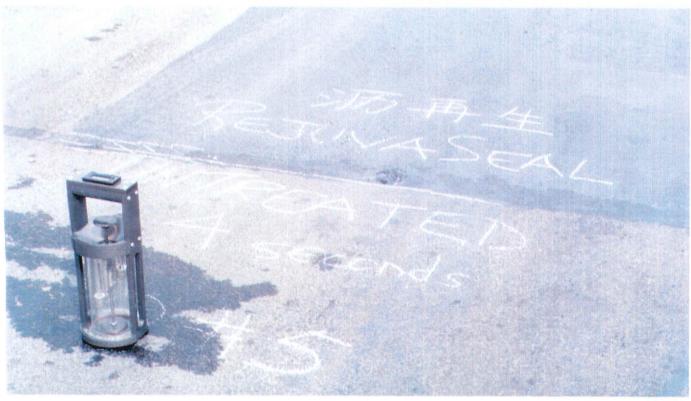
Figure 4.5 Humble Equipment Co. Outflow Meter

An "Outflow Meter" manufactured in the U.S.A. by Humble Equipment Company of Ruston, Louisiana and sold under the trademark "Outflow Meter" (see figure 4.5) was used to measure the asphalt pavement's capability to dissipate water, as concern has been expressed about hydroplaning on the RJSealTM treated surface, versus the untreated surface. The Outflow Meter gives readings in seconds for the dissipation of a known quantity of water. It is suggested that any readings between 3 and 10 seconds are satisfactory results for an asphalt surface, if hydroplaning is to be minimized. Initially readings were taken with this aforesaid Outflow Meter at six locations on the portion of Iron Man street selected for the test strips. These readings were taken at 3:00 pm on June 26.
