## REJUVASEAL ASPHALT PAVEMENT PRESERVATION TREATMENT CANADIAN EXPERIENCE AND CHINESE FIELD TRIALS

TONY SPEED  
Principal, TS<sup>2</sup> Consultants Inc.  
Hong Kong, China

JOHN EMERY  
President, John Emery Geotechnical Engineering Limited  
Toronto, Canada

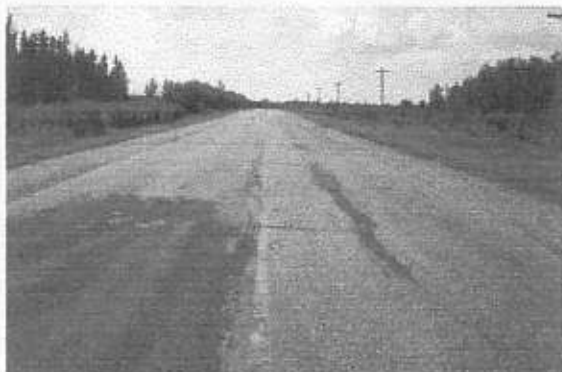
**PHOTO 1 ENTWISTLE ALBERTA SAND REJUVASEAL SITE**

The old, very poor condition, asphalt concrete pavement has a deteriorating chip seal surface with patching, crack sealing and some rutting.

Alberta Transportation and JEGEL have been monitoring a Sand RejuvaSeal demonstration project on Alberta Highway 16A:08 near Entwistle (some 100 km west of Edmonton) since August 1999 (Photographs 1 and 2) when the site was selected. The environmental conditions for this site range from hot summers to very cold, snowy winters typical of Canadian 'prairie' conditions (mean daily maximum temperature December to February of -15.4°C and annual snowfall of 105 mm water equivalent at Saskatoon Saskatchewan for instance).

Highway 16A:08 is essentially a fairly low traffic volume, old highway pavement section, parallel to the major provincial Northern Trans-Canada (Yellowhead Route) Highway 16. The Highway 16A:08 asphalt concrete pavement is 44 years old, with an aged deteriorating chip seal surface (surface treatment) as shown in Photographs 1 and 2. There has been significant loss of chip seal fines (ravelling), resulting in the coarse aggregate being readily removed by traffic action and maintenance activities. The surface treated old asphalt pavement is in overall very poor condition with cracking, patching, some flushing, chip seal loss and some wheelpath rutting. At best, the chip seal surface is at its terminal serviceability condition (very poor condition) and presented a real challenge to demonstrate the effectiveness of Sand RejuvaSeal. This pavement section would normally be repaired and resurfaced with hot-mix asphalt as was done recently for an adjacent pavement section.

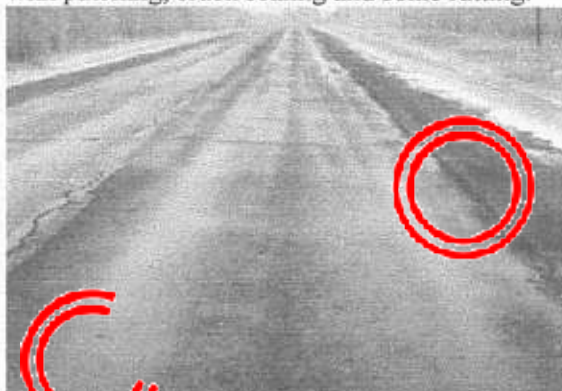
**PHOTO 3 SAND REJUVASEAL SURFACE APPEARANCE, 1 MONTH**

The Sand RejuvaSeal ( $0.272 \text{ l/m}^2$ ) was applied to the westbound lane (right) with the east-bound lane (left) used as an untreated control.

The Sand RejuvaSeal was placed on September 29, 1999, with the westbound lane treated and the eastbound lane left untreated as a control as shown in Photograph 3. The westbound lane was first swept to remove all loose material from the chip seal surface. Then, RejuvaSeal test patches were applied at 0.181, 0.226 and 0.272 l/m<sup>2</sup> (0.04, 0.05 and 0.06 US gal/yd<sup>2</sup>) to evaluate the appropriate application rate. Based on these test patches, a RejuvaSeal application rate of 0.272 l/m<sup>2</sup> was selected. For comparative purposes, the first 287 m of the westbound lane (from east to west, 3.2 m wide) was treated with 0.226 l/m<sup>2</sup> of RejuvaSeal and then the next 1357 m were treated at the selected application rate of 0.272 l/m<sup>2</sup>. A total of 5260 m<sup>2</sup> of chip seal surface was treated with RejuvaSeal. Approximately 0.48 kg of fine sand (fine boiler slag – 'black beauty') per m<sup>2</sup> was then applied to complete the Sand RejuvaSeal treatment of the chip seal surface. While ambient conditions were rather cool (about 15°C) and damp (light on and off drizzle), the Sand RejuvaSeal cured satisfactorily.

The Alberta Transportation and JEGEL demonstration site observations are best summarized through the descriptions given with Photographs 3 to 6 taken 1, 12 and 22 months after the Sand RejuvaSeal treatment of the chip seal surface. After 22 months (two winter seasons), the Sand RejuvaSeal treated surface is in significantly better condition, with a much lower rate of deterioration, than the control surface. As also noted by Alberta Transportation, the surface of the treated chip seal is somewhat softer than the untreated control, indicating that the Sand RejuvaSeal has mitigated some of the asphalt binder age hardening and provided strong adhesion to the chip seal surface. The chip seal coarse aggregate is well coated with Sand RejuvaSeal, so that the coarse aggregate is 'locked-in' by the improved matrix. This reduction in ravelling potential (coarse aggregate loss) is very important. The sand has resulted in an overall 'sandpaper' like texture. The Sand RejuvaSeal appears to have also mitigated some of the secondary cracking through some edge softening.

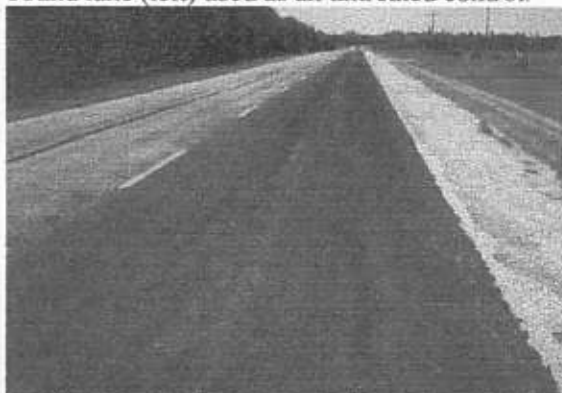
**PHOTO 5 SAND REJUVASEAL SURFACE APPEARANCE, 22 MONTHS**

The Sand RejuvaSeal has maintained its good surface appearance, while the untreated control (left) continues to rapidly deteriorate.

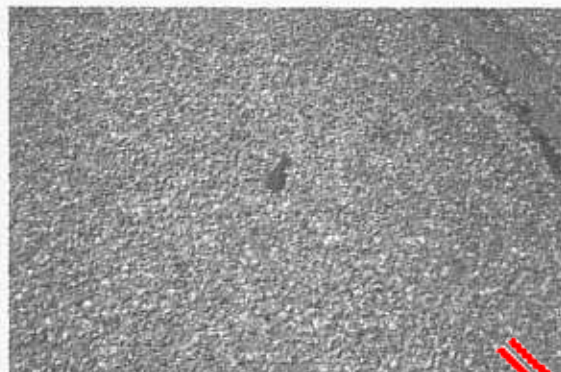
**PHOTO 2 DETERIORATING CHIP SEAL SURFACE APPEARANCE**

The significant loss of chip seal fines results in the removal of aggregate by traffic and maintenance equipment wear and tear.

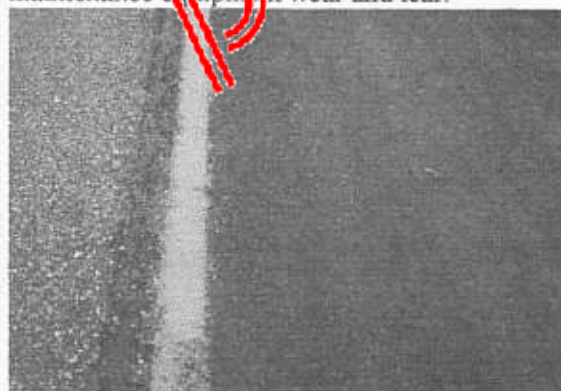
**PHOTO 4 SAND REJUVASEAL SURFACE APPEARANCE, 12 MONTHS**

The Sand RejuvaSeal has a good surface appearance, particularly compared to the still deteriorating (ravelling) untreated control (left).

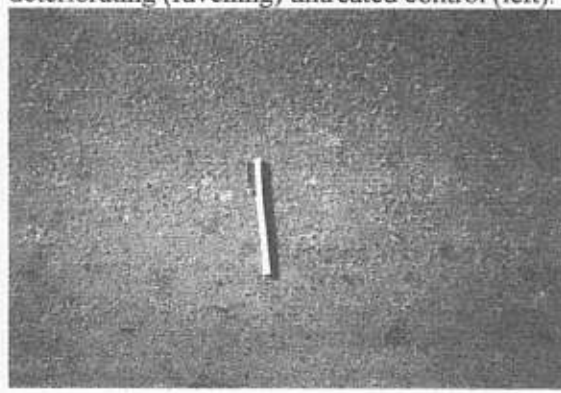
**PHOTO 6 SAND REJUVASEAL SURFACE PERFORMANCE, 22 MONTHS**

The coarse aggregate continues to be 'locked' in place by the Sand RejuvaSeal improved surface matrix, with little chip seal deterioration.

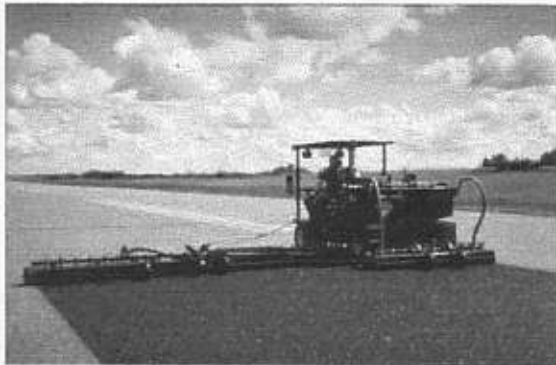
**PHOTO 7 TYPICAL REJUVASEAL  
RUNWAY APPLICATION SITE**

RejuvaSeal is applied using mobile distributors designed and equipped for effective, uniform application of coal-tar rejuvenator/sealer.

RejuvaSeal and Sand RejuvaSeal have been used for asphalt pavement preventive rejuvenation/sealing at a number of South and North American airports. The use of mobile distributors for the efficient and effective uniform application of coal-tar rejuvenator/sealer for large airport surfaces is very important as shown in Photograph 7 at CFB Wainwright Alberta. Also, it is very important to monitor the frictional characteristics (friction number) of the treated airport asphalt pavement surfaces to ensure that acceptable levels are achieved and maintained as indicated in Photograph 8 for Sand RejuvaSeal at Wainright.

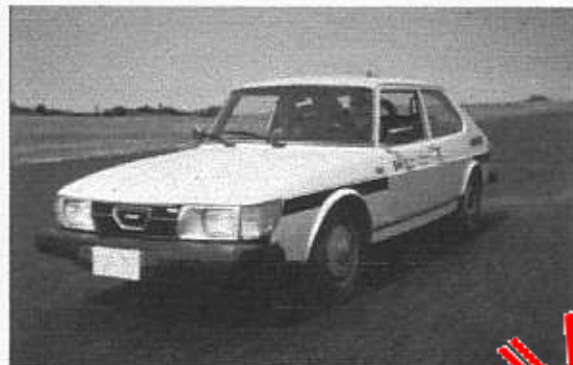
**PHOTO 8 SARYS FRICTION TESTER (SFT)  
IN ACTION ON RUNWAY**

Acceptable levels of frictional characteristics (skid resistance) are imperative to the safe use of runways, taxiways, roads and highways.

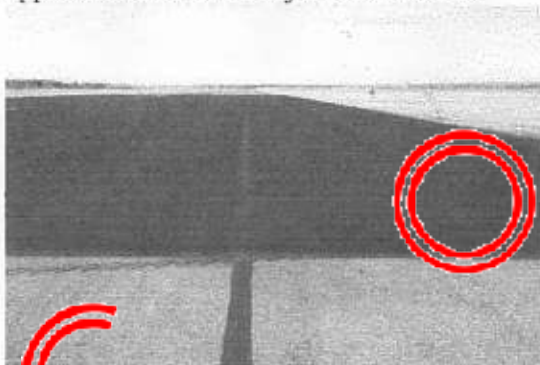
**PHOTO 9 COLD LAKE ALBERTA AIRPORT  
SAND REJUVASEAL TRIAL SECTION**

The runway asphalt concrete pavement surface (foreground) exhibited oxidation and ravelling with considerable coarse aggregate loss.

The monitoring of Sand RejuvaSeal projects at CFB Moose Jaw Saskatchewan and CFB Cold Lake Alberta is of interest, as the taxiway and runway asphalt pavements involved were experiencing considerable ravelling (loss of fines leading to insufficient matrix to hold the coarse aggregate in place) which created a potential FOD problem. The Sand RejuvaSeal treatment of the Cold Lake trial section that resulted in subsequent full use, was applied to the 20 year old runway asphalt pavement in October 1999 (Photograph 9) at a rate of 0.272 l/m<sup>2</sup> with 0.47 kg/m<sup>2</sup> of frictional sand ('black beauty'). This Sand RejuvaSeal treatment of the Cold Lake trial section resulted in a much improved surface matrix to resist ravelling (Photograph 10 with sand patch macrotexture test). The demonstrated satisfactory overall performance of the trial section resulted in the Sand RejuvaSeal treatment of the Cold Lake asphalt pavement taxiways and runways in September 2000.

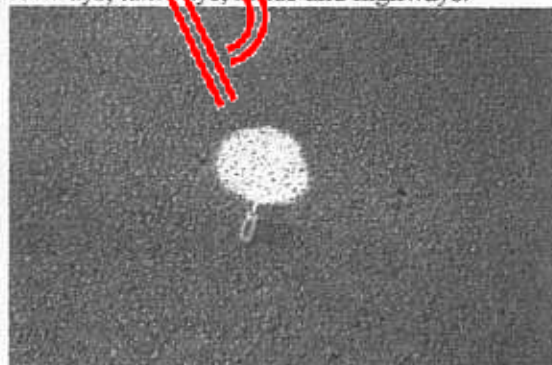
**PHOTO 10 RUNWAY SAND REJUVASEAL  
APPLICATION APPEARANCE**

The Sand RejuvaSeal ( $0.272 \text{ l/m}^2$ ) has good frictional properties and appearance, with a much improved surface matrix to resist ravelling.

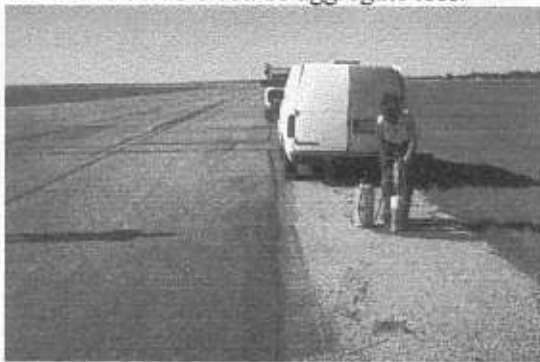
**PHOTO 11 MOOSE JAW SASKATCHEWAN  
AIRPORT SAND REJUVASEAL, 22 MONTHS**

The Sand RejuvaSeal ( $0.226 \text{ l/m}^2$ ) has good frictional properties and appearance, particularly compared to the control section being cored (right).

The Sand RejuvaSeal treatment of the asphalt pavement taxiways and runways at CFB Moose Jaw in October 1999 was based on the satisfactory evaluation of a previously treated runway test section. For Moose Jaw, the Sand RejuvaSeal was applied to the 31 year old (generally) asphalt pavement surfaces at a rate of 0.226 l/m<sup>2</sup> with 0.27 kg/m<sup>2</sup> of frictional sand ('black beauty'). Inspection of the treated surfaces after 15 and 22 months (after two years of winter maintenance with considerable steel broom use) indicated that the Sand RejuvaSeal has good frictional properties and appearance (Photograph 11), and the improved surface matrix (Photograph 12) continues to resist oxidation, deterioration and coarse aggregate loss (ravelling) with very few coarse aggregate popouts. From this ongoing airport asphalt pavement monitoring program it is anticipated that the Sand RejuvaSeal treatment service life will be at least four years for the harsh airport service conditions.

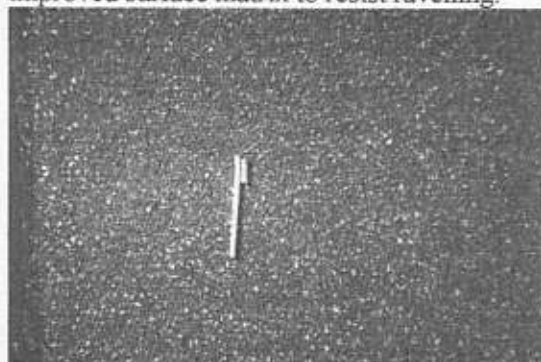
**PHOTO 12 RUNWAY SAND REJUVASEAL  
SURFACE PERFORMANCE, 22 MONTHS**

The improved surface matrix continues to resist oxidation, deterioration and aggregate loss, even with extensive winter maintenance steel broom use.

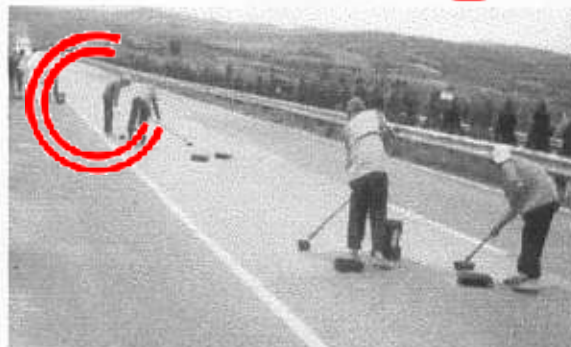
**PHOTO 13 TYPICAL CHINESE REJUVASEAL DEMONSTRATION SECTION**

The RejuvaSeal was applied to this 600m<sup>2</sup> Kun-Chieu Highway demonstration section with paint rollers to ensure uniformity (0.22 l/m<sup>2</sup>).

Crown Capital Enterprise Limited of Hong Kong entered into an agreement with the Yunnan Highway Management Department, Kunming, in May 2001 to analyze the performance of RejuvaSeal on highways within Yunnan Province. Two demonstrations of RejuvaSeal have been undertaken in close proximity to Kunming. The initial location was on the two-lane Kun-Lu Highway that leads from Kunming, some 70 km north/north-west to LuChwen. The test section is located on the northern outskirts of the city of Kunming, just 1 km short of the Highway tollgate. A second demonstration was undertaken at the 38 km marker on the primary Kun-Chieu Highway (G320) that leads from Kunming, some 129 km northeast to Chieu Chin. This test section is approximately 30 km northeast of Kunming. The Kun-Lu highway demonstration test section is located on a straight asphalt pavement section with a slight uphill grade. A 348 m long strip on the southbound lane was undertaken. There is a slight camber to the road, which causes water to run off rather than puddle on the road. The asphalt surface on the section treated is apparently two years old, with no major disfigurations or fuel spills observed, although excess asphalt cement in some locations had bled through to the surface resulting in a smooth, shiny surface. On May 9, 2001, RejuvaSeal was applied at a rate of 0.23 and 0.16 l/m<sup>2</sup> / (average 0.20 l/m<sup>2</sup>) as shown in Photograph 13. Details of the application are summarized in Table 3.
