**Application of RJSeal™
Yangtze River Bridge, JiuJiang, JiangXi,
Peoples Republic of China**

September 2004

**TS² Consulting Inc.
Lamma, Hong Kong**

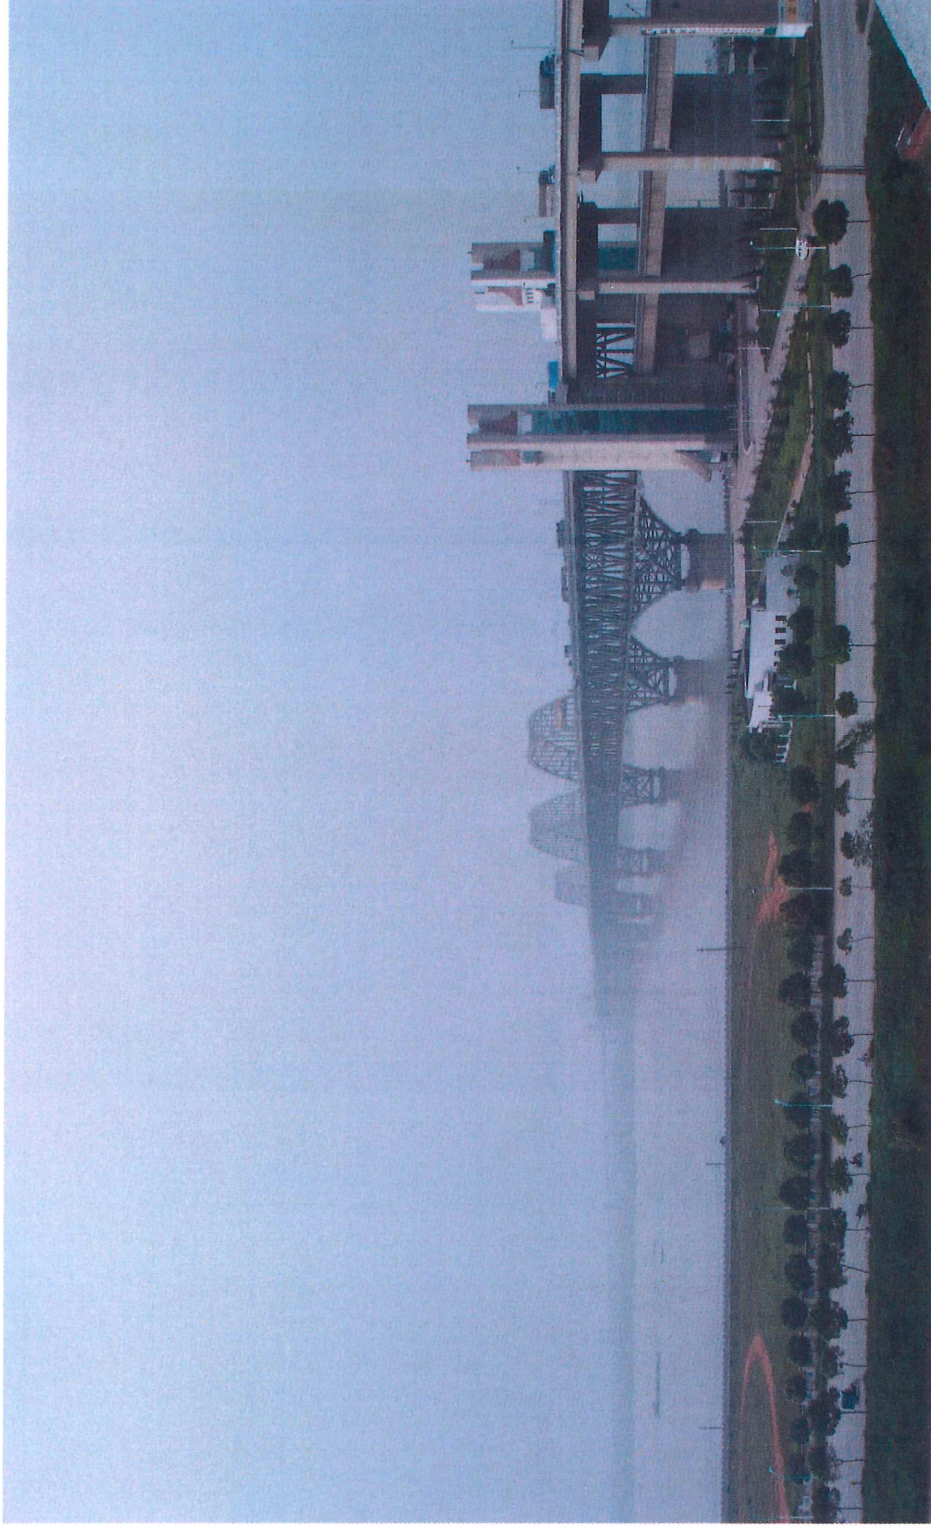
Figure 4.1 General Overview of
Yangtze River Bridge at Jiujiang

The Application Section on the bridge encompassed the portion carried on a steel truss deck, some 1,811 metres long, on the Yangtze River Bridge is located approximately 0.9 Kilometres east of the City of JiuJiang. See figure 4.0, which follows, for a location of the general locale. The location of bridge is graphically shown in figure 4.1, which follows.

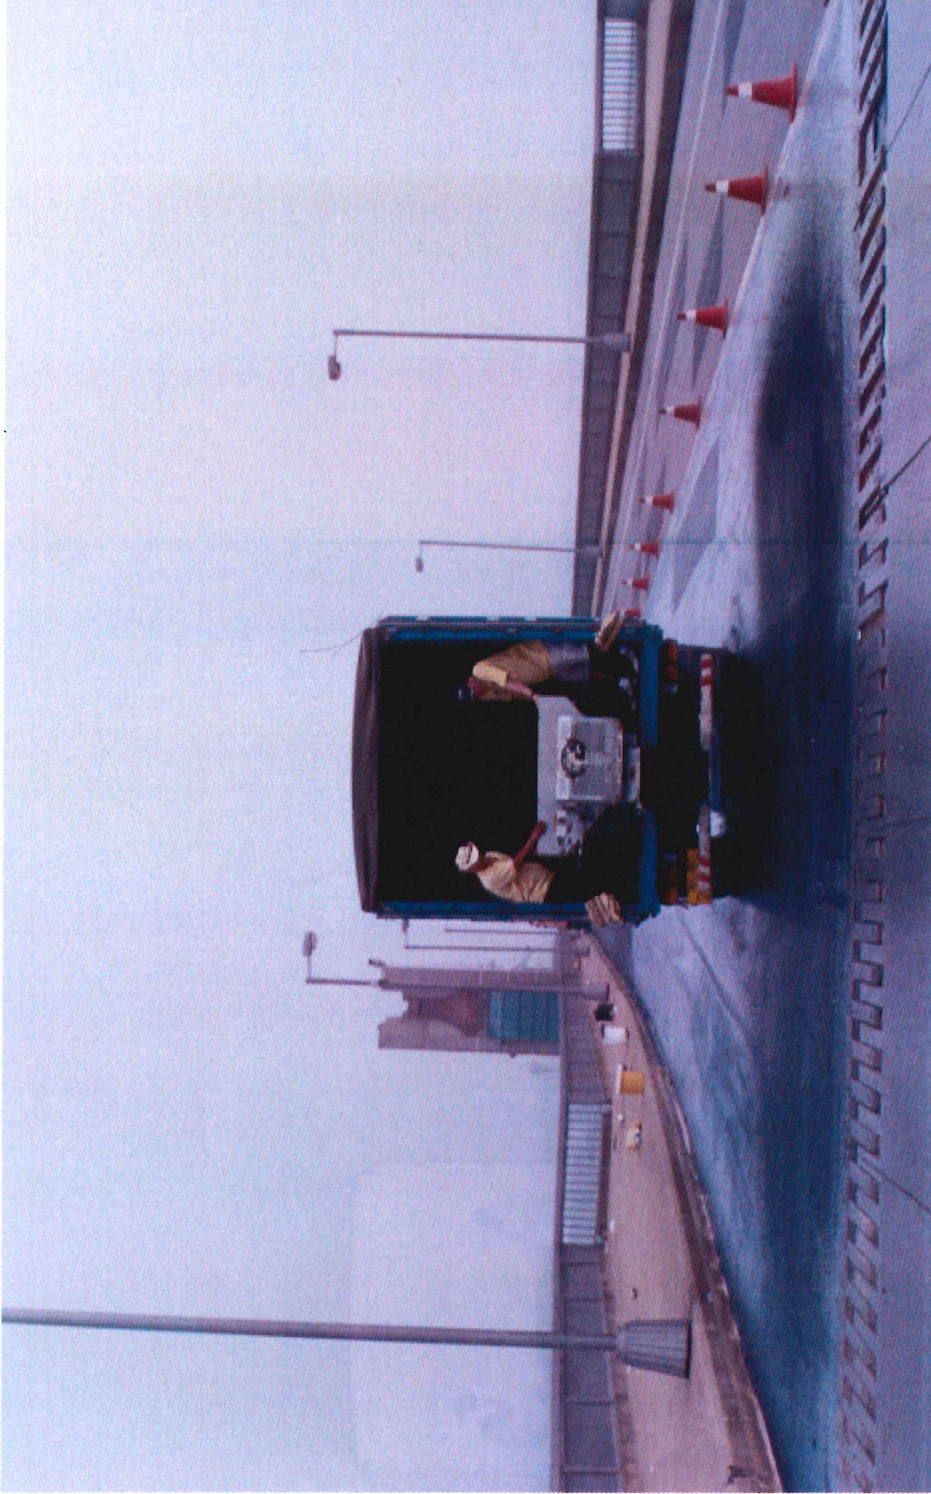
Figure 4.3 Slag Application,
Northbound Lane

On September 4, the Desco D200 Sprayer was used to spray RJSeal on the northern end of the bridge deck. Here the width of the two driving lanes are 3.6 metres between the painted centre dividing line and the shoulder marker line. A bicycle path, nominally 2.5 metres, occurs on the outside of the driving lane. The work was completed in two stages, first on the east side (northbound lane) and once that was dry then the west side (southbound lane). Work on this most northerly portion finished at 6:00 pm. Photos showing the application of RJSeal™ follow in figures 4.3, 4.3 and 4.4 on the following pages.

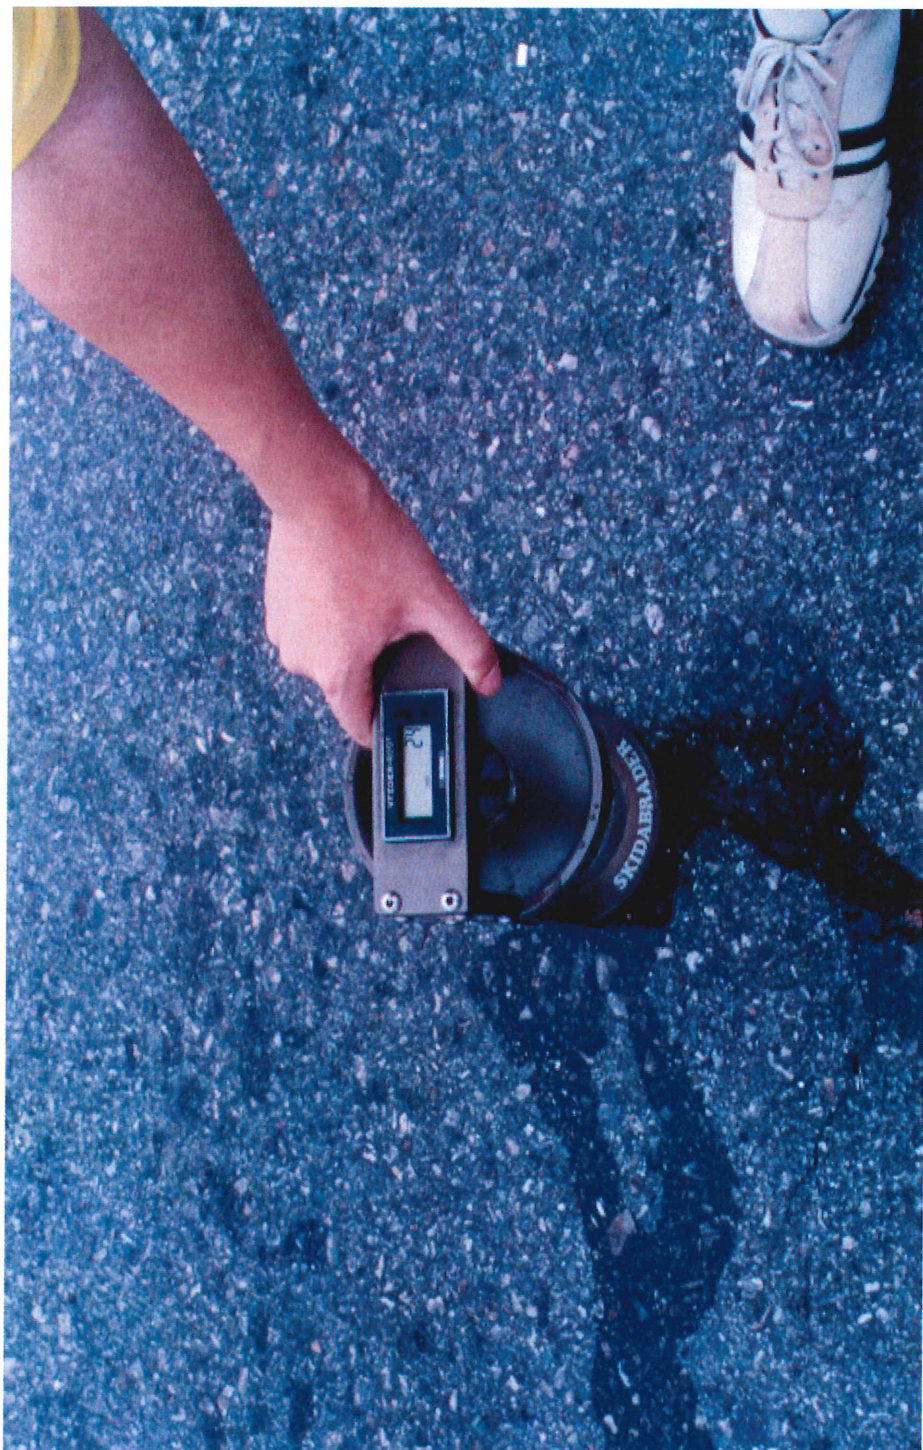
Figure 4.5
Humble Equipment Co. Outflow Meter

An “Outflow Meter” manufactured in the U.S.A. by Humble Equipment Company of Ruston, Louisiana and sold under the trademark “Outflow Meter” (see figure 4.3) was used to measure the asphalt pavement’s macrotexture, as concern has been expressed about hydroplaning on the RJSeal™ treated surface, versus the untreated surface. The procedure is documented in the ASTM working paper, WK-364. The Outflow Meter gives readings in seconds for the dissipation of a known quantity of water. It is suggested that any readings between 3 and 10 seconds are satisfactory results for an asphalt pavement surface, if hydroplaning is to be minimized.

Readings were taken with this aforesaid Outflow Meter at locations on September 2 and 3 on that portion of the Bridge selected for the Application. The results are shown in the table that follows:

- Readings in the 3 to 10 second range are quite acceptable from a skid resistance/hydroplaning viewpoint.

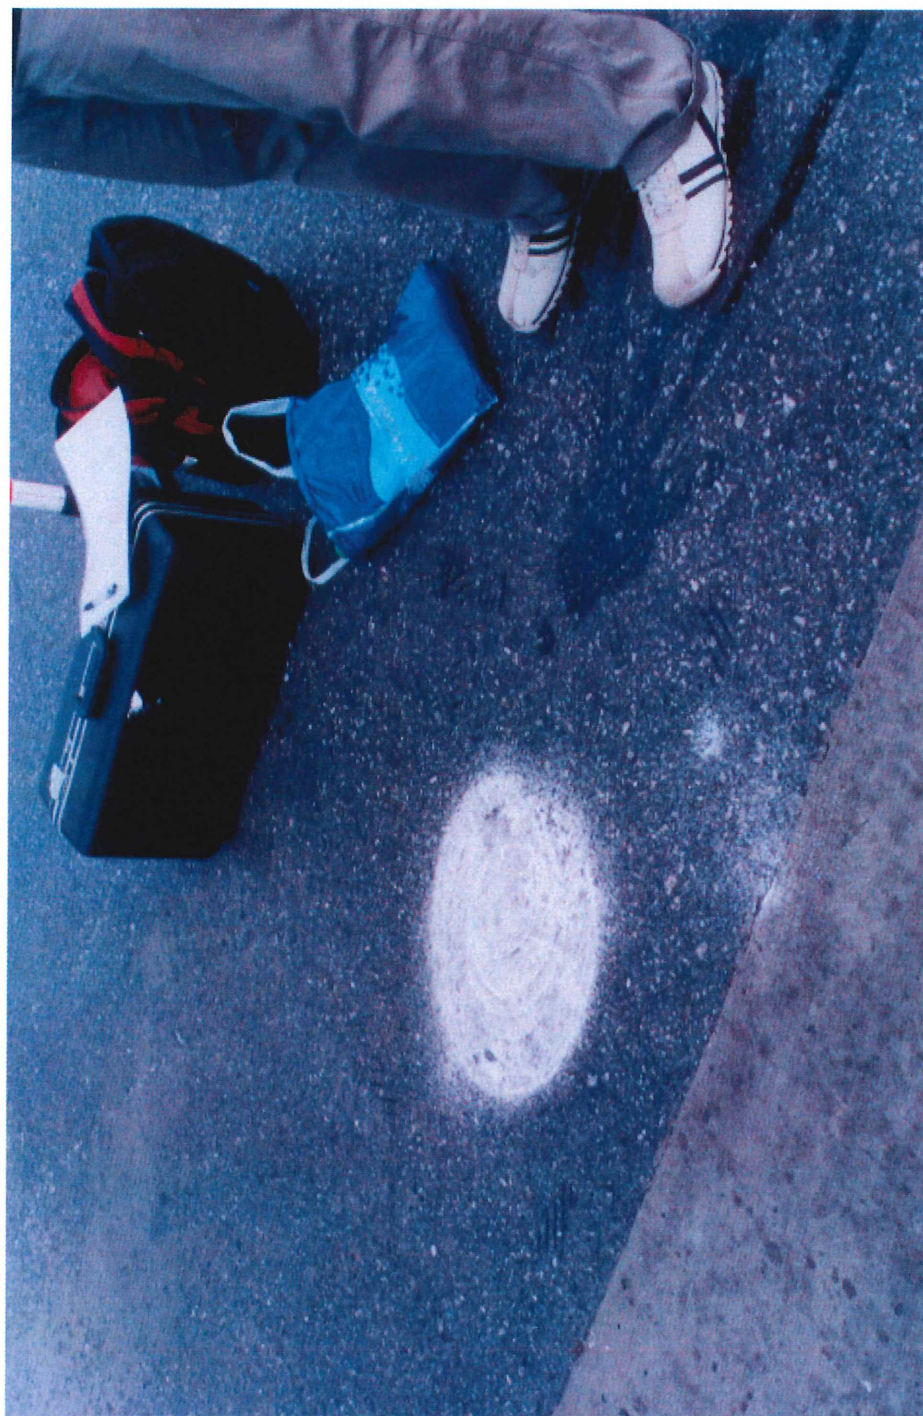
Figure 4.6 Sand Patch Test

The sand patch test (ASTM Standard E965-96 OR China Standard T 0961-95) will be used to ascertain the Pavement Macrotexture Depth. Comparison was undertaken at several locations on both the untreated and RJSeal™ treated sections in close proximity to the Outflow meter tests.
