**Demonstration of RJSeal™
Shennanxinzhou LiJao Interchange,
Shenzhen, Guangdong Province,
Peoples Republic of China**

September 2004

**TS² Consulting Inc.
Lamma, Hong Kong**

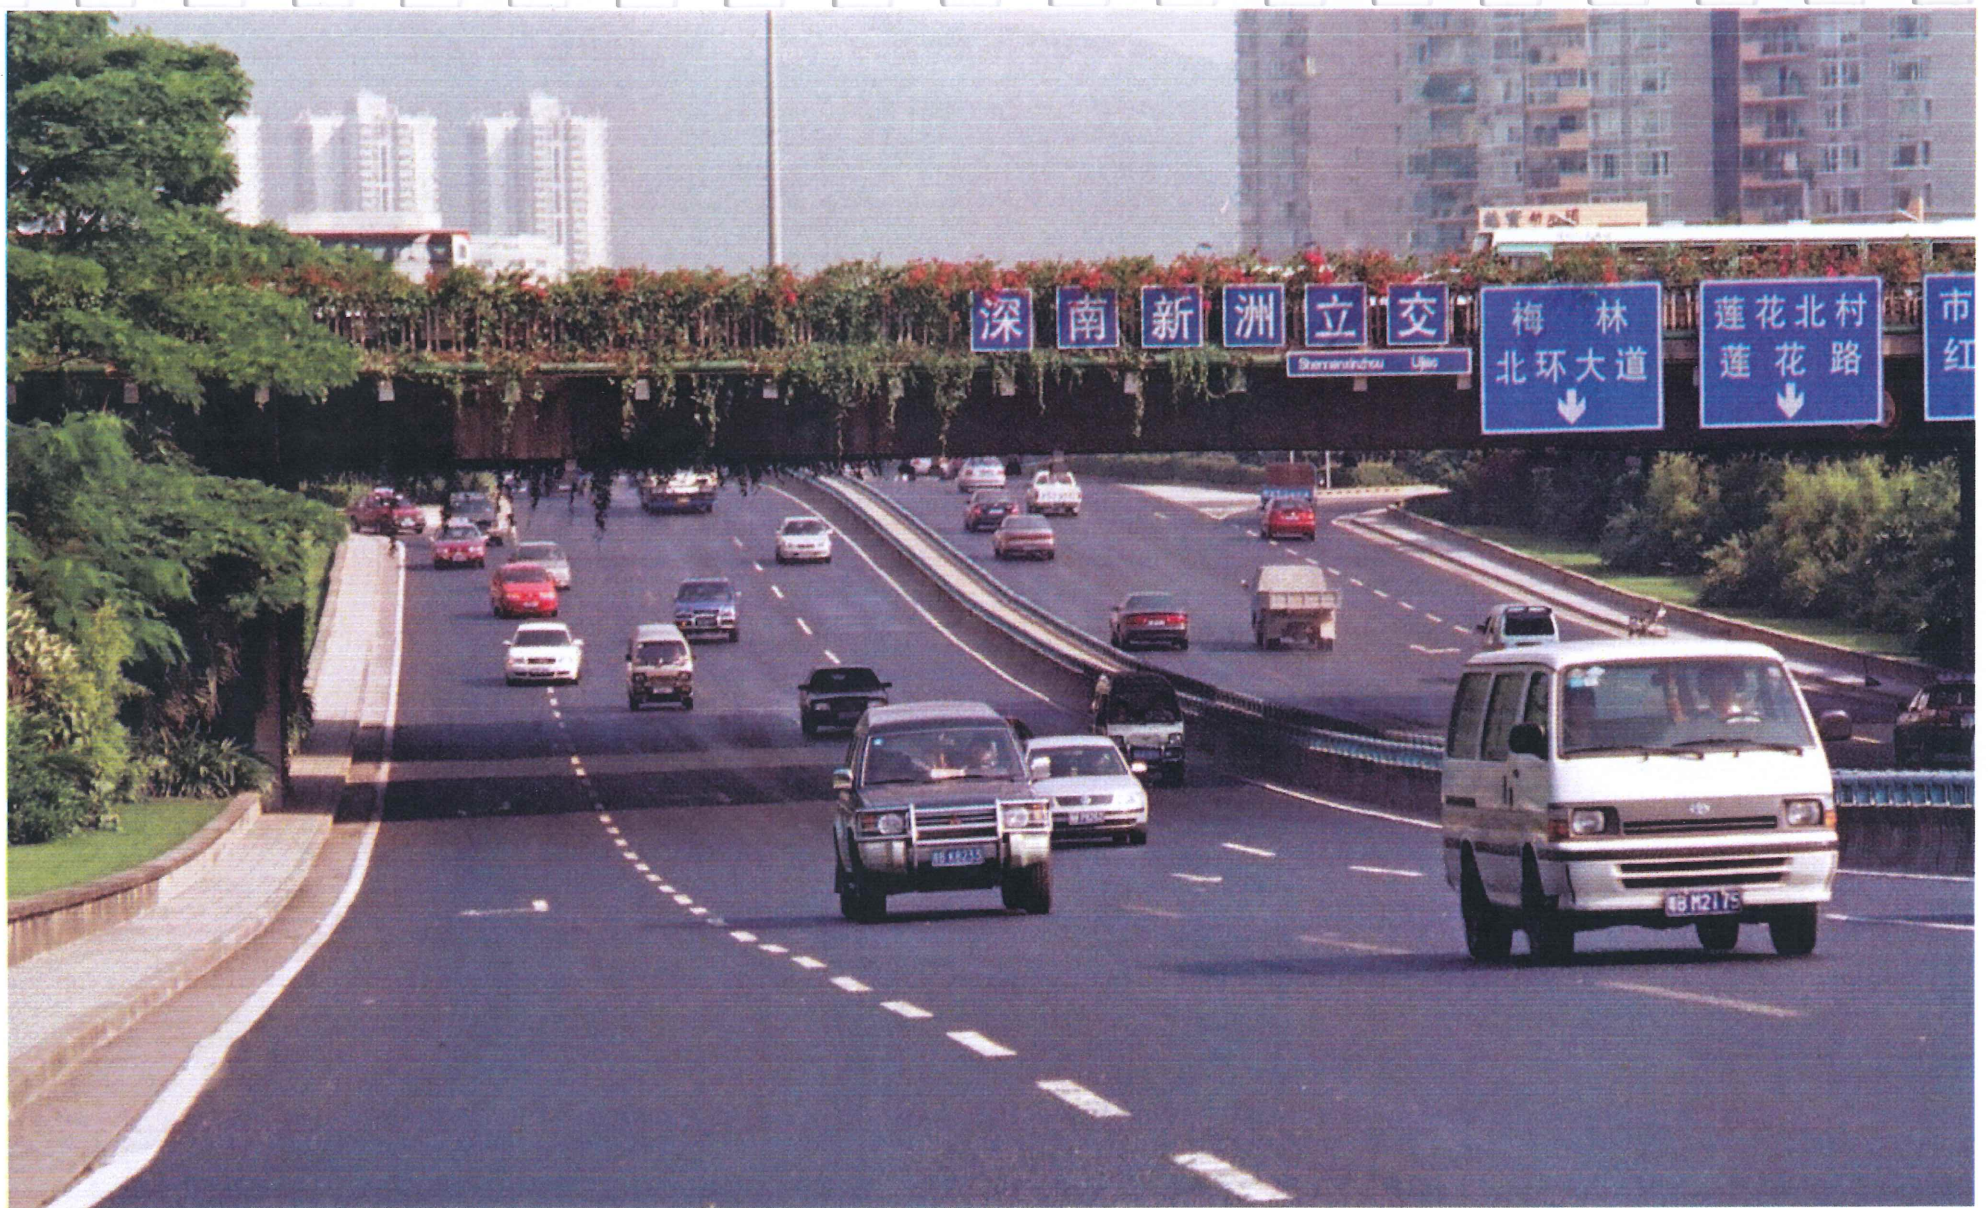
Figure 4.2 Finished RJSeal Surface.

Ambient temperatures at the time of the application on all three days (September 25, 26 and 27) were in the 28 degree Celsius range in the late evening and early morning, but it warmed up to approximately 32 Celsius by mid-afternoon. Humidity was in the 65% range. Photos showing the test application of RJSealTM follow in figures 4.1, 4.2 on the following pages.

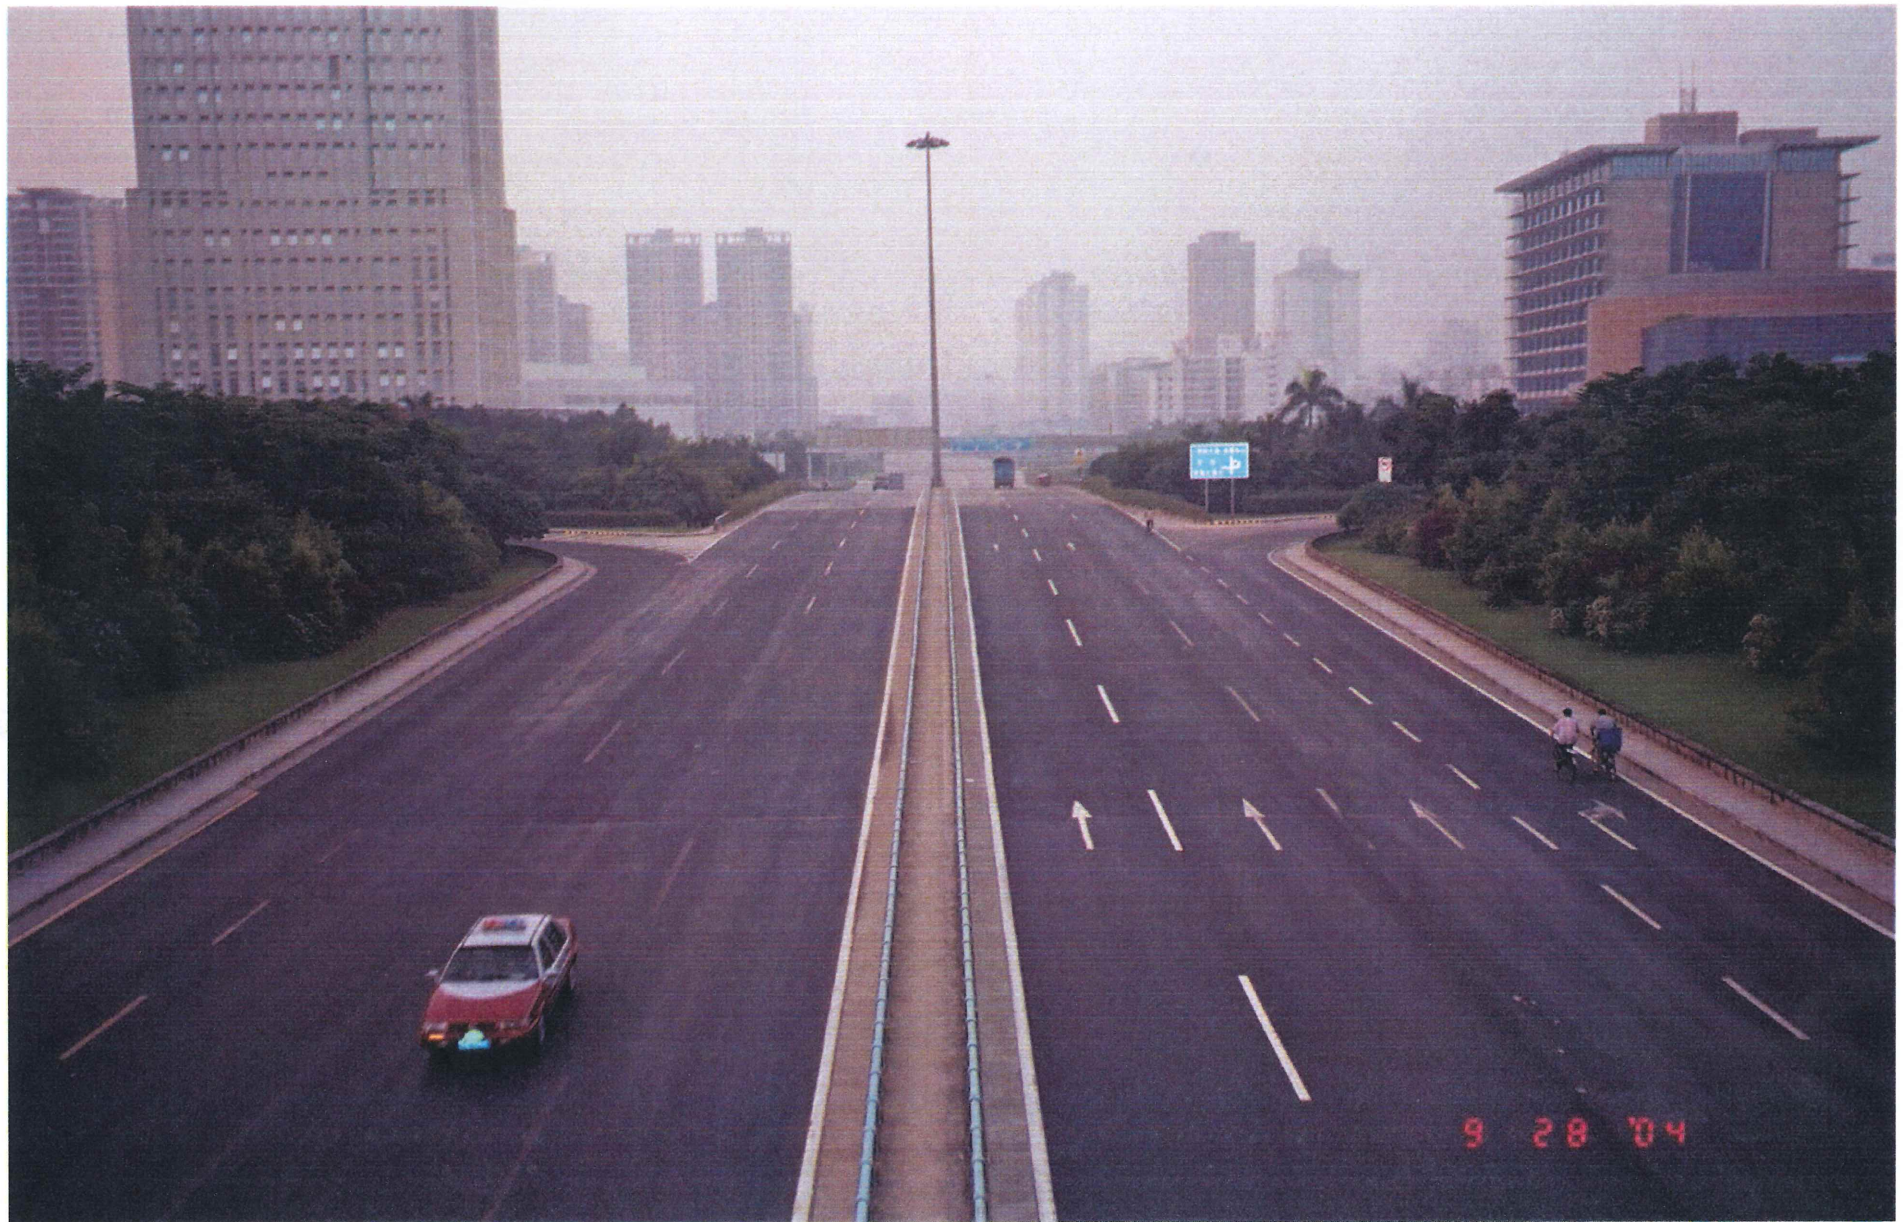
Figure 4.4 Inspection of RJSeal Surface
on following day

Xinzhou Road and Shennan Avenue were visited on October 4 around 3:30 pm and a difference was readily perceived between the RJSeal™ treated section and the adjoining untreated portion. A jack-knife was used to dig two small holes in the asphalt pavement, to a depth of 3 centimetres, some 150 metres south of the start point (north end) of the demonstration section on Xinzhou Avenue, to determine the penetration of the RJSeal™. This was one week after the application of RJSeal™ and at these two locations the newly rejuvenated surface was evident, by the black resilient surface layer, which was now approximately 5 millimetres thick. Below that depth, the grey, oxidized layer of asphalt was evident. See figure 4.4 for details on the road on inspection, the week following the application of RJSeal™.
