RJSeal™ Application JinHa Highway No. 102, LiuShunTun, HeilongJiang, Peoples Republic of China

September 2004

TABLE OF CONTENTS

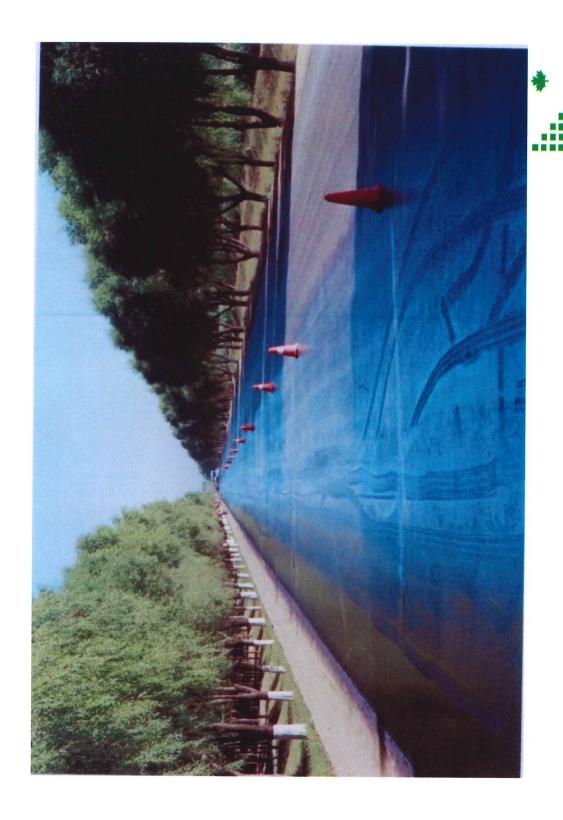
Figure 4.1 Test Strip on JinHa Highway No.102.

The 1.0 kilometre long application section on JinHa Highway No. 102 is comprised entirely of asphalt pavement. See figure 4.0 for the location of the test strip with respect to the village of LiuShunTun is graphically shown in figure 4.1, which follows.

There is a slight camber to the road, which causes water to run off toward the shoulder, rather than puddle on the road. No significant oil spills were observed, just the occasional drop of transmission oil, crankcase oil or hydraulic fluid. The asphalt pavement surface was not appreciably worn with no rutting due to traffic wear. There was aging and oxidation of the bitumen, which extended to a depth of several millimetres. There were longitudinal cracks, and also lateral cracks, which had recently been filled with tar. The entire portion of the treated asphalt pavement section overlies a compacted silty-clay, sub-grade

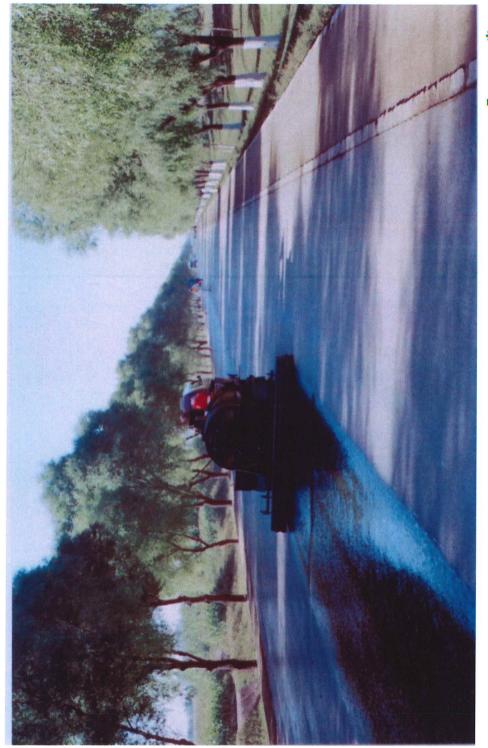
Figure 4.2 Typical Application Procedure.

RJSealTM was applied, using a Desco D200 Sprayer. See Appendix B for technical information on this unit. This unit can uniformly apply the RJSealTM in the application.

Ambient temperatures at the time of the application on September 9 were in the 22 degree Celsius range, with humidity in the 70% range. Photos showing the test application of RJSealTM follow in figures 4.2, 4.3 and 4.4. on the following pages.

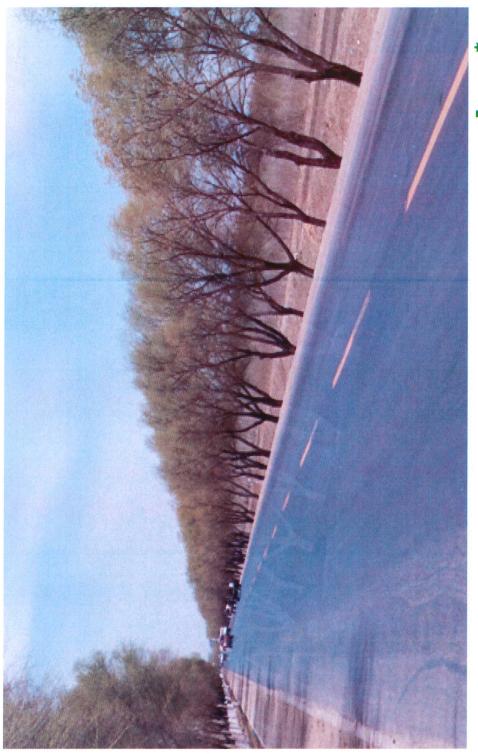
Figure 4.4 Site visit - May 2005

A site visit on May 1, 2005 (Refer to Appendix C for more details) was made to check to entire test section and evaluate the penetration of the RJSealTM. A difference was readily perceived between the RJSealTM treated sections and the adjoining untreated lanes. A screwdriver was used to dig several small holes in the asphalt pavement, to determine the penetration of the RJSealTM. At these locations the rejuvenated surface was evident, by the black resilient surface layer, which was now approximately 1 centimetre thick. Below that depth, the grey, oxidized layer of asphalt was evident. This is pictorially shown in Figure 4.4 that follows.

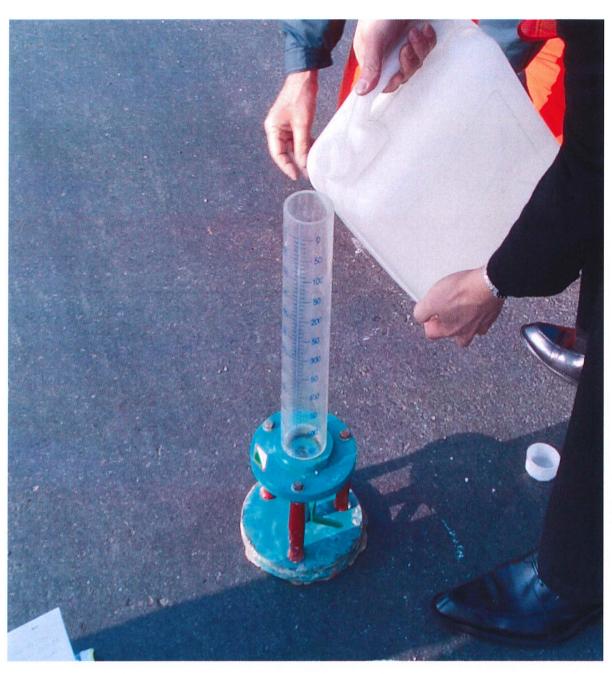
Figure 4.6 Water Penetration Test

Water Penetration Tests (China Testing Standard T 0730-2000) will be undertaken at several locations on the JinHa Highway on both treated and segment treated with RJSealTM. During the inspection on May 1, 2005, water was poured on the RJSealTM treated segment and no water penetrated the asphalt pavement, whereas on the adjoining untreated segment water penetrated the pavement at the micro-cracks that laterally cross the highway

See Figure 4.6 that follows for a pictorial presentation of the Water Penetration Meter.

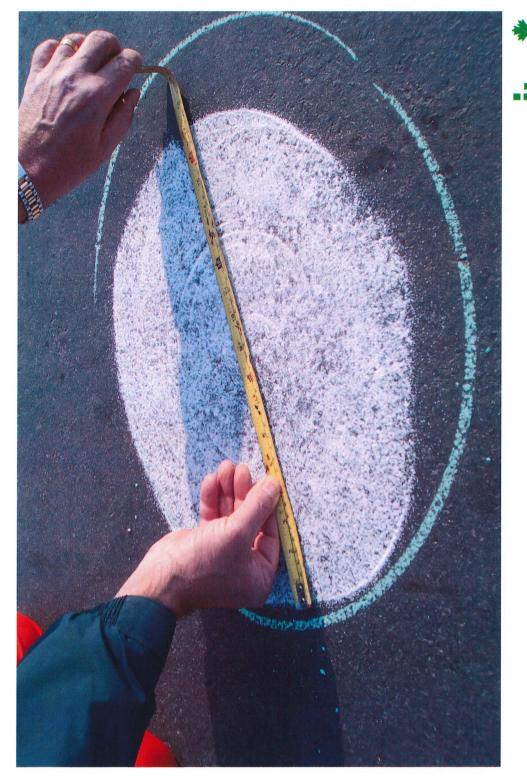
Figure 4.7 Sand Patch Test

The sand patch test (ASTM Standard E965-96 OR China Standard T 0961-95) will be used to ascertain the Pavement Macrotexture (Depth of Structure). Comparison will be undertaken at several locations on the untreated section in close proximity to the Water Penetration Meter tests.

See Figure 4.7 which follows, showing the sand patch testing procedure.
