**Demonstration of RJSeal™
East Harbour Tunnel,
Hong Kong**

**TS² Consulting Inc.
Lamma, Hong Kong**

November 15, 2004

INSPECTION OF EASTERN HARBOUR TUNNEL

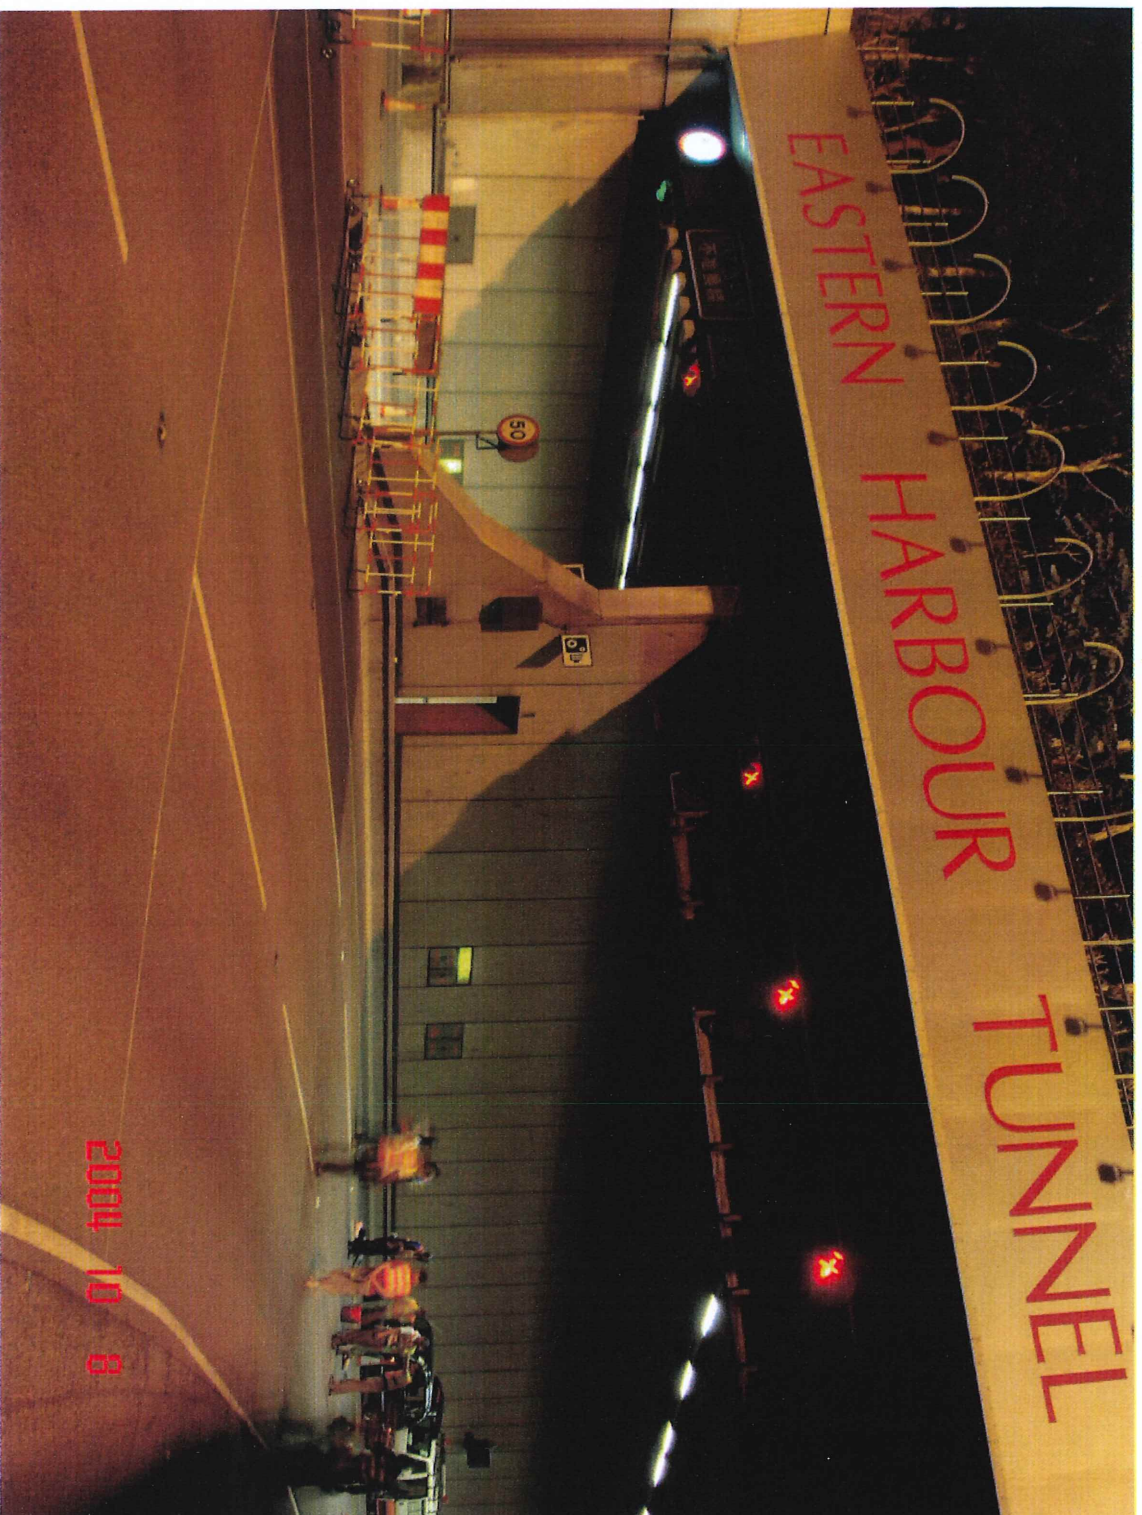
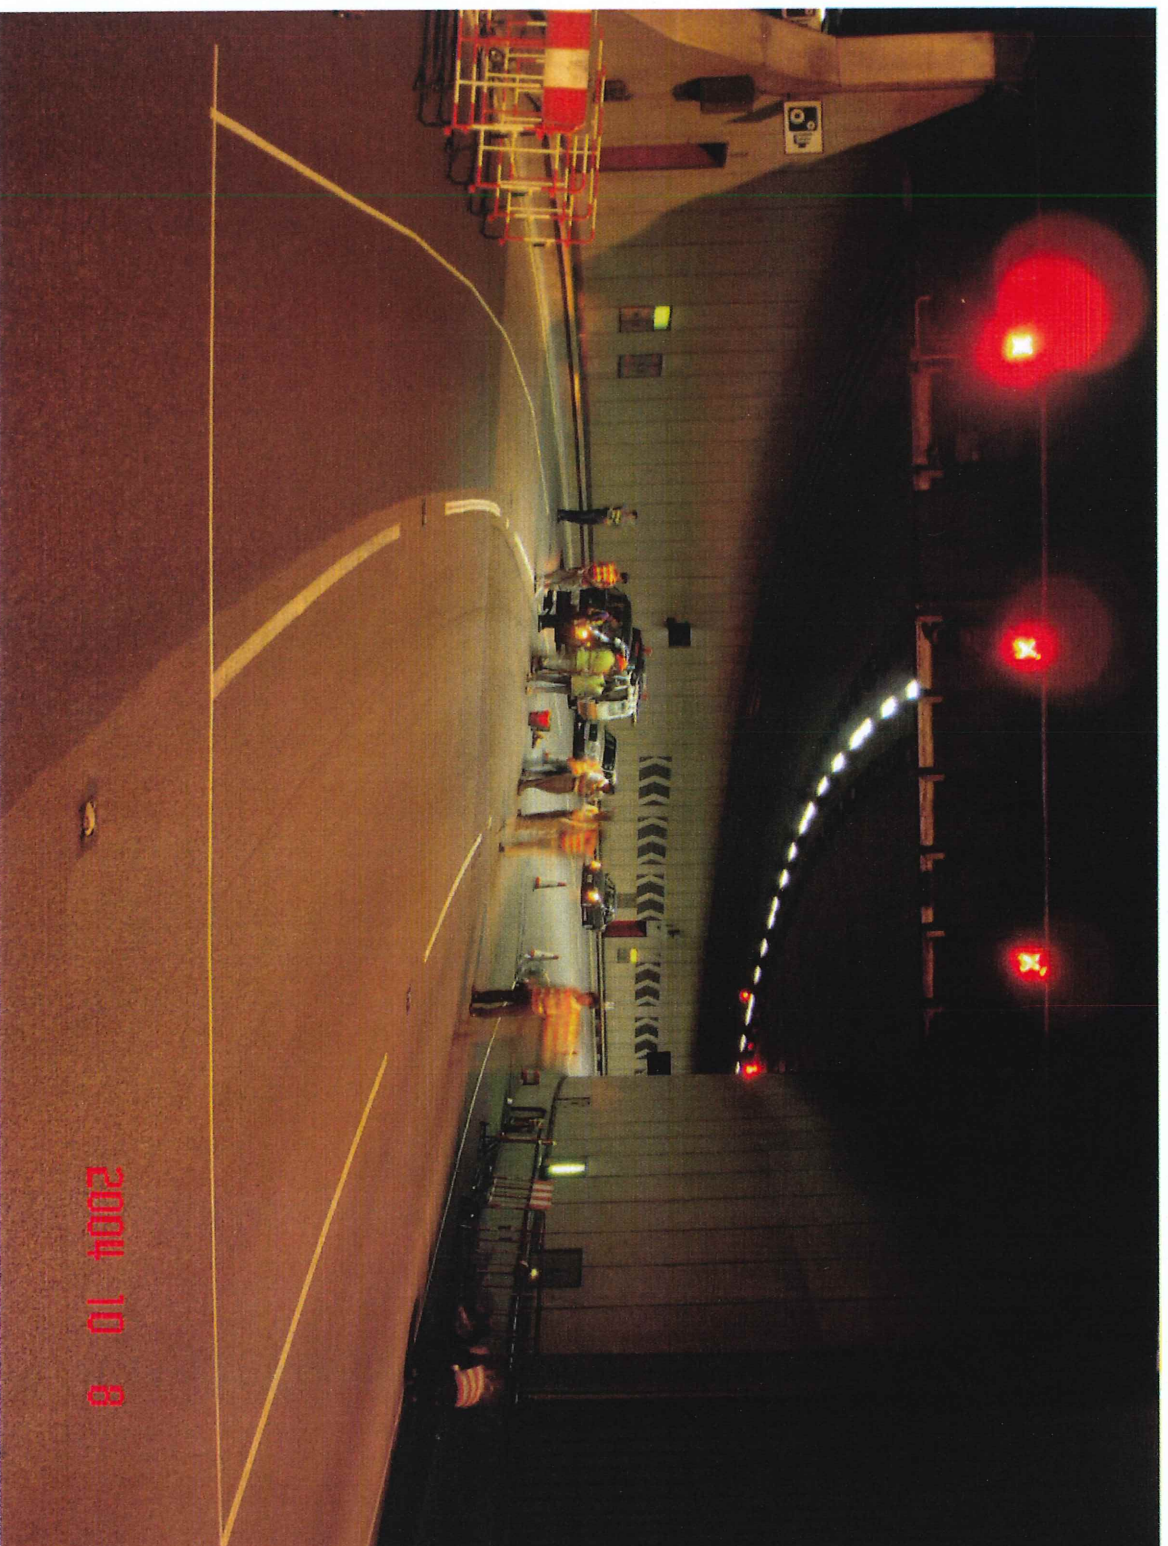
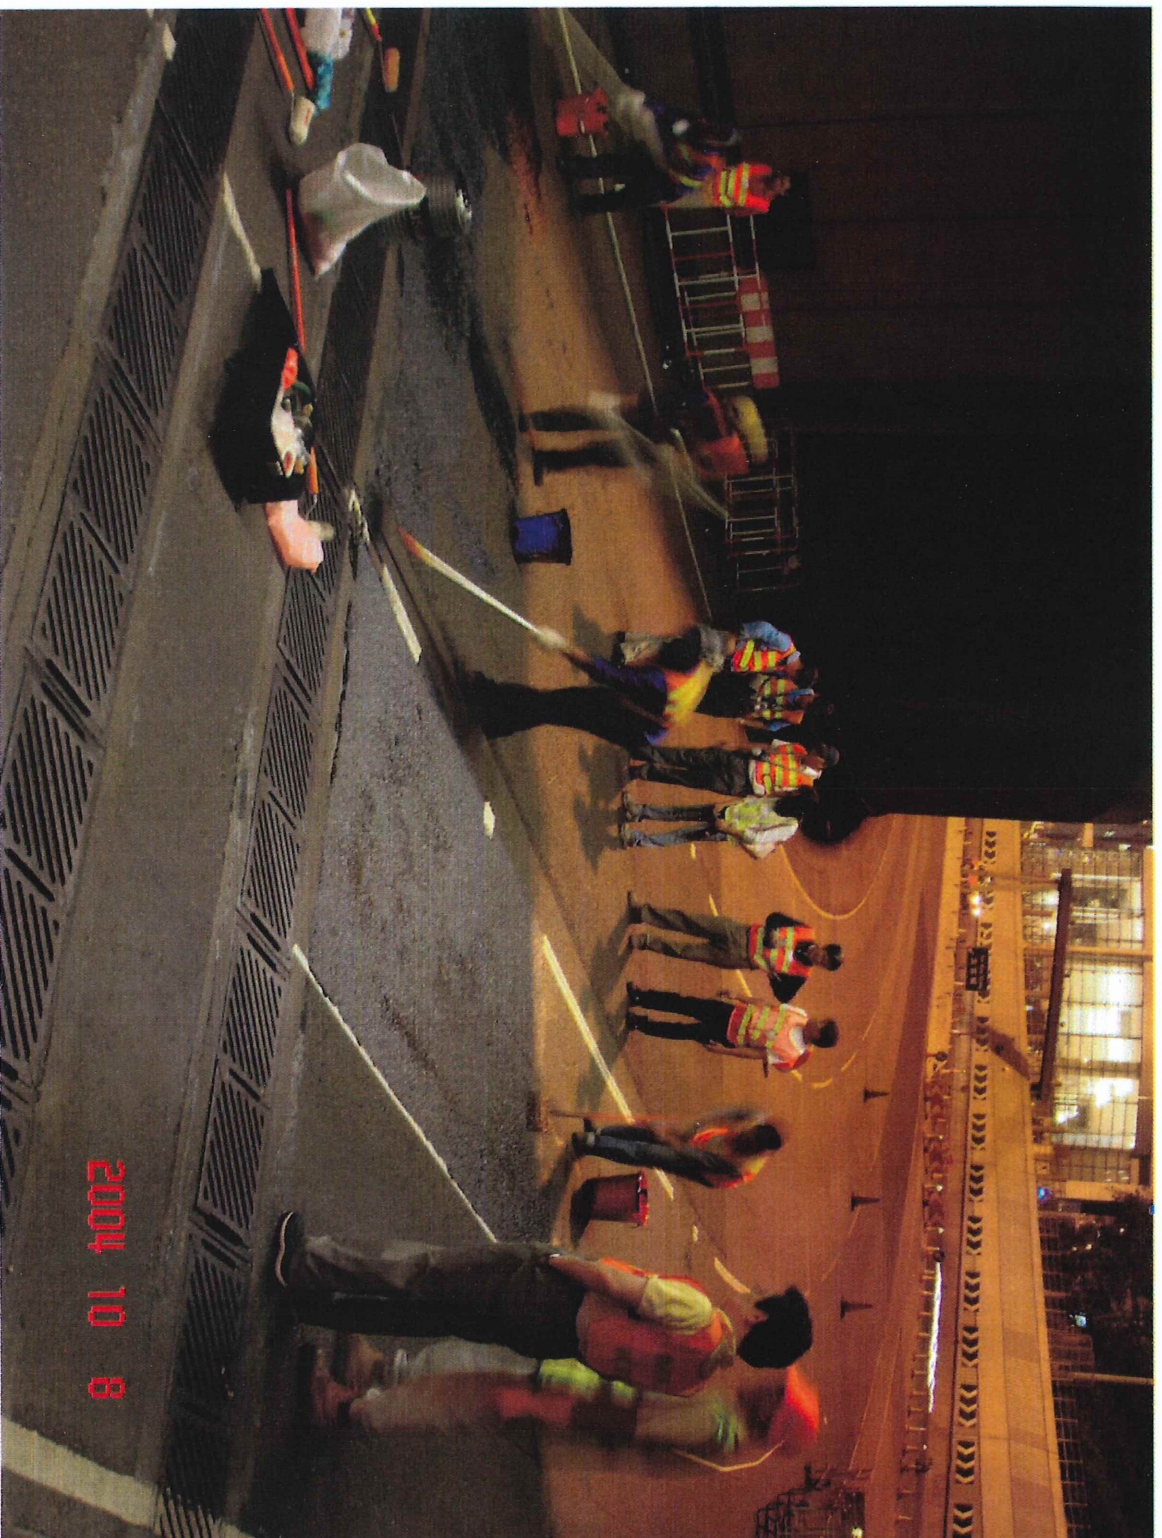
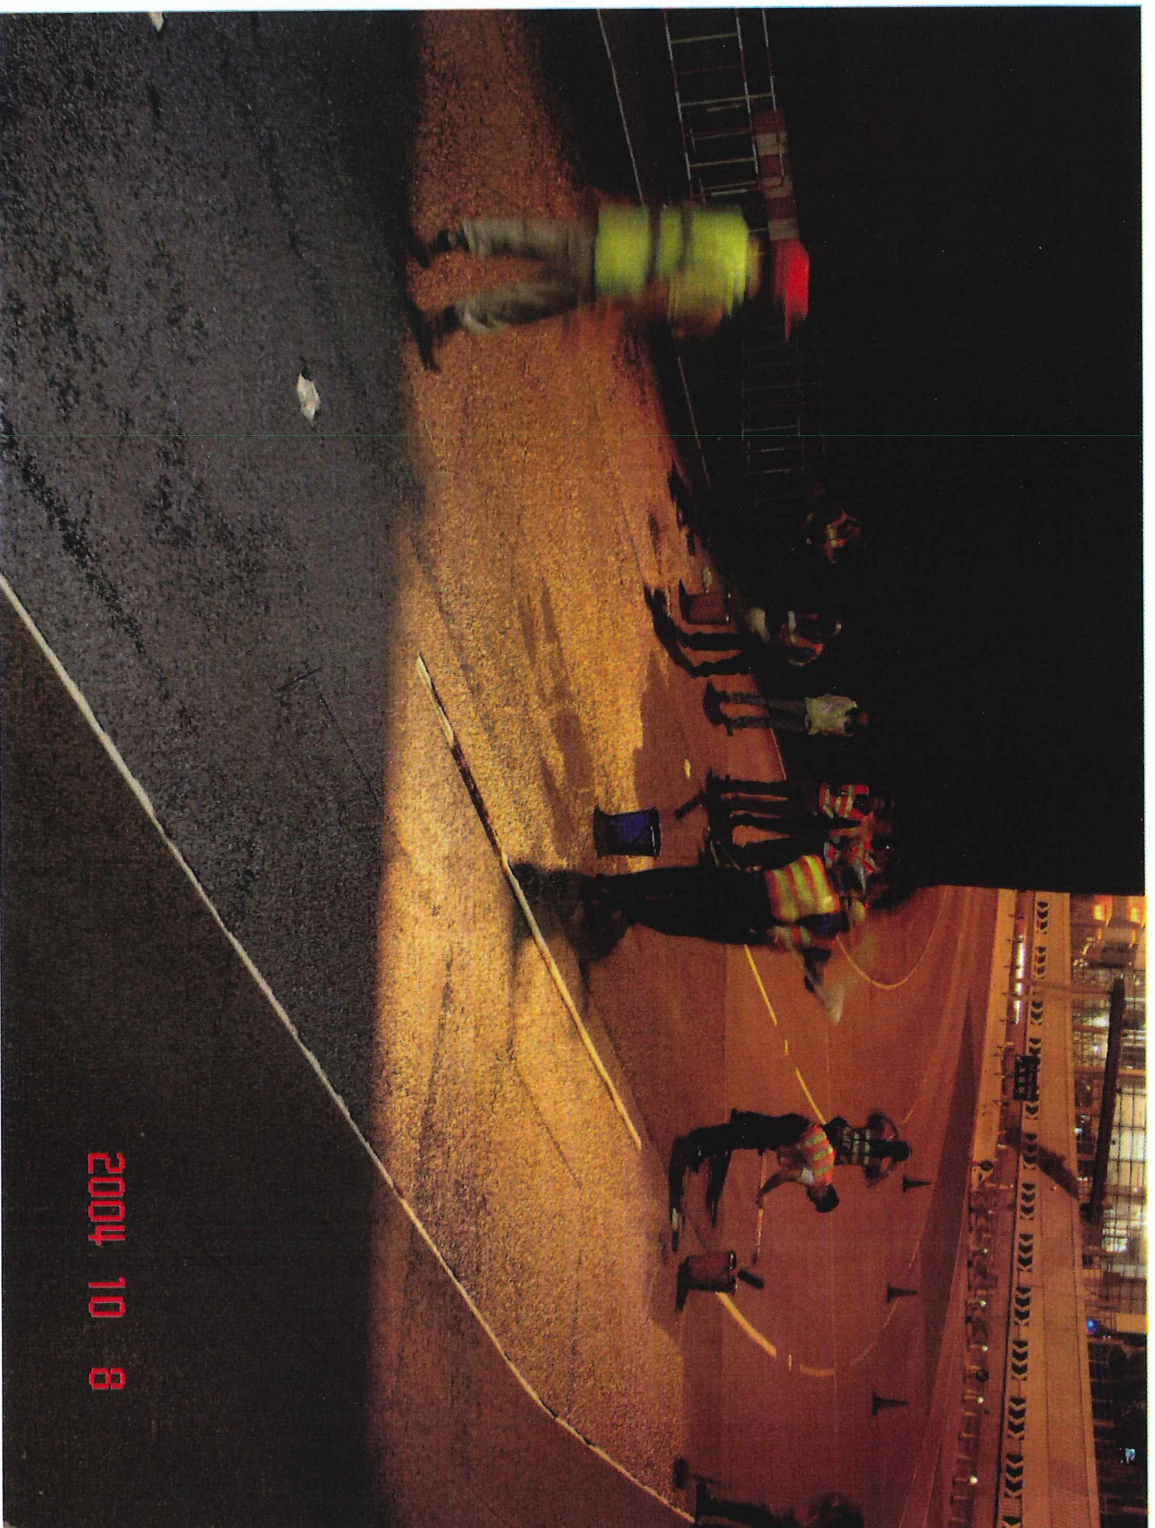
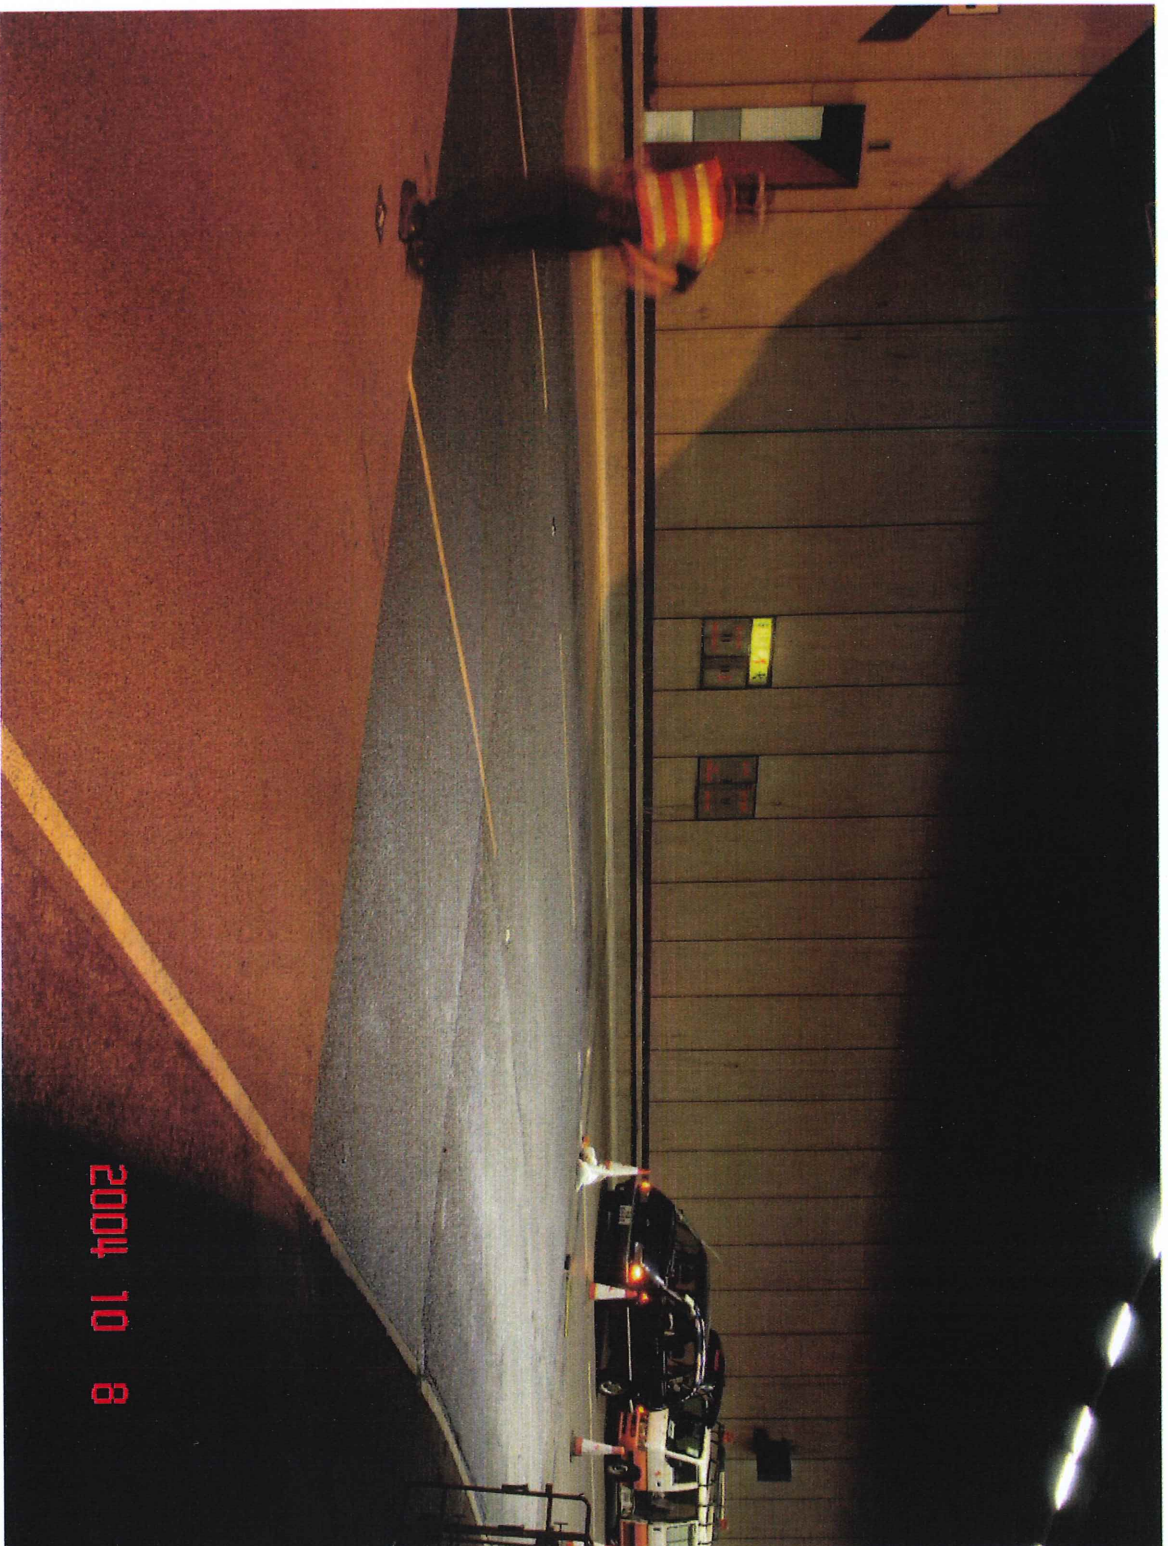
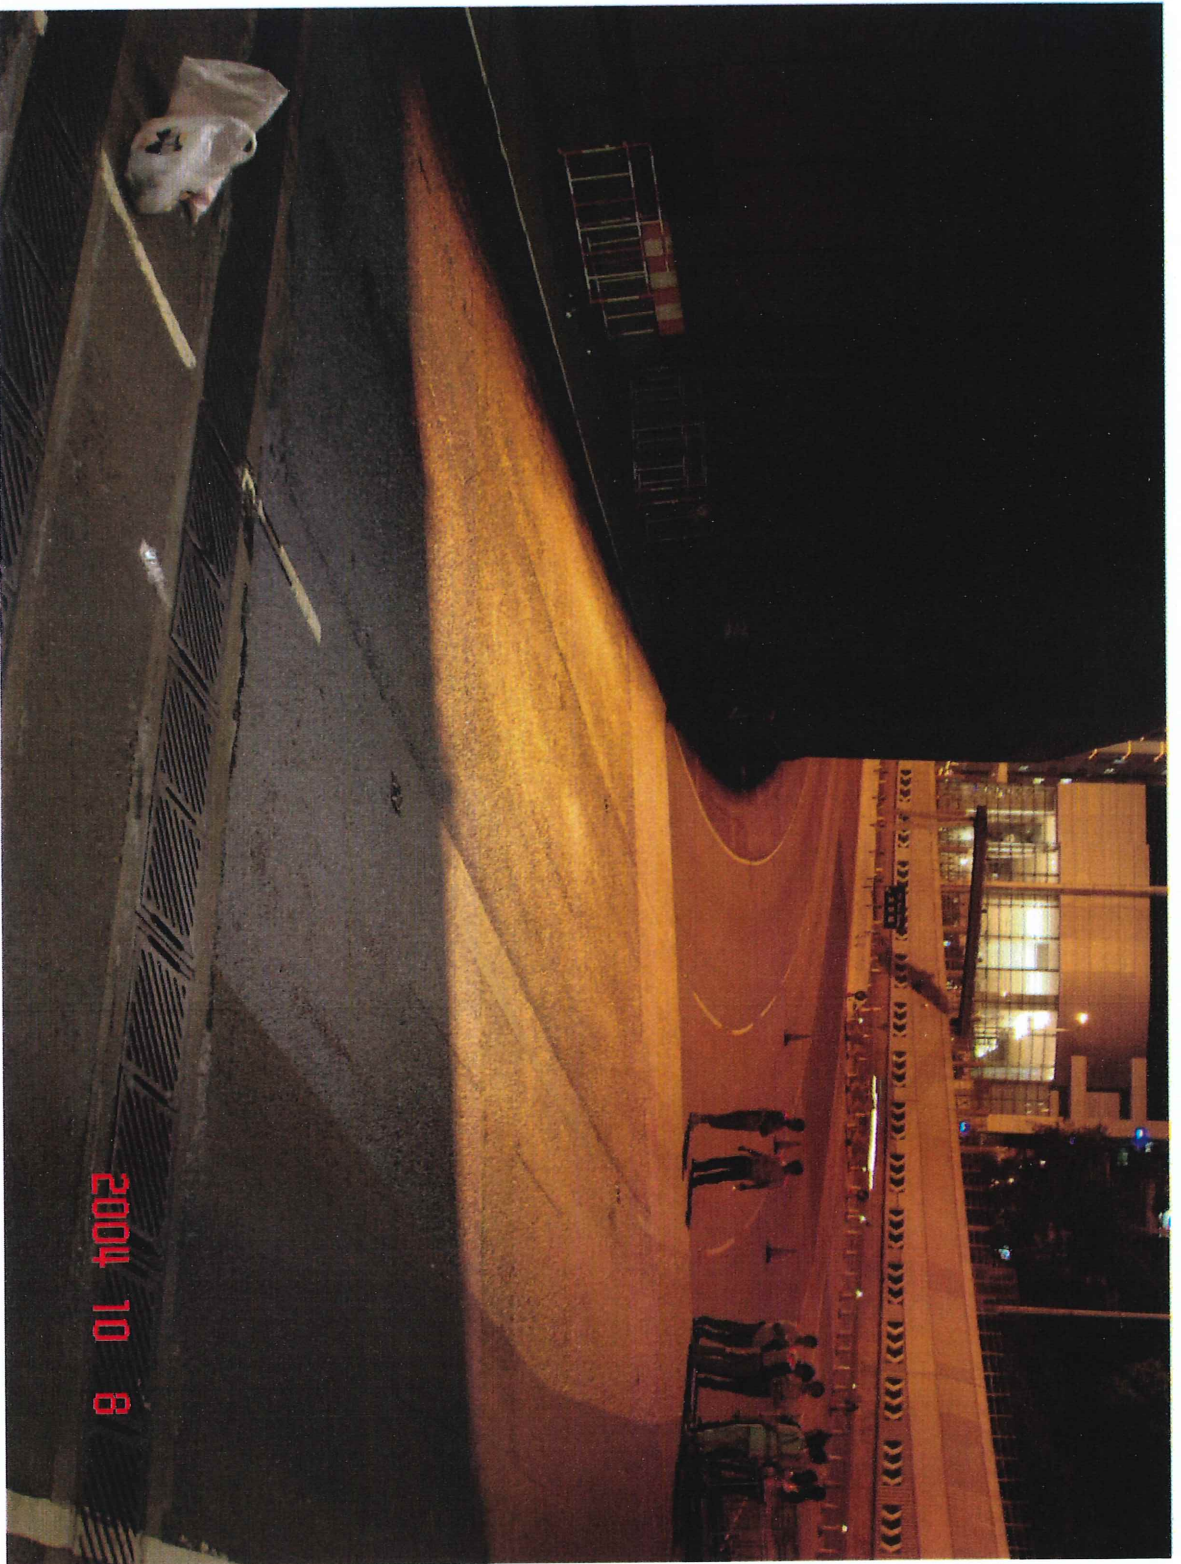
Figure 1a - HK Side Portal of East Harbour Tunnel

Figure 1b - HK Side Portal of East Harbour Tunnel

Figure 1c - HK Side Portal of East Harbour Tunnel

Figure 1d - HK Side Portal of East Harbour Tunnel

Figure 1e - HK Side Portal of East Harbour Tunnel

Figure 1f - HK Side Portal of East Harbour Tunnel

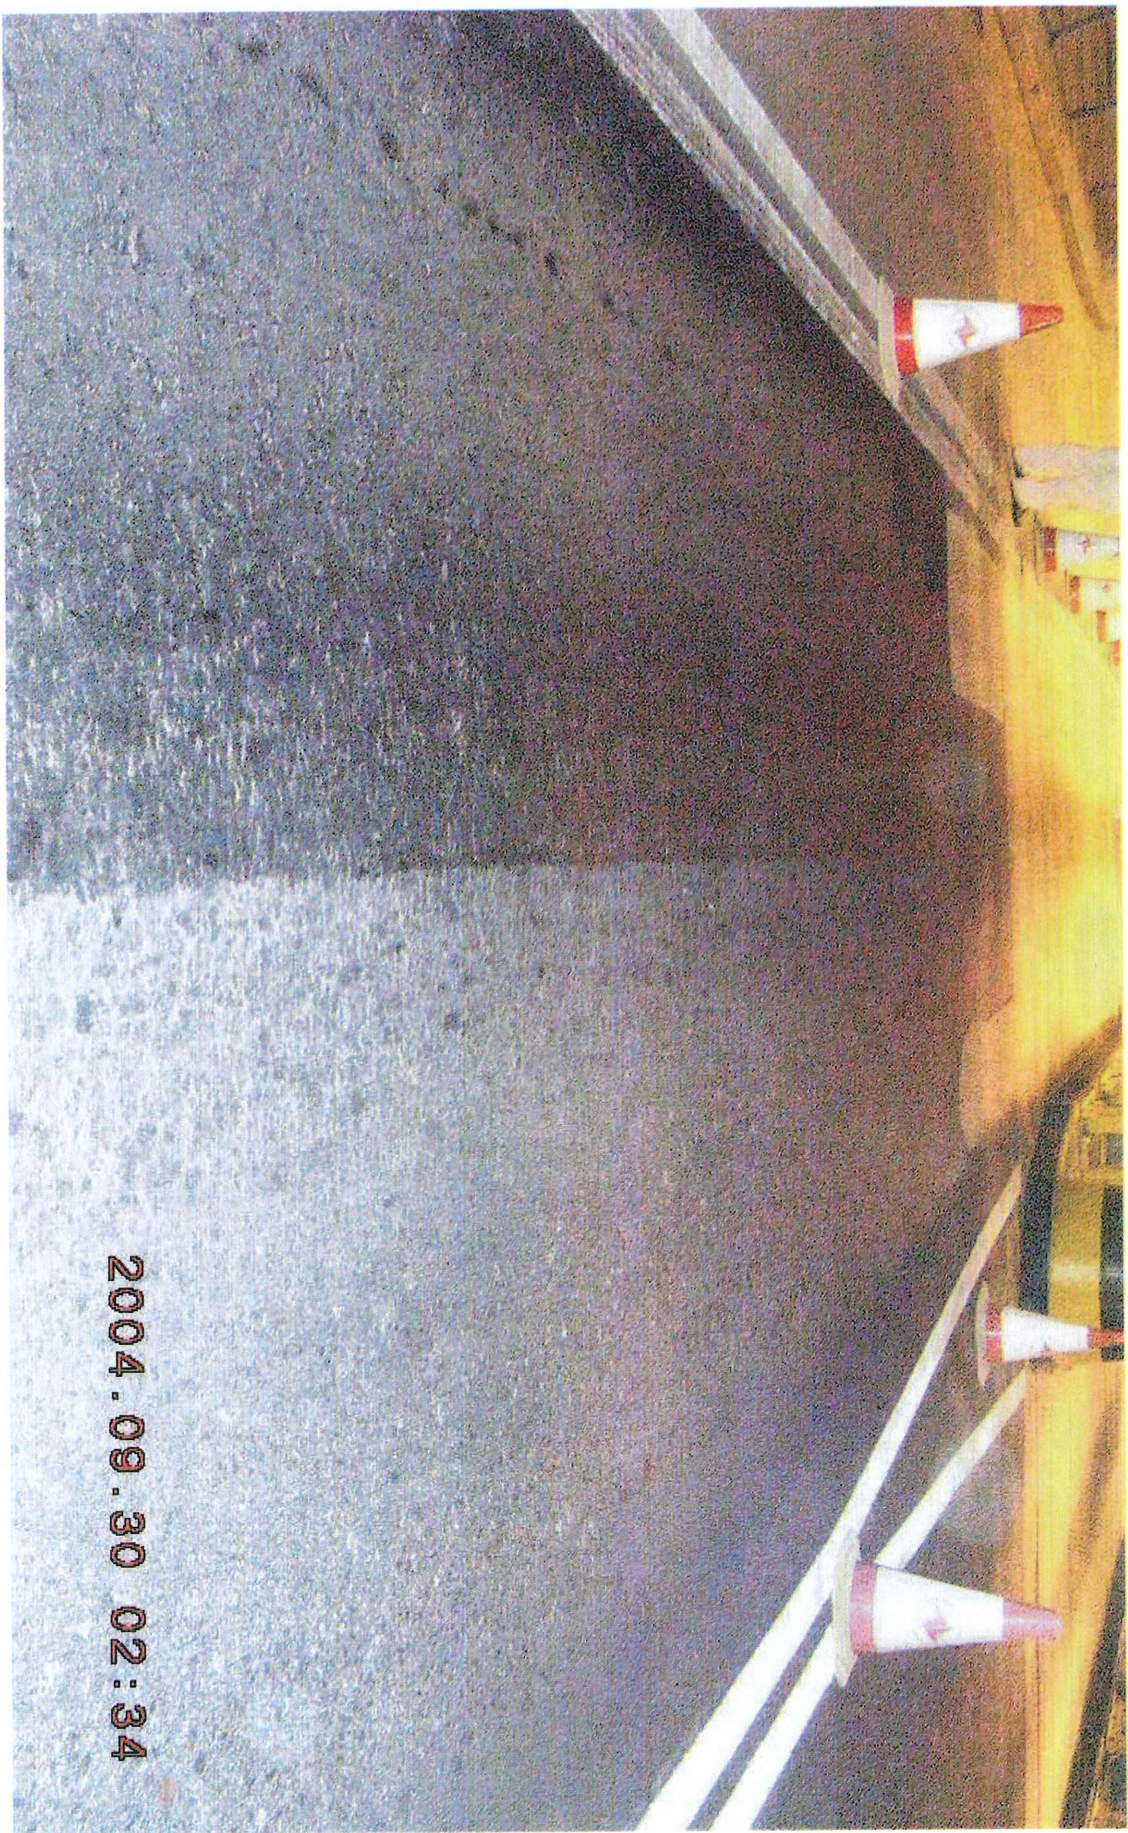
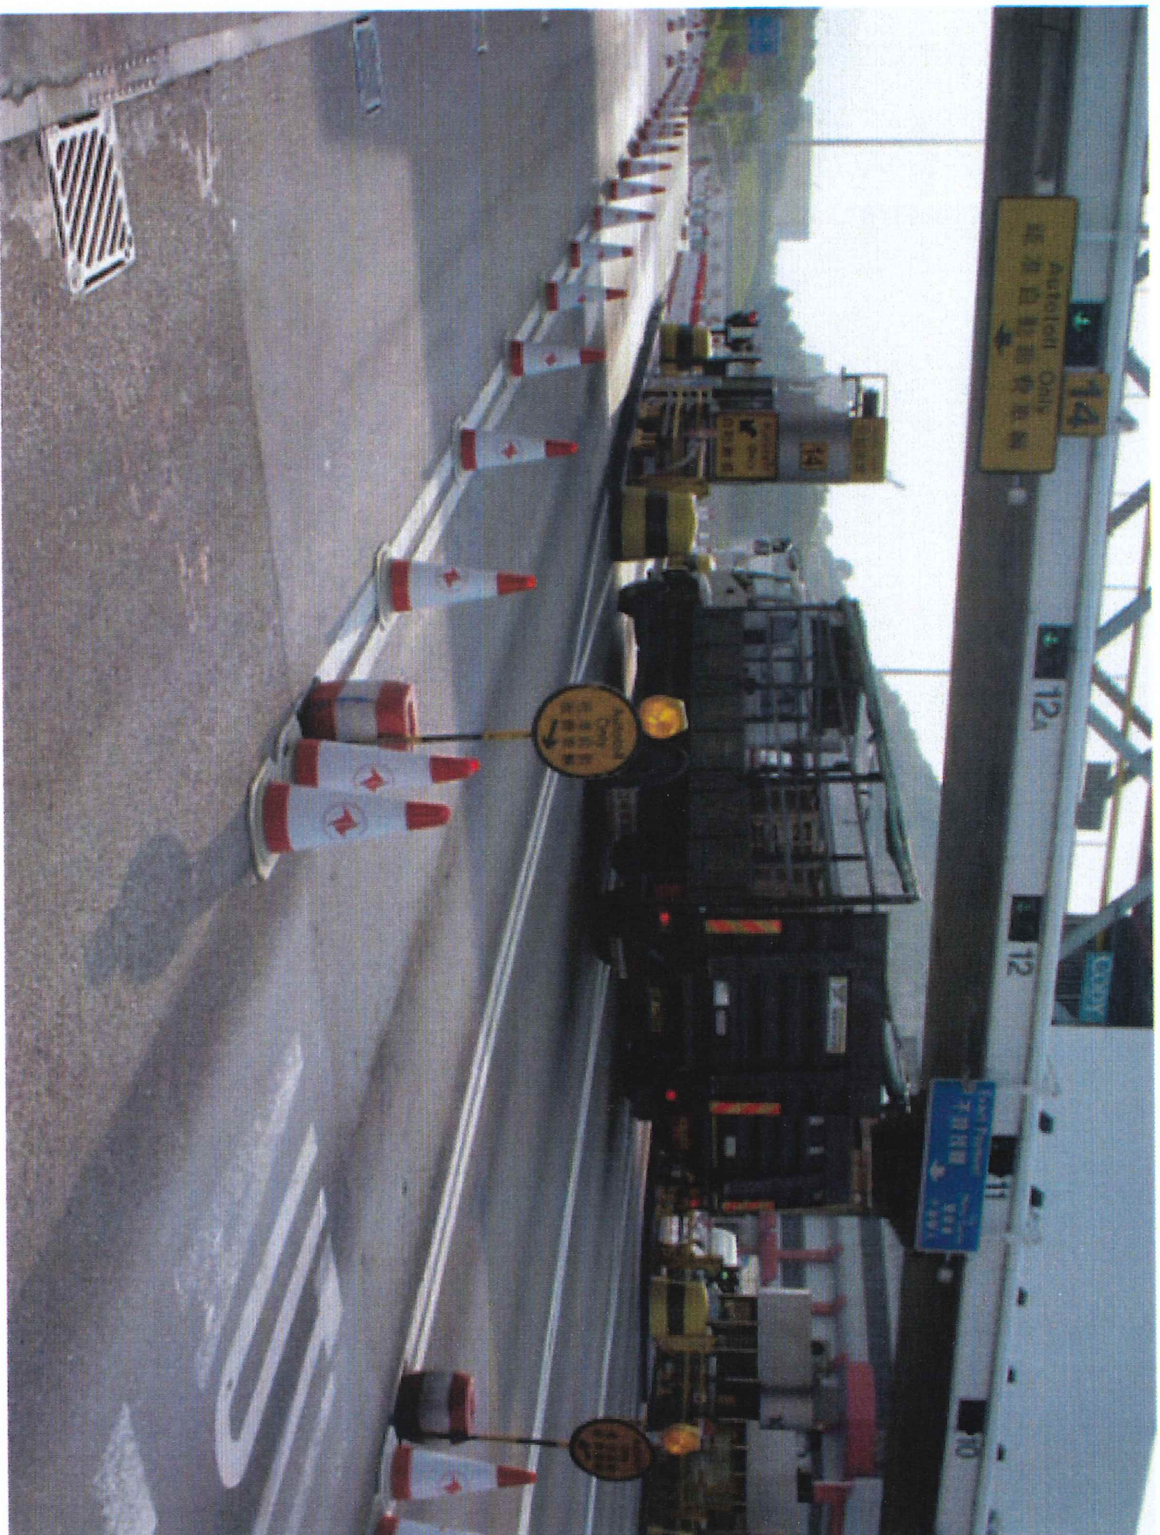
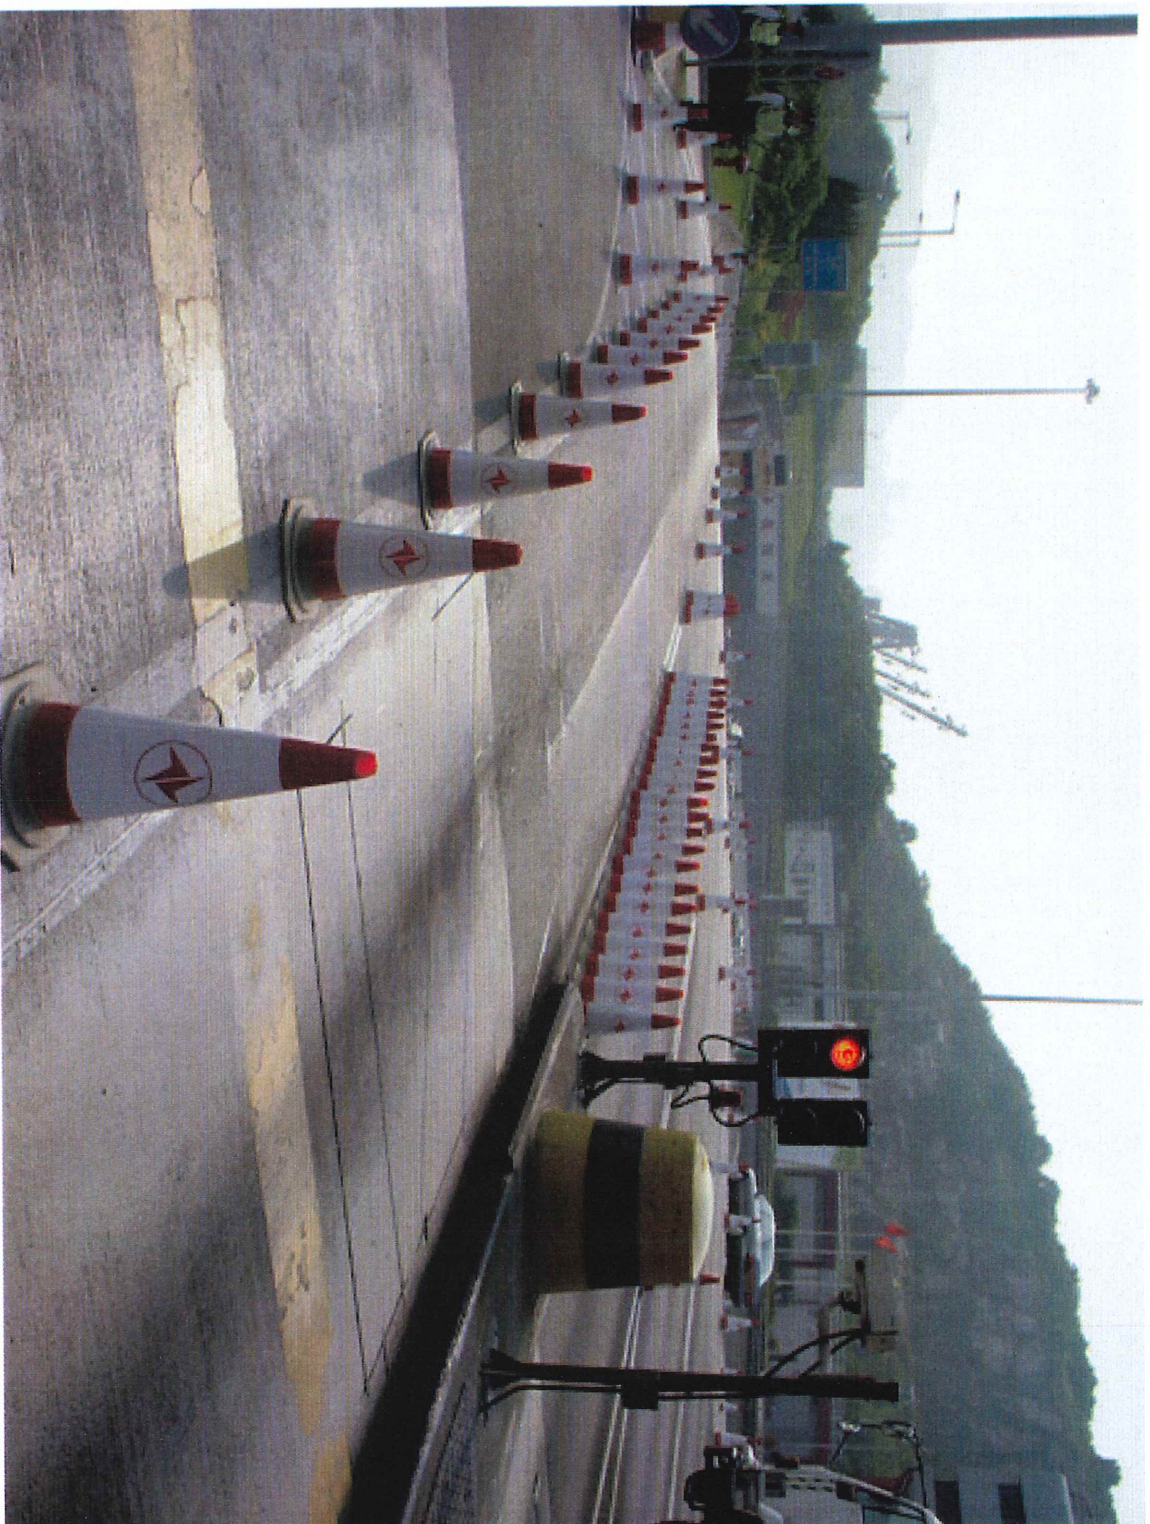
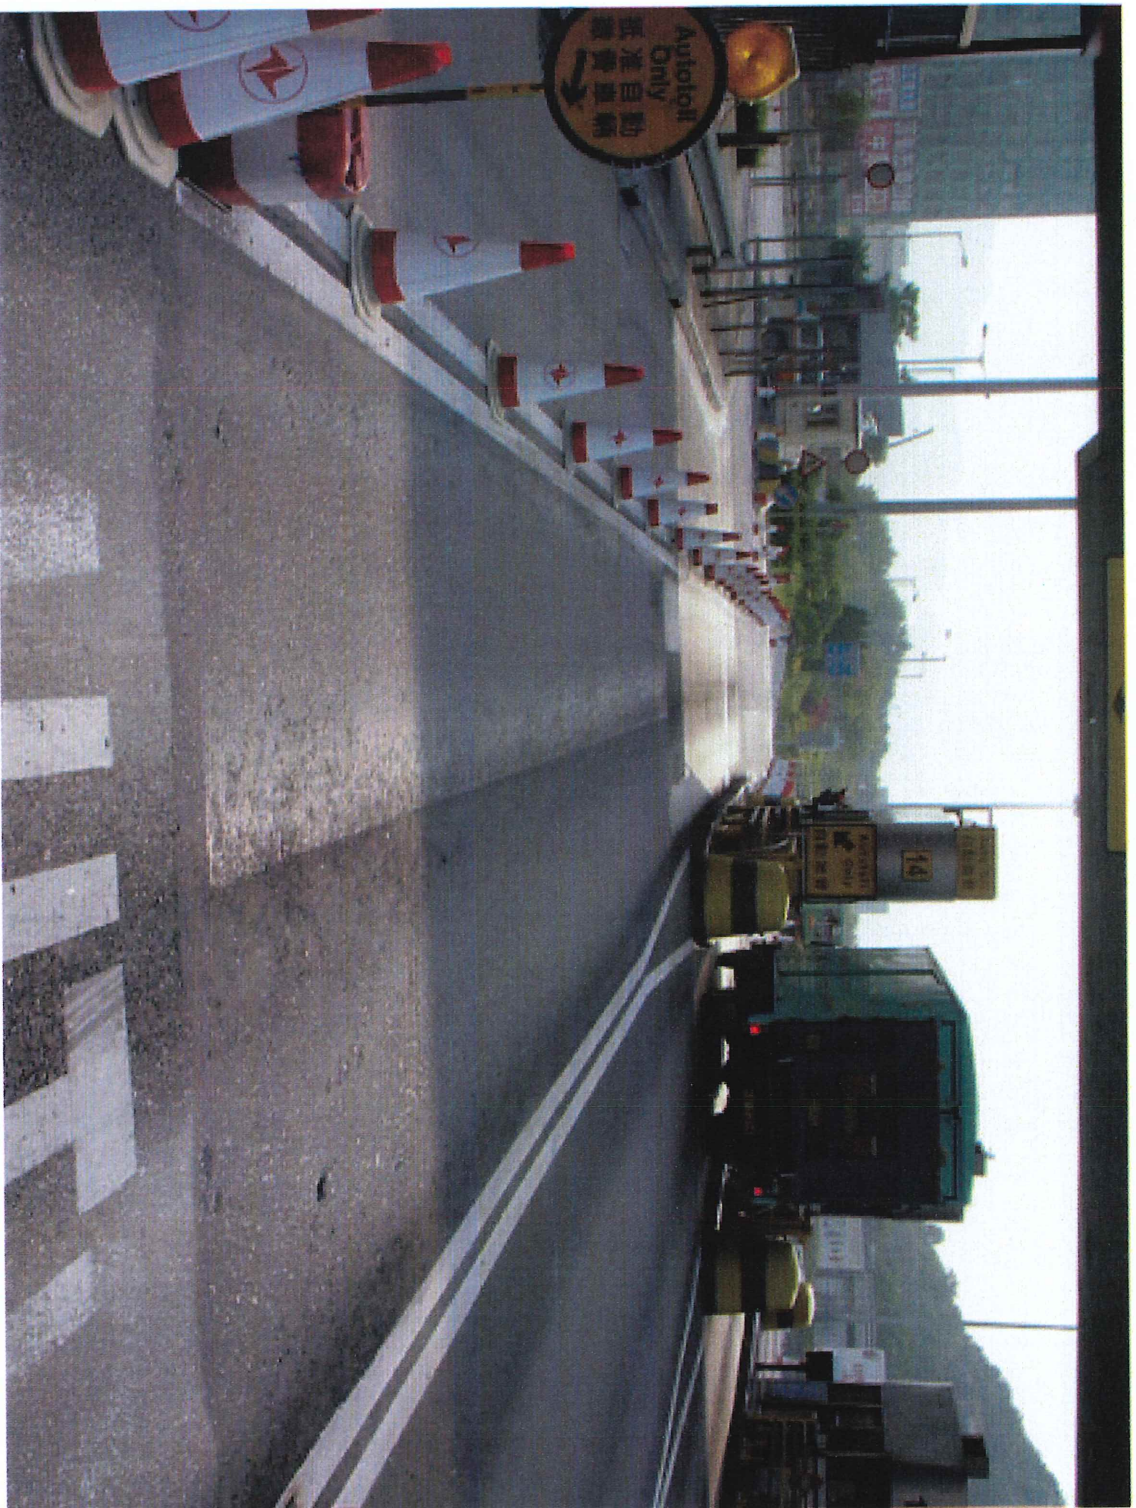
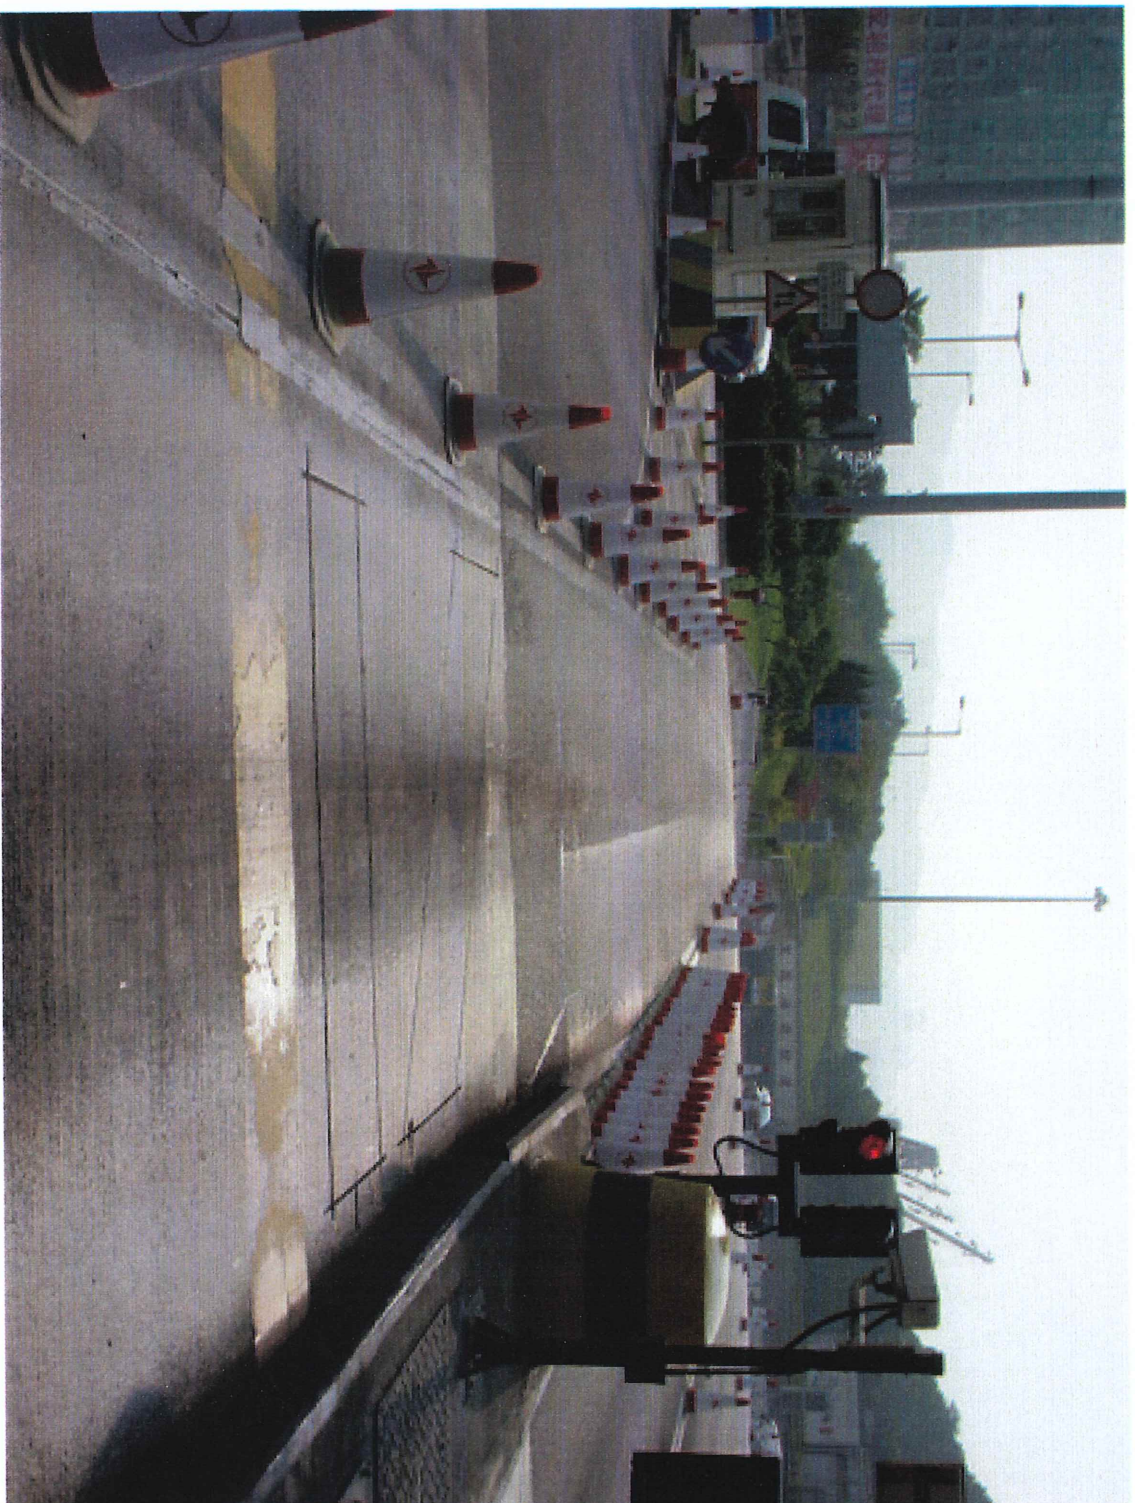
Figure 2 (including 2a to 2d) illustrates the location of two demo strips that were undertaken in proximity to Toll Booth Number 14, located at the Kowloon side of the facility. This toll booth is unmanned and serves as an automatic toll collector for heavy vehicles, such as buses and trucks which travel to Hong Kong Island. Immediately in front of the toll booth, a 15-metre long strip (2 metre wide) was treated with RJSealTM on March 5, 2004 for demonstration purposes. Similarly a 15-metre long demo strip was completed immediately after the concrete apron beside Toll Booth No 14.

The asphalt pavement at this location is a Stone Matrix Asphalt (SMA) with 25 mm aggregate at the tollbooth. Normally the pavement fails quite quickly in proximity to the tollbooths and is completely replaced every 6 to 9 months, due to the excessive traffic of heavily loaded vehicles. This is attributable to the fact, that all vehicles usually would slow down or brake in front of the Auto Toll Booth and then resume their speed, thus adding dynamic loading to the heavy static load of these vehicles, resulting in short life span of the asphalt road at about 6 to maximum 9 months. After more than 6 months, the site observation and experience with these two demo strips shows that RJSeal™ has extended the life of the asphalt pavement and still shows no significant sign of fatigue, whilst on the other side of the road surface where no RJSeal was applied, cracks are evident.

Figure 2 - Test Strip of March 5, 2004
in front of Toll Booth No. 14

There is no better test of a product than the reality of its application. The two test patches before and after the Auto Tollbooth were put into service in March and for more than six month, under non-stop daily service under the severe weather of the rainy season in this semi-tropical place from March till September. The traffic records indicate that more than 1.2 million vehicles passed through the Auto Tollbooth alone during the 6 month period ending September 5, 2004. This included 25,000 heavy goods vehicles, 64,000 single-decker buses and 300,000 double-decker buses.

The untreated road surface showed cracks and signs of structural failure. It has to be replaced. Yet when the author went to the site in September and again in early November, the treated surface still showed no sign of fatigue or failure and raveling was negligible, as no fine loss was observed. The test proves that it can withstand the static load and induced live load of the vehicles whilst braking and accelerating.

The demonstration proves that RJSeal can stabilize the new asphalt and in fact improve the resistance to flexure cracking due to the high volume of traffic with heavily loaded vehicles, whilst not losing its ductility.

The phenomena suggest that the life span of asphalt road surface of the toll booth area can definitely be extended through the application of RJSeal.

Since there is no extensive data to identify how long the life span can be extended, the test result does suggest that RJSeal should be applied at the toll booth area at least once every 6 months. As such, it is believed that the life span of the road surface can last at least two to three more cycles, say 18 months.

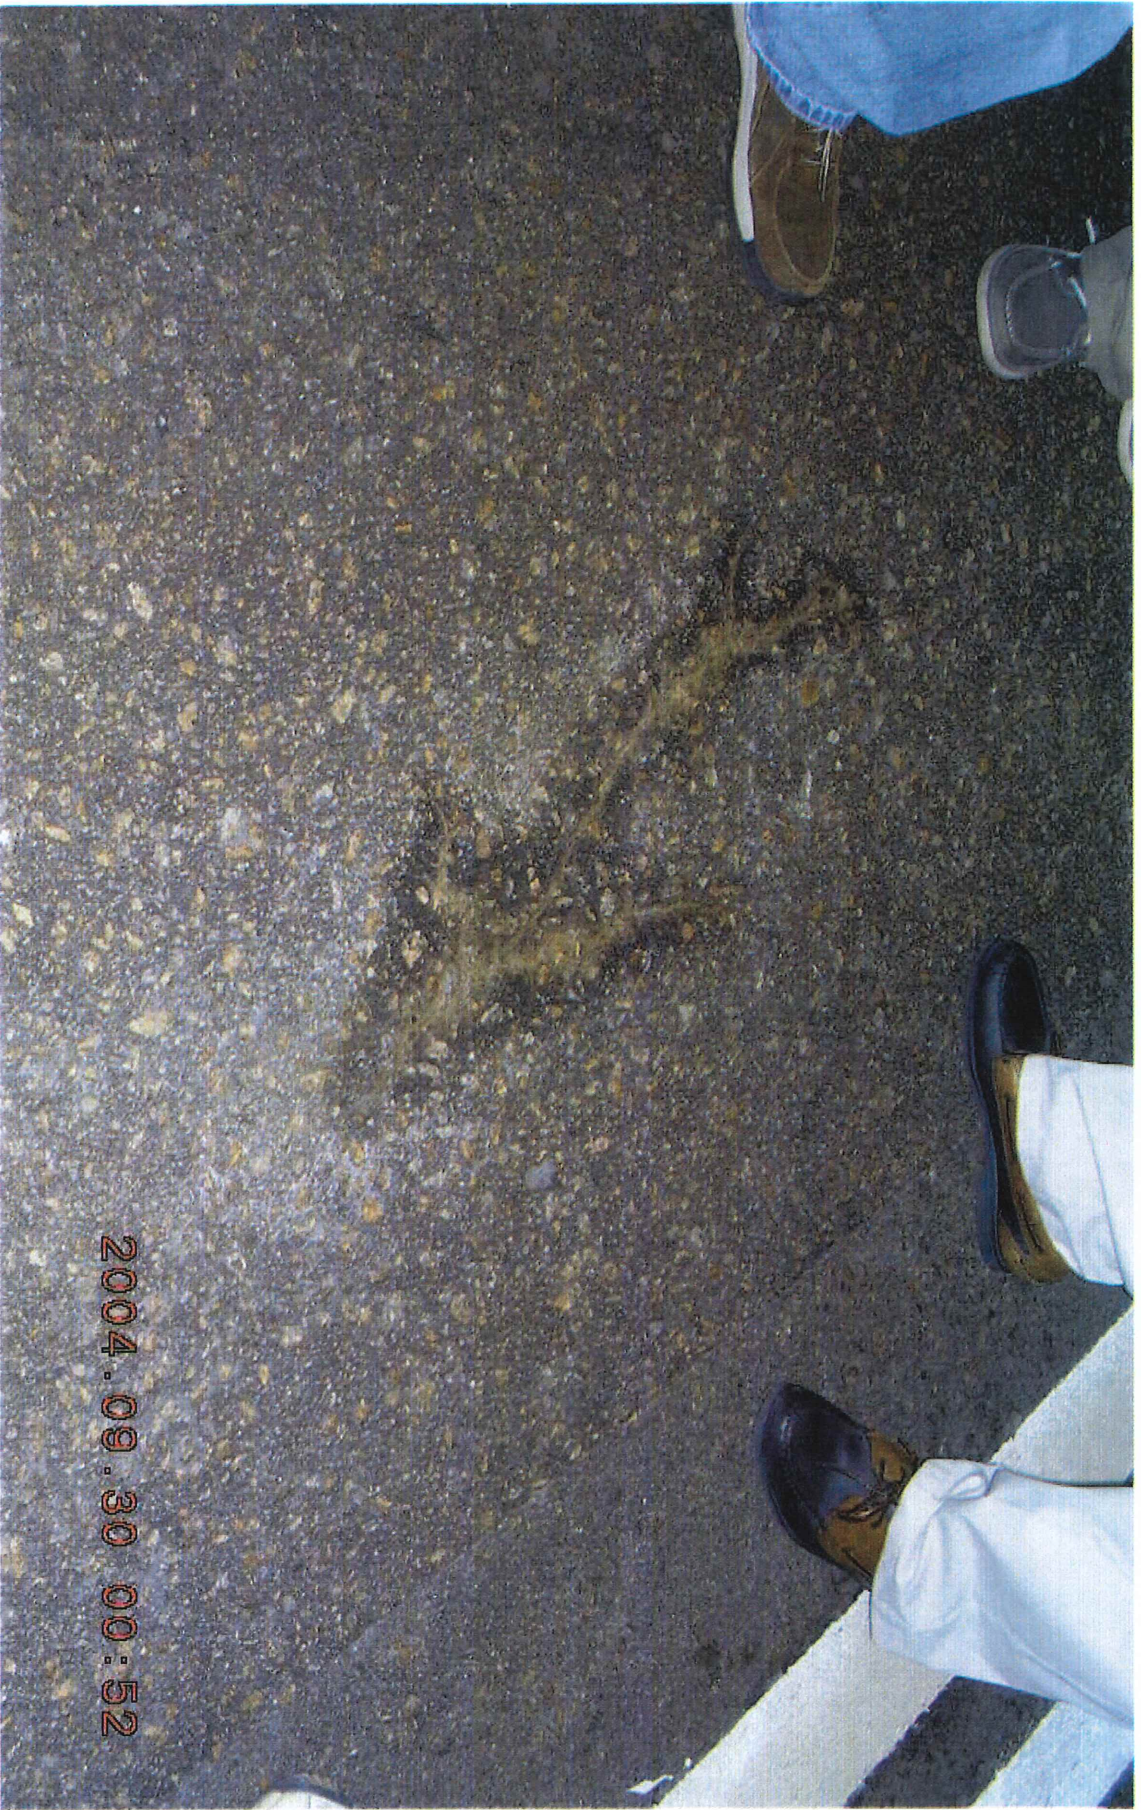
The entrance to the tunnel descends at a gradient of approximately 6% and this portion had extensive problems, with water ingress from sidewalls and floor. See [Figure 3](#) for a graphic illustration of water ingress, through a porous area in the floor. Shortly after the opening of the Eastern Harbour Tunnel for service, the operating company had to install supplemental drainage down the centre of the tube (between the two driving lanes) with branch lines to the side of the tube for collection of nuisance water.

Furthermore, water percolating down the exterior skin of the tube and then arising at porous portions of the asphalt overlay results in erosion of the bitumen binder and eventually leads to the formation of honeycomb asphalt and thence potholes and local failure of the asphalt pavement. These potholes are cut out and patched on a periodic basis.

Figure 3 - Water Seepage from Floor

The general inspection of the entire Kowloon side toll area including the entrance area also suggests that some preventive measures must be undertaken in the near future to prevent further serious road surface deterioration of the structures.
