**Demonstration of RJSeal™
East Harbour Tunnel,
Hong Kong**

**TS² Consulting Inc.
Lamma, Hong Kong**

November 15, 2004

INSPECTION OF EASTERN HARBOUR TUNNEL

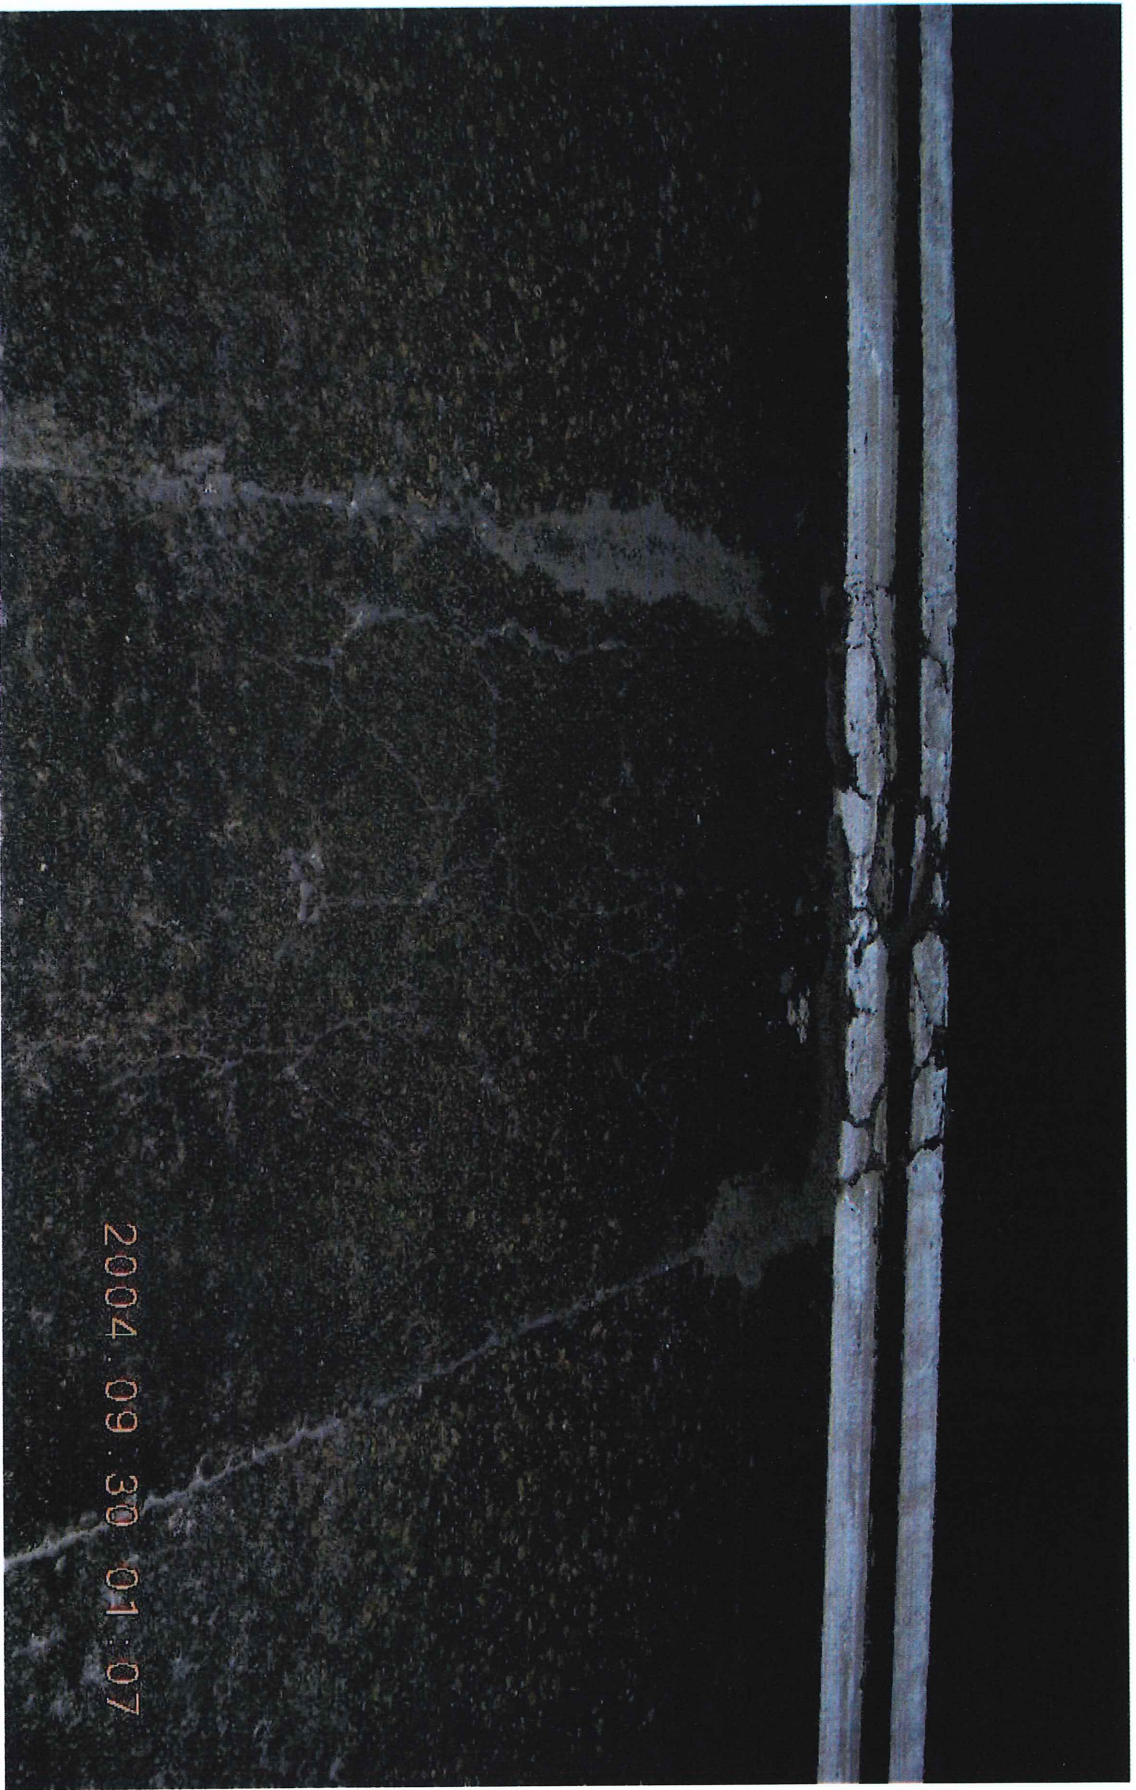
The drainage system that was retrofitted, post-completion also has presented some maintenance problems due to flexure of the asphalt pavement that overlies the cross drains from the central collector. See [Figure 4](#) for illustration of the asphalt failure at the cross drain. This is especially prominent in the initial portion of the tunnel at the decline on the way down to the level central portion. Inspection of the asphalt pavement in the central portion shows no significant problems, although in the wheel path of both lanes, there is a raveling (loss of fines and exposure of the stone matrix).

Figure 4 - Damaged Asphalt at Cross Drain

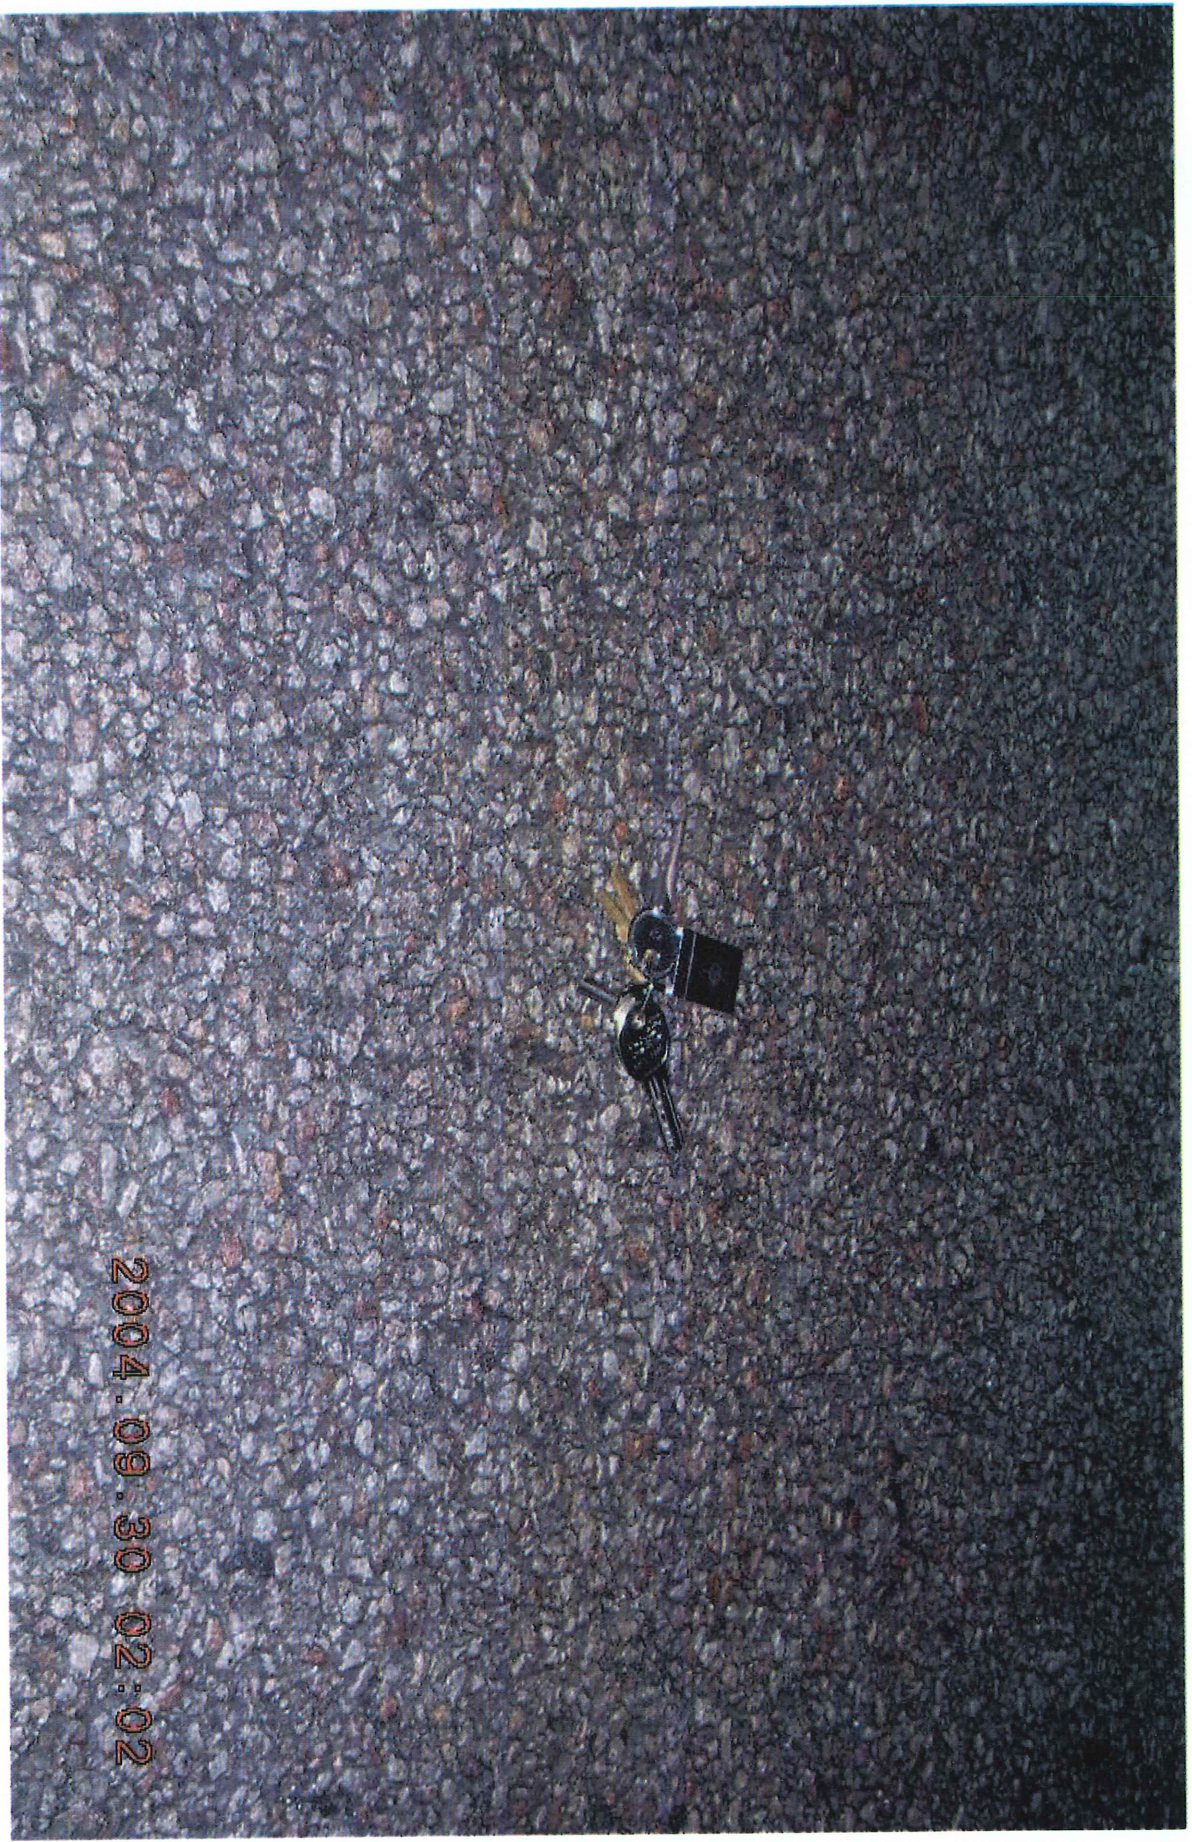
See [Figure 5](#) illustrating the exposure of the stone matrix. At the present time, the exposed stones have sufficient bitumen binder to hold them in place, but it is suspected that in the next year, some maintenance material should be applied to rejuvenate the bitumen, which is now quite stiff. Attempts to dig into asphalt pavement with a pocketknife indicate that the bitumen binder is now quite inflexible.

Figure 5 - Exposed Pebbles in Asphalt Pavement

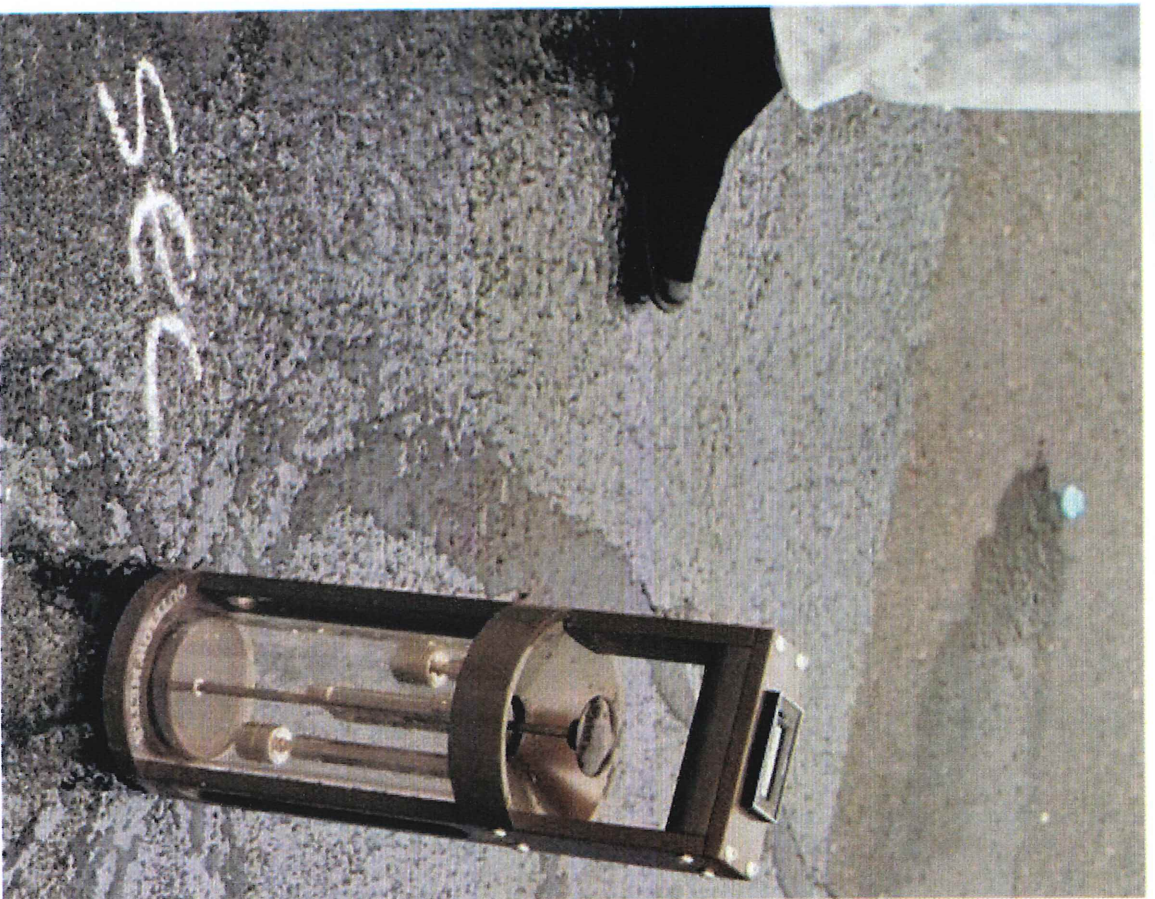
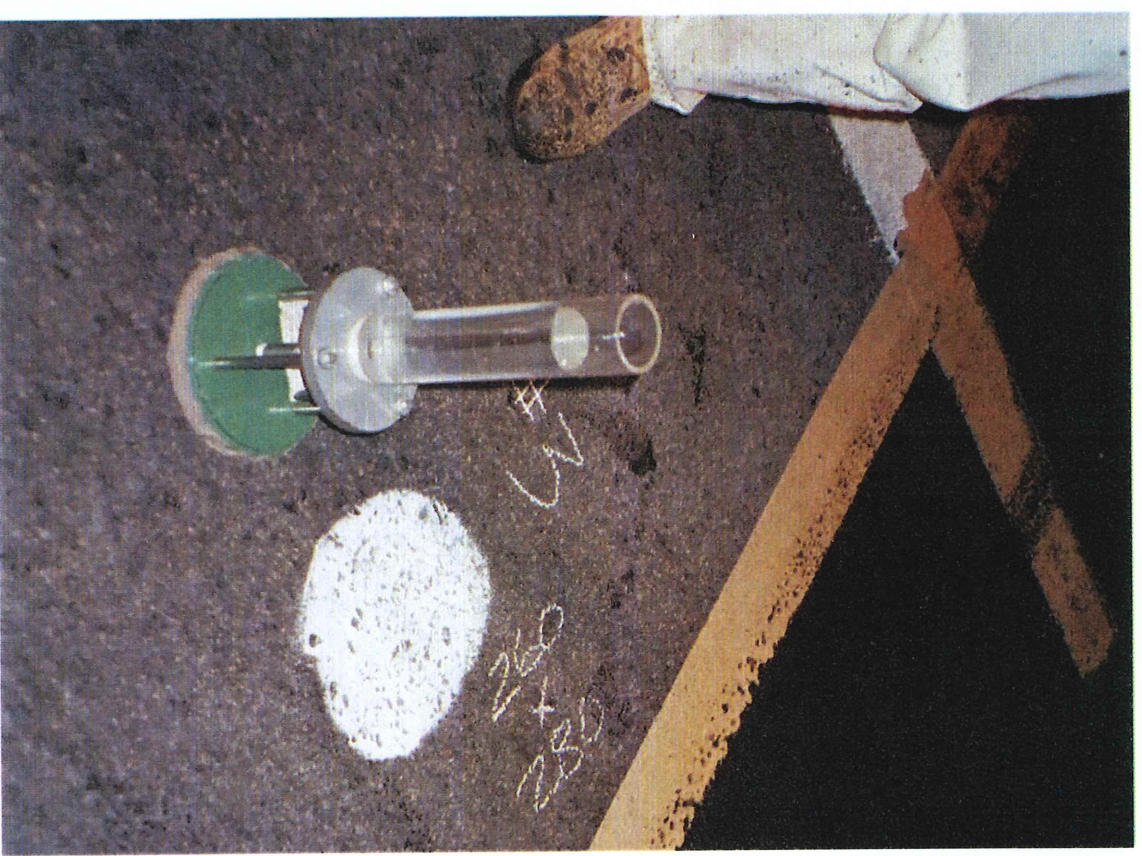
The following test procedures were implemented to test the asphalt pavement. Figure 6 shows the suggested type of equipment that can be used for the various test procedures. Comparisons were undertaken at several locations on both the untreated and RJSeal™ treated sections (see Figure 7).

The sand patch test (ASTM Standard E965-96 OR China Standard T 0961-95) was used to ascertain the Pavement Macrotexture Depth. It reflects the roughness of the surface. By comparisons, it would show that the RJSeal application should not affect the macrotexture depth.

Water Penetration Tests (China Testing Standard T 0730-2000) were undertaken at several locations on the untreated portion of the road, in close proximity to the test strips and later on the RJSeal™ treated section. For porous friction coarse, the water should flow through before and after the RJSeal treatment.

An "Outflow Meter" manufactured in the U.S.A. by Humble Equipment Company of Ruston, Louisiana and sold under the trademark "Outflow Meter" was used to measure and compare the relativity of the asphalt pavement's macrotexture, to ascertain the hydroplaning potential on the RJSeal™ treated surface, versus the untreated surface. The procedure is documented in the ASTM working paper, WK-364. The Outflow Meter gives readings in seconds for the dissipation of a known quantity of water. It is suggested that any readings between 3 and 10 seconds are excellent and readings less than 15 seconds are satisfactory for an asphalt pavement surface, if hydroplaning is to be minimized.

Figure 6 - Humble Equipment Co. Outflow Meter
Water Penetration Meter & Sand Patch Test

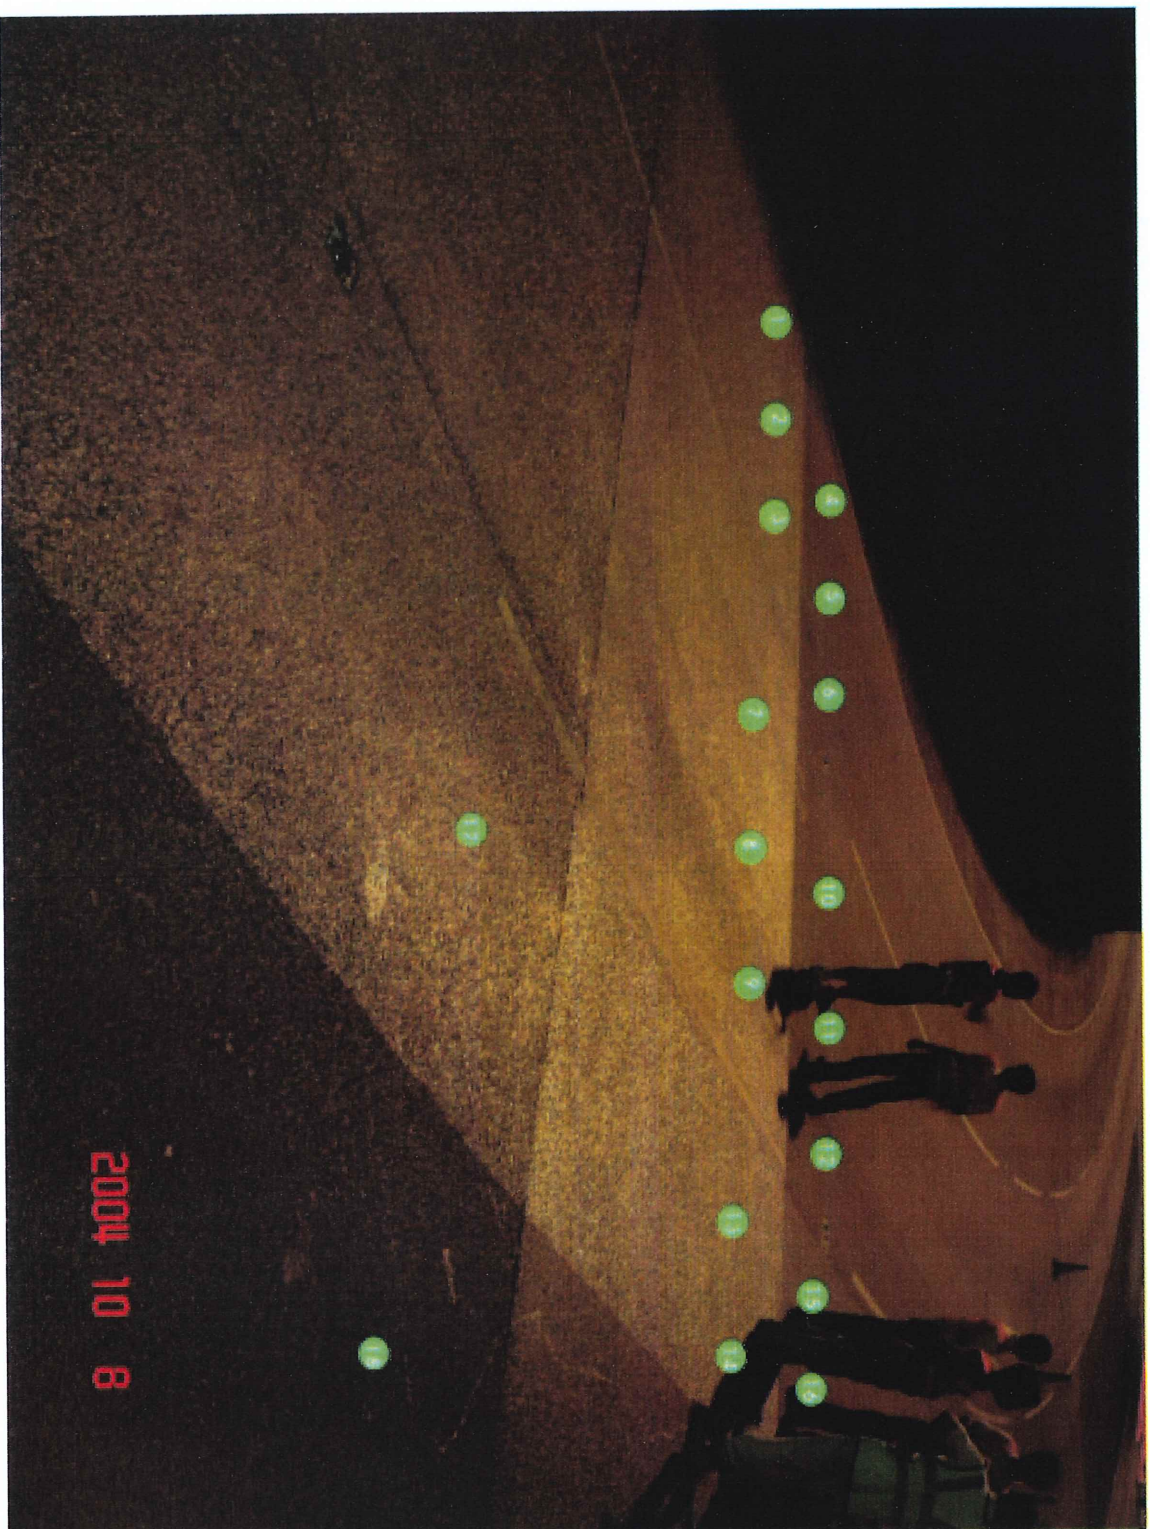
Figure 7 - Locations of RJSealTM Treated and
Untreated Sections

Location			
1 year Old Surface	Untreated Surface	Treated Surface	Remarks
• Macrotexture Depth	0.93 mm	0.93 mm	Test Nos. 13-16
• Water penetration	100 ml/min	685 ml/min	Test Nos. 13-16
• Hydroplaning potential	4 seconds	4seconds	Test Nos. 13-16
2 year Old Surface	Untreated Surface	Treated Surface	Remarks
• Macrotexture Depth	0.98-1.24 mm	1.04-1.24 mm	Test Nos. 1-12
• Water penetration	480 ml/min	160-960 ml/min	Test Nos. 1,3,4,6
• Hydroplaning potential	4 seconds	3 seconds	Test Nos. 7,10
3 year Old Surface	Untreated Surface	Treated Surface	Remarks
• Macrotexture Depth	0.42-0.48 mm	0.41-0.47 mm	Test Nos. 7,10
• Water penetration	117 ml/min	135 ml/min	Test Nos. 7,10
• Hydroplaning potential	2 seconds	2 seconds	Test Nos. 7,10
