**RJSeal™ Application
Xisihuan BeiLu, Wukusong Overpass
Beijing,
Peoples Republic of China**

June 2005

**TS² Consulting Inc.
Lamma, Hong Kong**

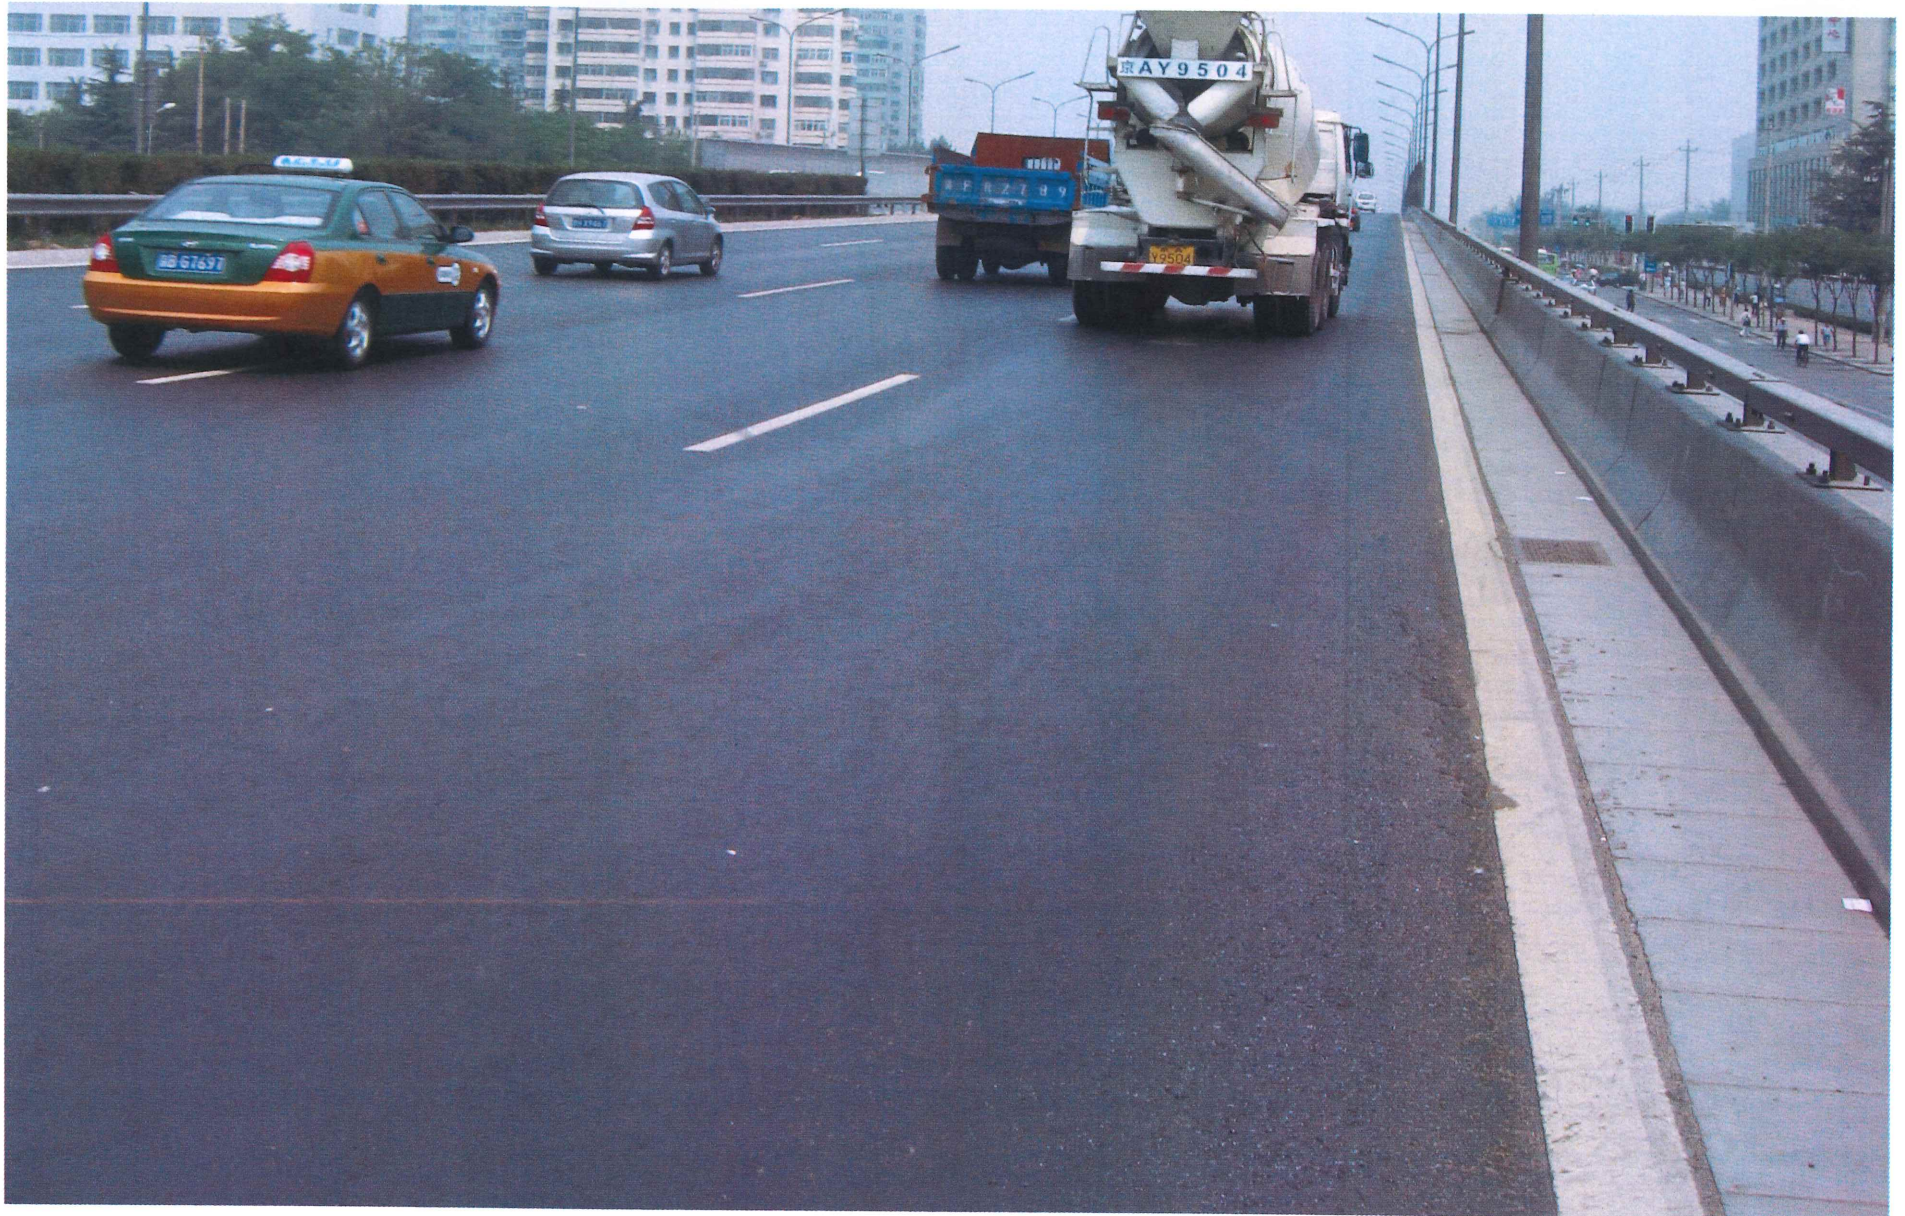
Figure 4.1 Test Strip on WuKuSong Overpass.

The 730 metre long application section on Xisihuan BeiLu, at the Wukusong Overpass is comprised of a hot mix asphalt pavement. See figure 4.0 for the location of the test strip with respect to the City of Beijing is graphically shown in figure 4.1, which follows.

There is a slight camber to the road, which causes water to run off toward the shoulder, rather than puddle on the road. No significant oil spills were observed, just the occasional drop of transmission oil, crankcase oil or hydraulic fluid. The asphalt pavement surface was not appreciably worn with no rutting due to traffic wear. There was aging and oxidation of the bitumen, which extended to a depth of several millimetres. There were longitudinal cracks, and also lateral cracks, which had recently been filled with tar. The entire portion of the treated asphalt pavement section overlies a concrete overpass deck.

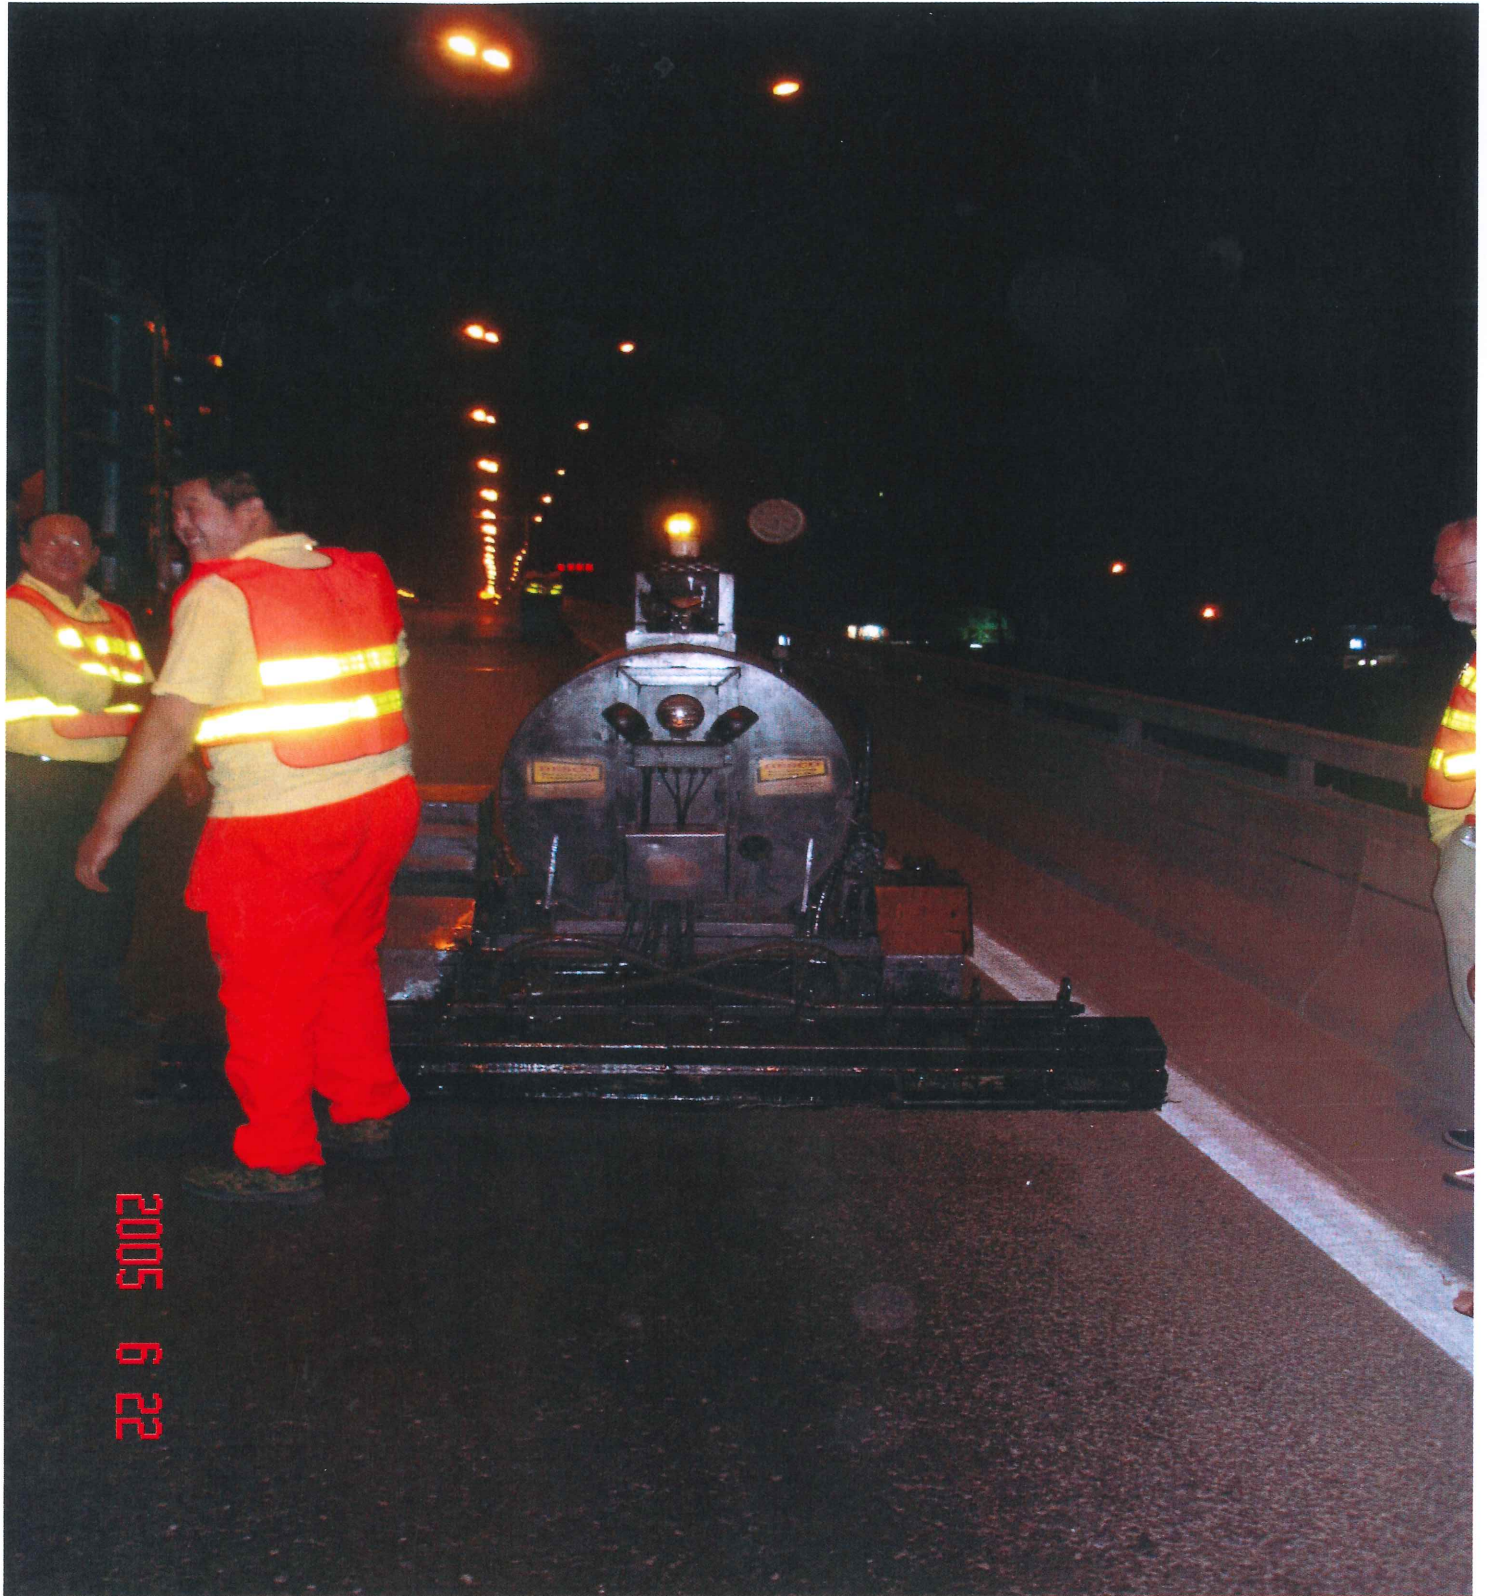
Figure 4.2 Typical Application Procedure.

RJSeal™ was applied, using a crew of 26 workers using two Desco D200 Sprayers. The specifications of these sprayers are shown in Appendix B. They applied the RJSeal™ in a uniform manner. Ambient temperatures at the time of the application on June 18 were in the 24 degree Celsius range, with humidity in the 50% range. Photos showing the test application of RJSeal™ follow in figures 4.2, 4.3 and 4.4. on the following pages.

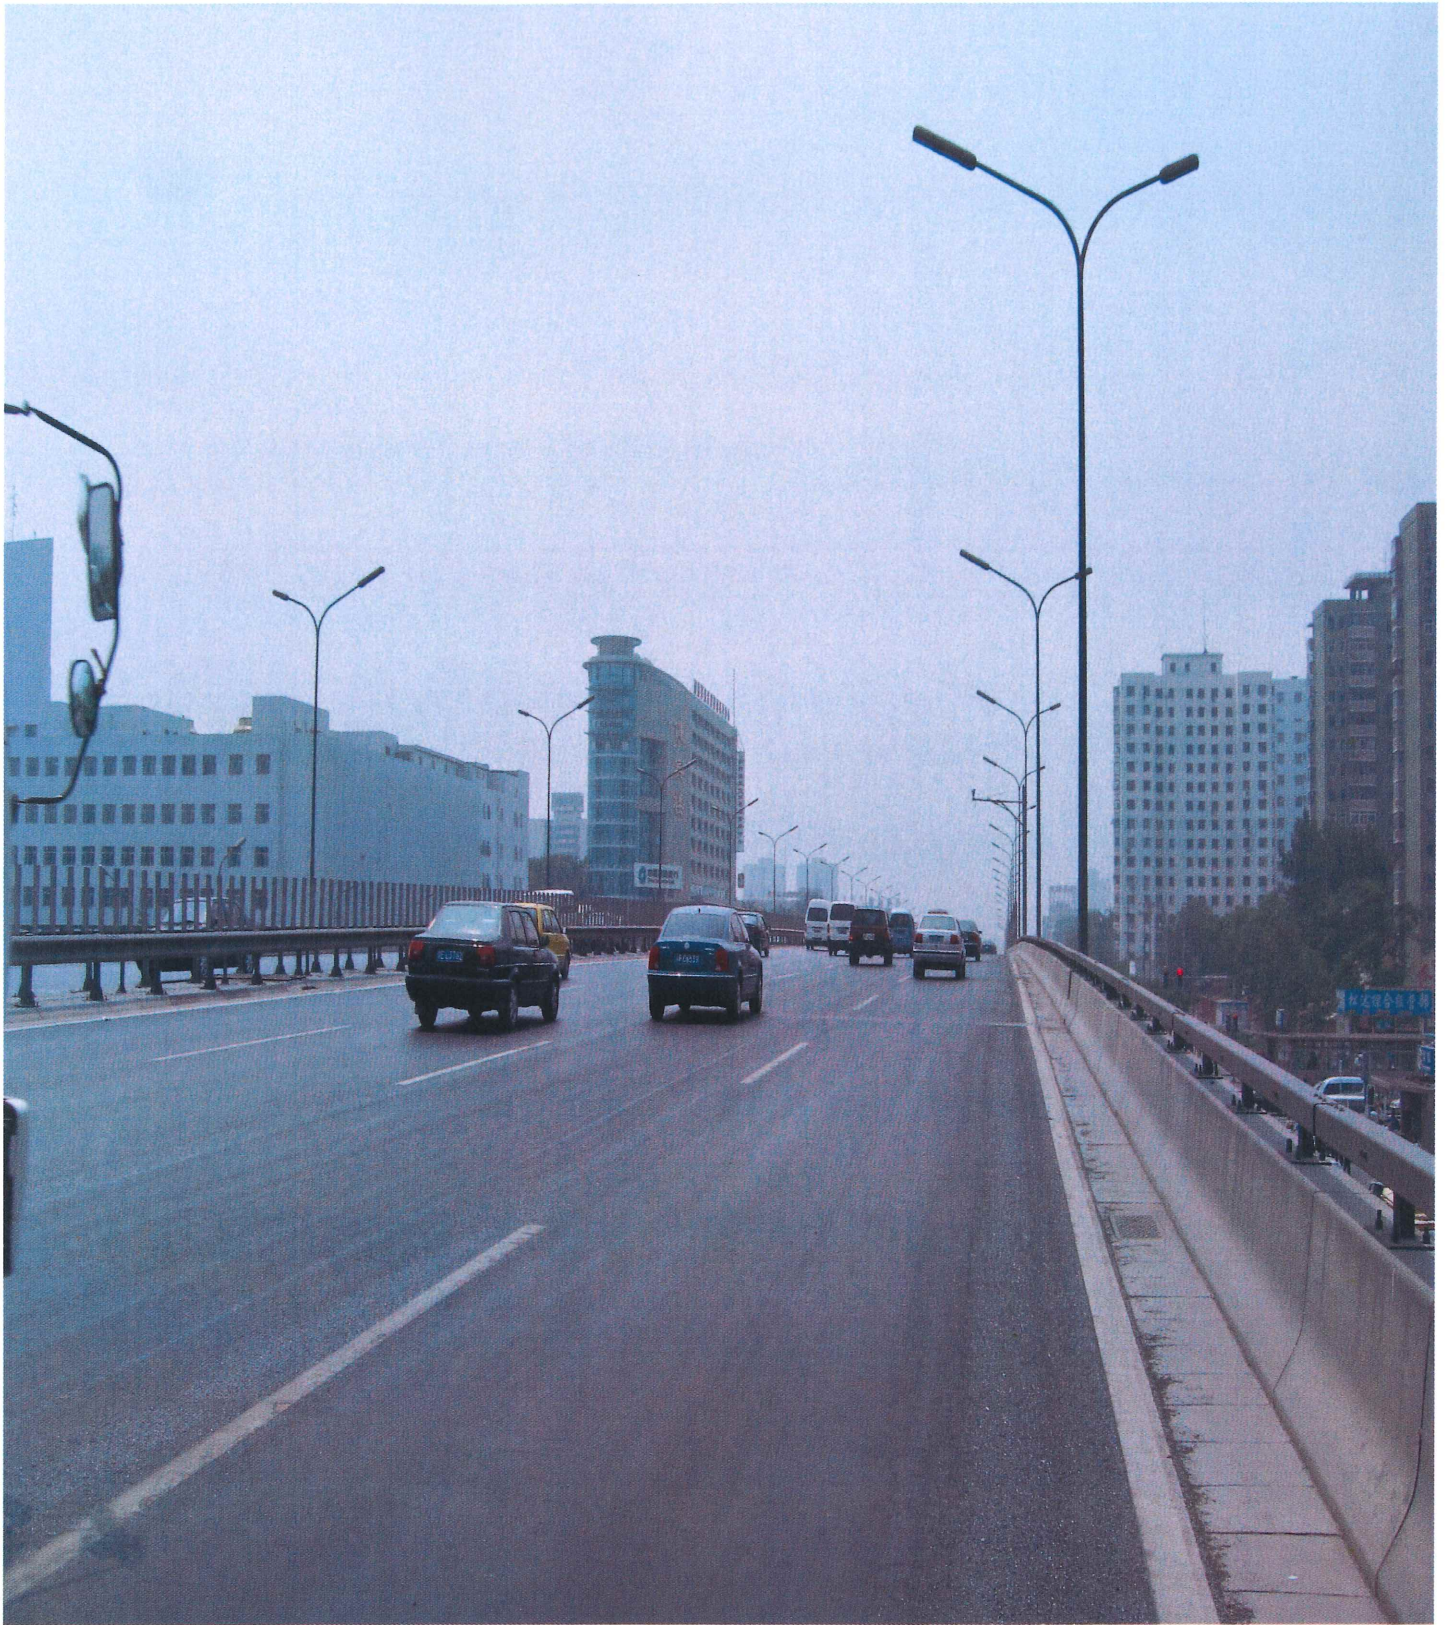
Figure 4.3 Finished Surface.

Subsequent inspection of the test strip on June 23, showed that the application rate of 4.3 m²/kg was adequate for the asphalt pavement at this location

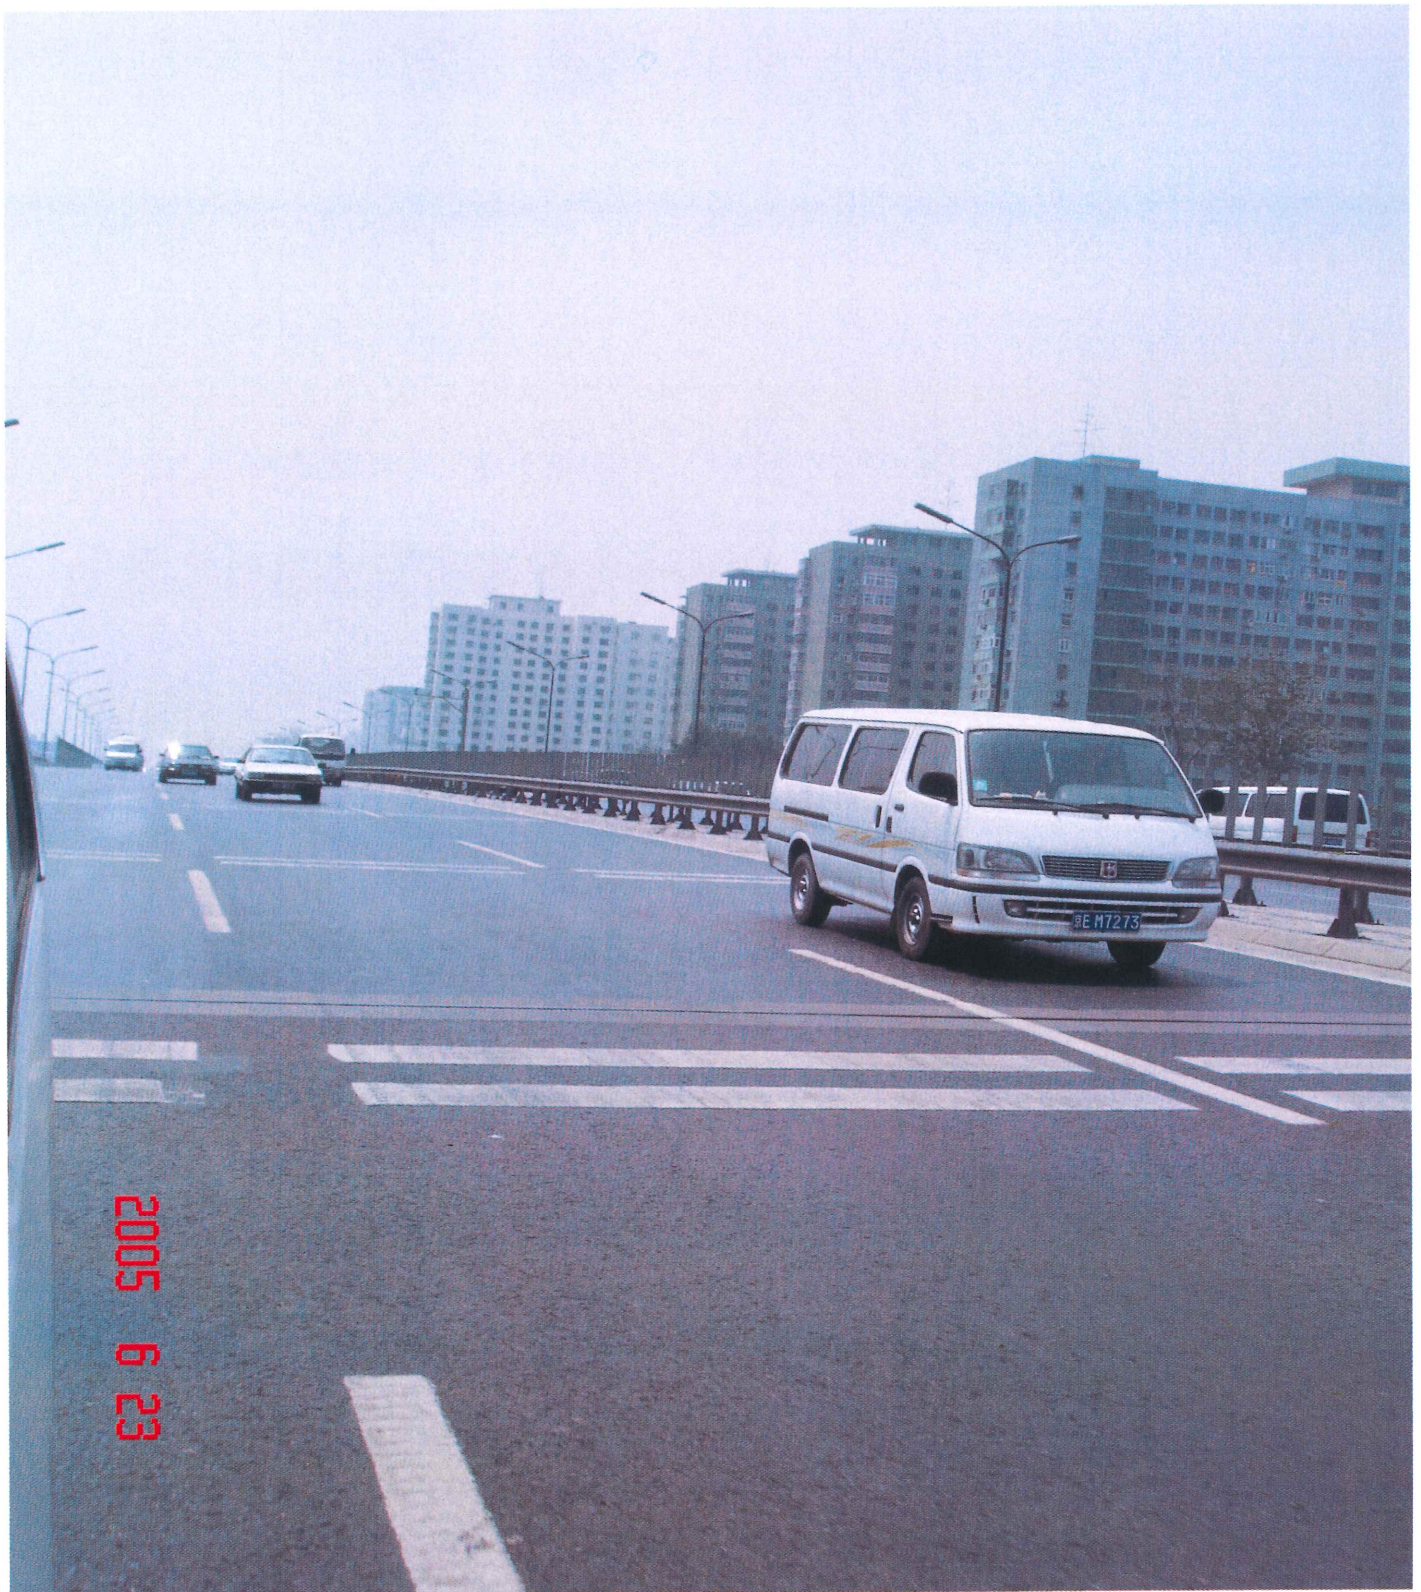
Figure 4.4 Site visit - June 23, 2005

A site visit on June 23, 2005 (Refer to Appendix C for more details) was made to check to entire test section following the application of the RJSeal™. This is pictorially shown in Figure 4.4 that follows.

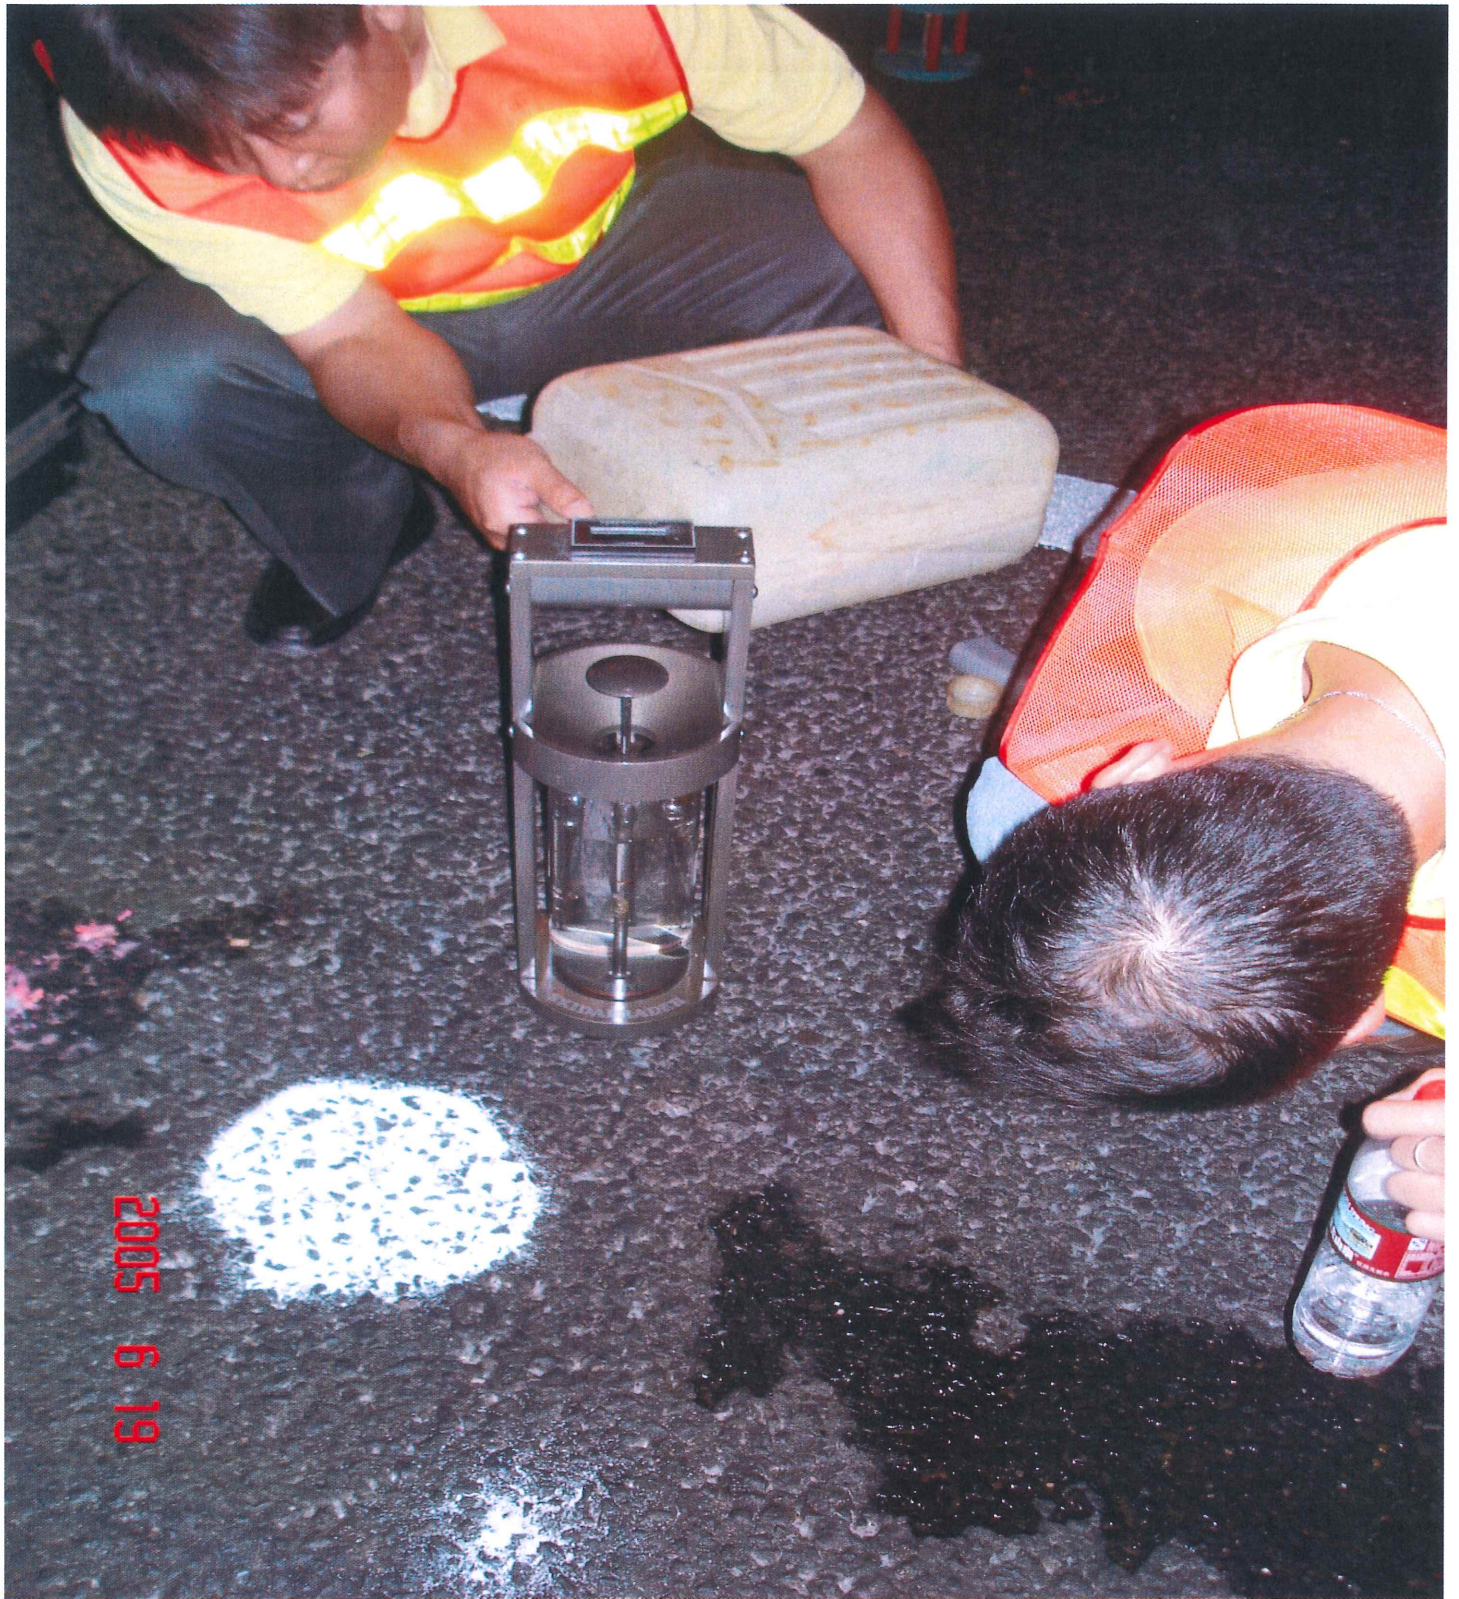
Figure 4.5 Outflow Meter

An “Outflow Meter” manufactured in the U.S.A. by Humble Equipment Company of Ruston, Louisiana and sold under the trademark “Outflow Meter” (see figure 4.5) was used to measure the asphalt pavement’s capability to dissipate water prior to and following the application of RJSeal, as concern has been expressed about hydroplaning on the RJSeal™ treated surface, versus the untreated surface. The procedure is documented in the ASTM Standard E2380-05. The Outflow Meter gives readings in seconds for the dissipation of a known quantity of water. It is suggested that any readings between 3 and 10 seconds are satisfactory results for an asphalt surface, if hydroplaning is to be minimized. Results from the tests are shown in the table that follows:

Outflow Meter Tests			
Location	Untreated Pavement (sec)	RJSeal Treated (sec)	Loc'n relative to Expansion Joint
Km 39+695 Lane 3 Northbound	2		4.2 m south
Km 39+695 Lane 2 Northbound	3		4.0 m south
Km 41+410 Lane 3 Southbound	2	3	1.0 m north
Km 41+410 Lane 2 Southbound	3		1.0 m north

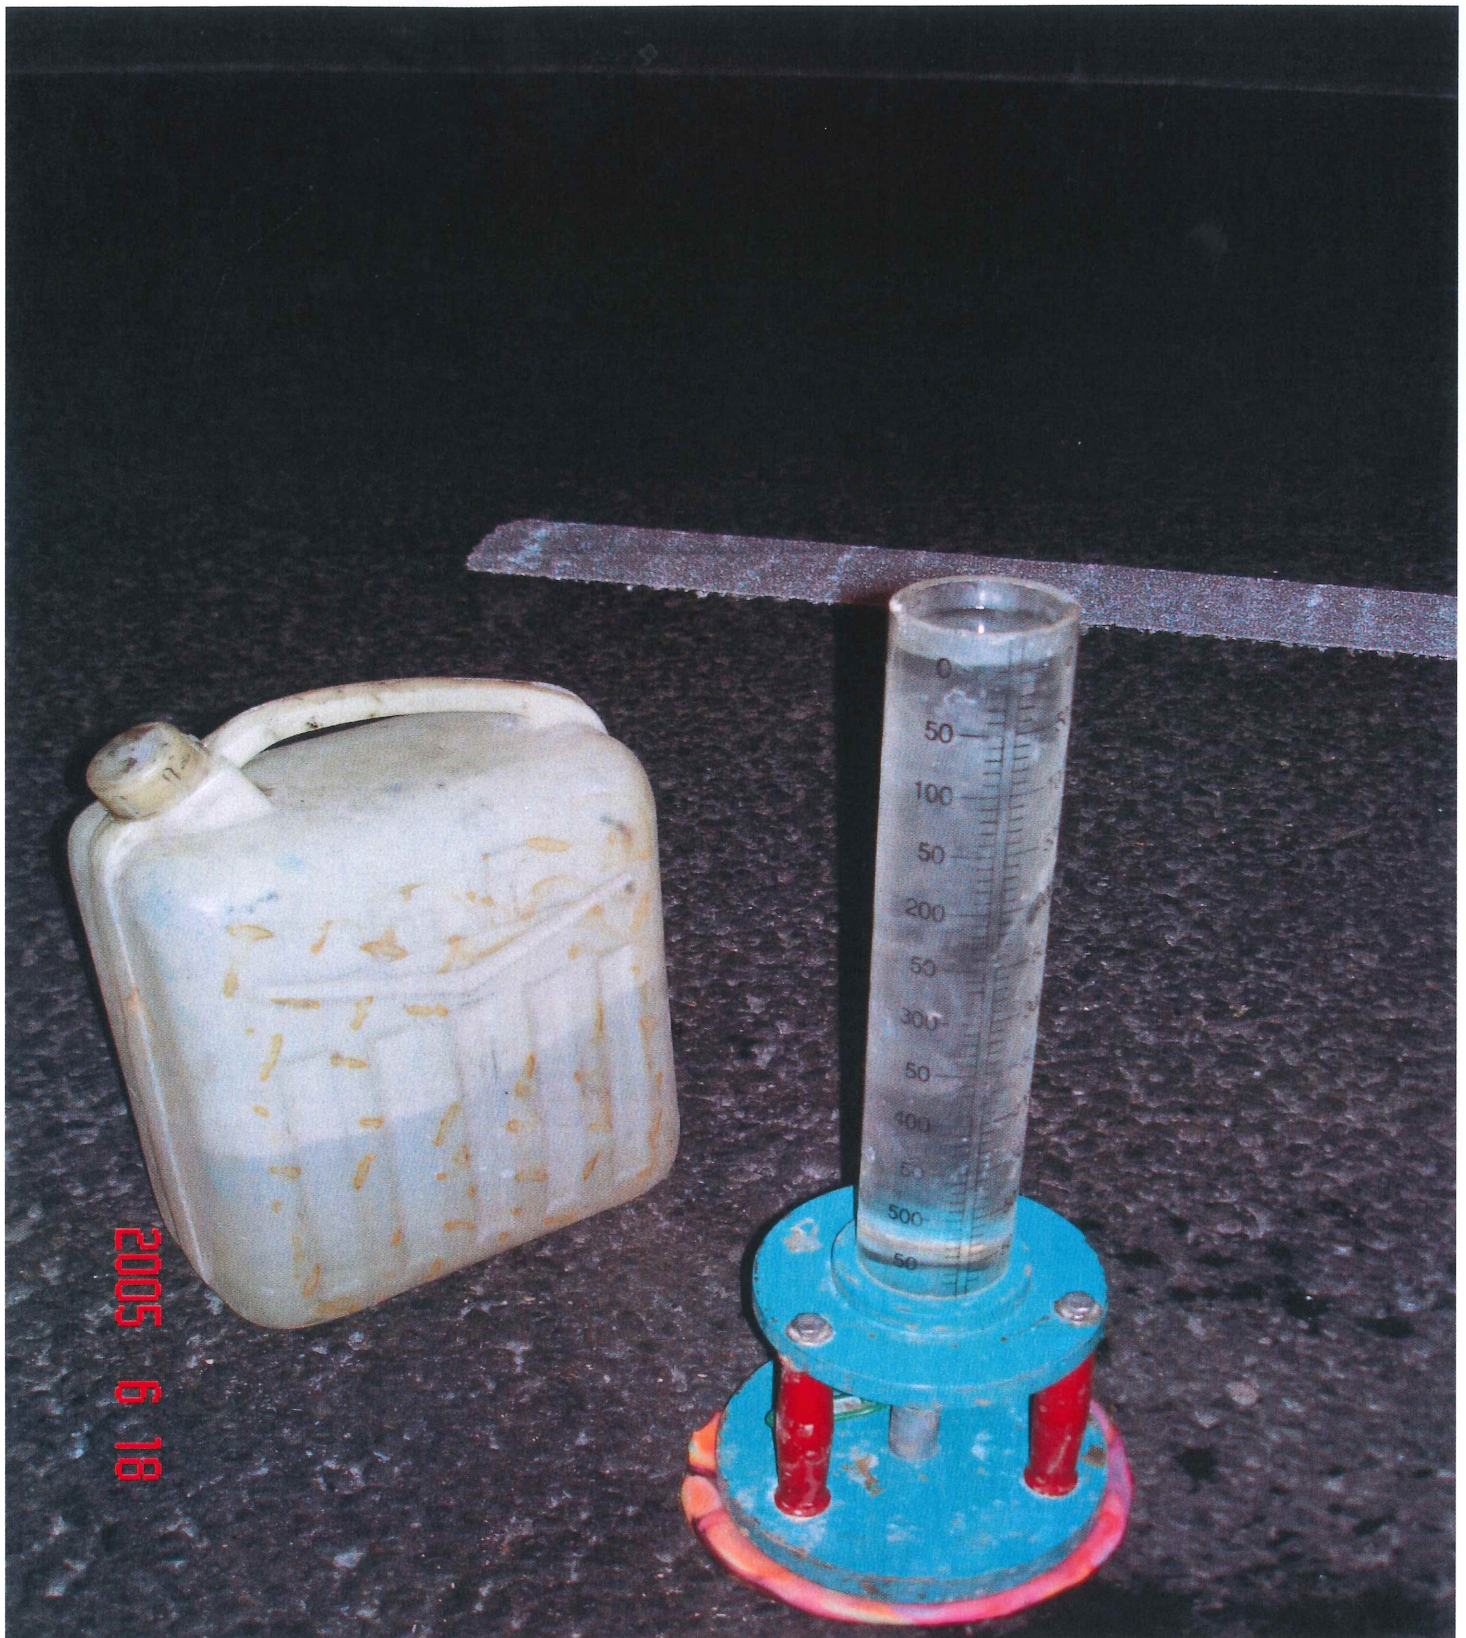
Figure 4.6 Water Penetration Test

Water Penetration Tests (China Testing Standard T 0730-2000) will be undertaken at several locations on the Xisihuan BeiLu, Wukusong Overpass on both treated and segment treated with RJSeal™.

See Figure 4.6 that follows for a pictorial presentation of the Water Penetration Meter.

Water Penetration Test			
Location	Untreated pavement (ml)	Treated pavement (ml)	Loc'n relative to Expansion Joint
Km 39+695 Lane 3 Northbound	0		4.2 m south
Km 39+695 Lane 2 Northbound	0		4.0 m south
Km 41+410 Lane 3 Southbound	0		1.0 m north
Km 41+410 Lane 2 Southbound	0		1.0 m north

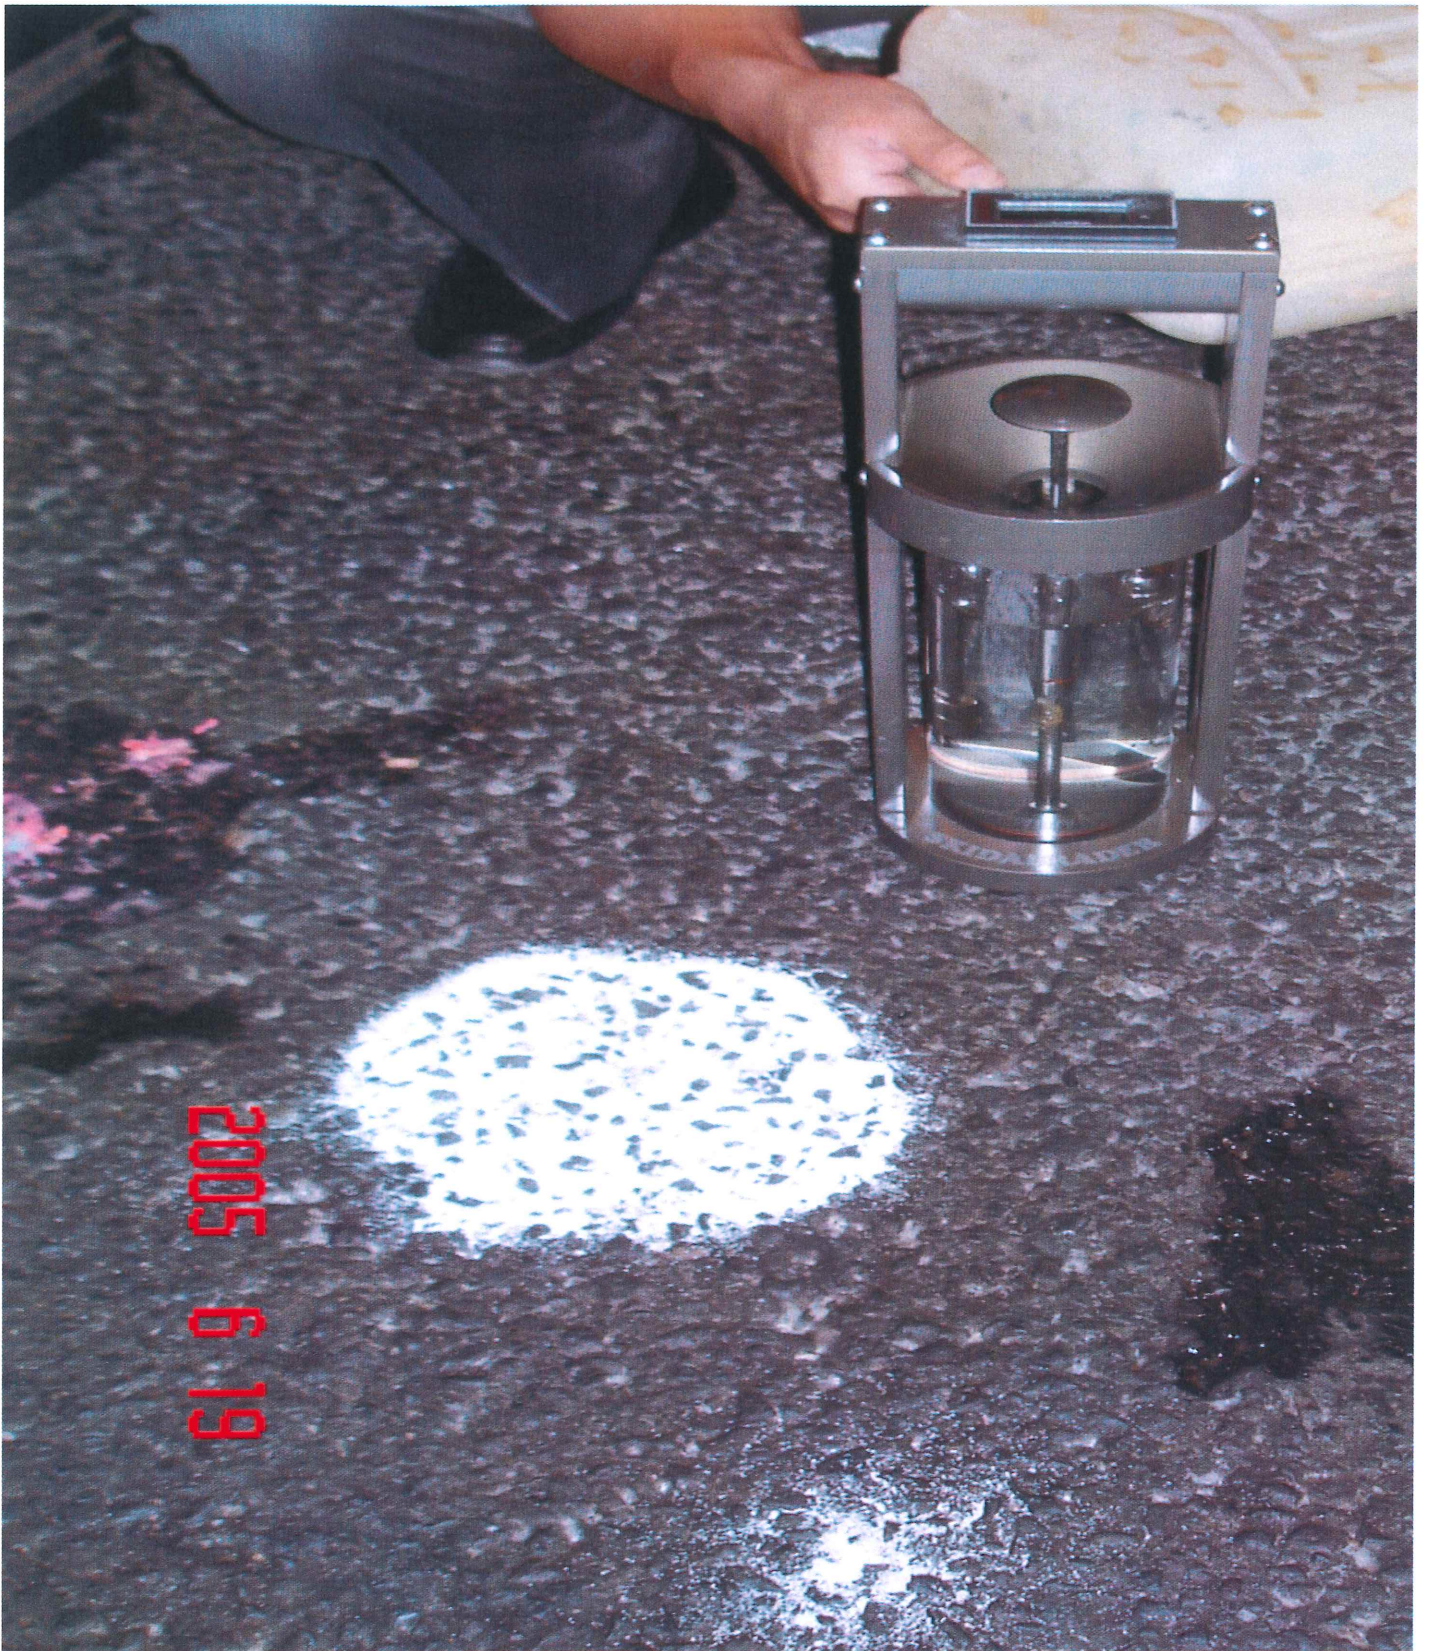
Figure 4.7 Sand Patch Test

The sand patch test (ASTM Standard E965-96 OR China Standard T 0961-95) was used to ascertain the Pavement Macrotexture (Depth of Structure). Comparison at several locations on the untreated section in close proximity to the Water Penetration Meter tests. Results are presented in the table that follows:

See Figure 4.7 which follows, showing the sand patch testing procedure.

Sand Patch Tests – Depth of Texture			
Location	Untreated Pavement (mm)	RJSeal Treated (mm)	Loc'n relative to Expansion Joint
Km 39+695 Lane 3 Northbound	0.67		4.2 m south
Km 39+695 Lane 2 Northbound	0.82		4.0 m south
Km 41+410 Lane 3 Southbound	0.76		1.0 m north
Km 41+410 Lane 2 Southbound	0.63		1.0 m north
