RJSeal<sup>™</sup> Application Old Airport Road, Harbin, HeilongJiang, Peoples Republic of China

September 2005

#### 1.0 INTRODUCTION

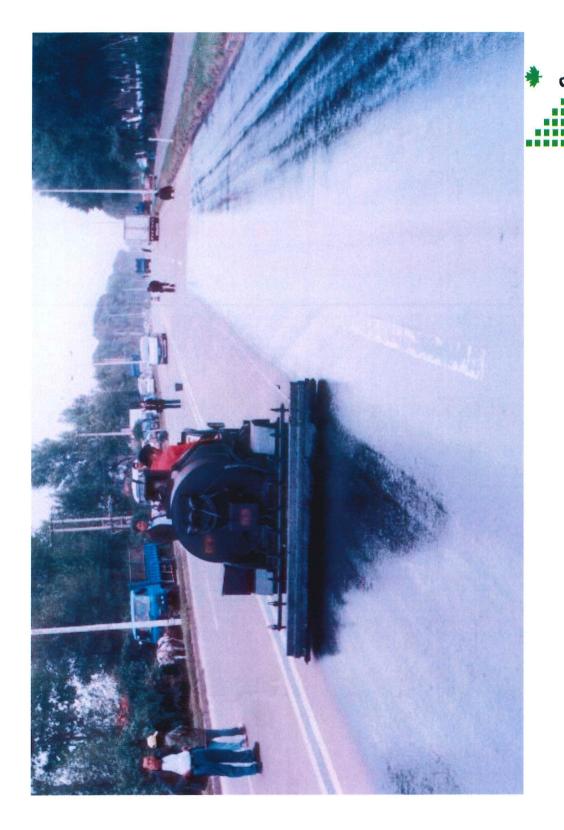
Figure 4.1 Test Strip on Old Airport Road Highway G102.

On September 22 thru 26, 2005, all four lanes of the Old Airport Road were treated with RJSeal<sup>TM</sup>, commencing just west of the junction with the new Airport Expressway and continuing west for 4.1 Kilometres. The location selected for an application of RJSeal<sup>TM</sup> was at the following geographic location:

There is a slight camber to the road, which causes water to run off toward the shoulder, rather than puddle on the road. No significant oil spills were observed, just the occasional drop of transmission oil, crankcase oil or hydraulic fluid. The asphalt pavement surface was not appreciably worn with no rutting due to traffic wear. There was aging and oxidation of the bitumen, which extended to a depth of several millimetres. The entire portion of the treated asphalt pavement section overlies a compacted silty-clay, sub-grade

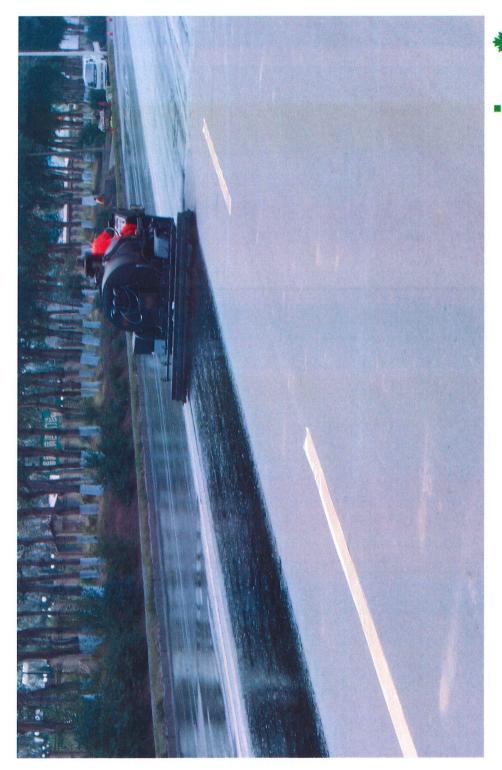
Figure 4.2 Typical Application Procedure.

An initial test application was conducted at the west end of the zone selected for the RJSeal<sup>TM</sup> Application to determine the most appropriate application rate. This then lead to adjustment of the application rate, given the drying time experienced and the smoothness of the pavement as well as the penetration of the RJSeal<sup>TM</sup> into the pavement surface. The initial test application is shown in figure 4.1 which follows. Photos showing the application of RJSeal<sup>TM</sup> follow in figures 4.2, 4.3 and 4.4. on the following pages.

RJSeal<sup>TM</sup> was applied, using a Desco D200 Sprayer. See Appendix B for technical information on this unit. This unit can uniformly apply the RJSeal<sup>TM</sup> in the application.

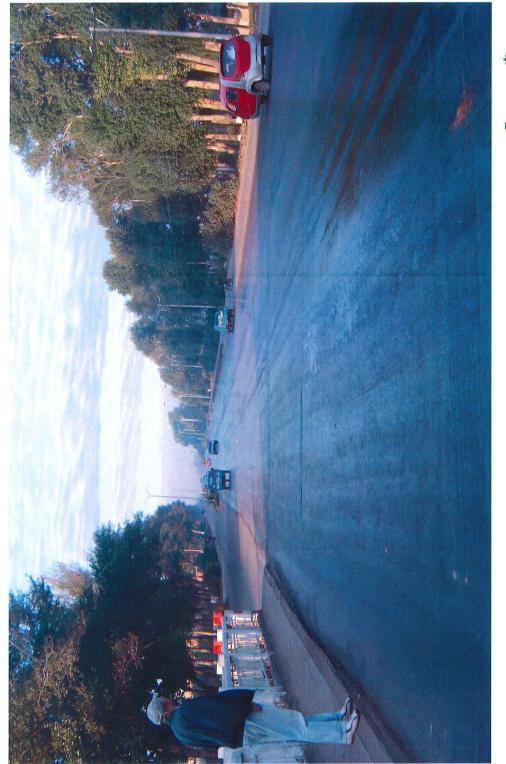
Figure 4.5 Finished Surface.

Subsequent inspection, showed that the application rate of 5.5 m<sup>2</sup>/kg was adequate for the asphalt pavement at this location

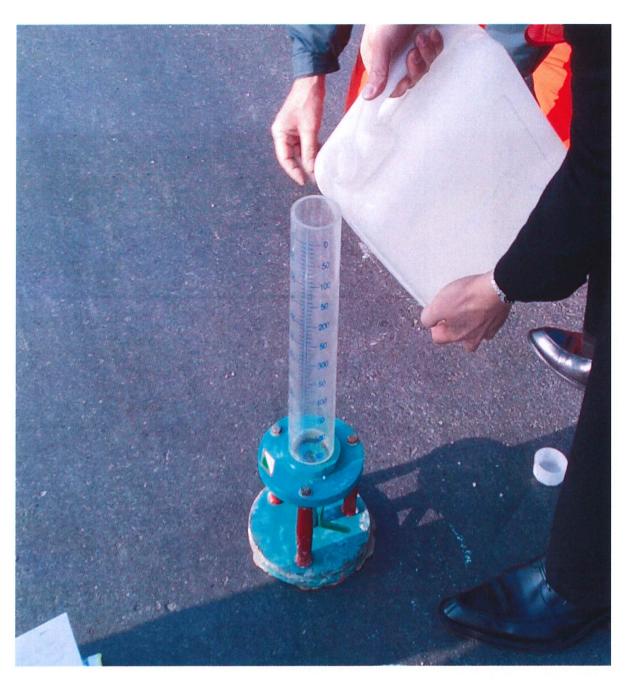
Figure 4.6 Water Penetration Test

Water Penetration Tests (China Testing Standard T 0730-2000) were undertaken at several locations on the Old Airport Road on both treated and segment treated with RJSeal $^{\rm TM}$ .

See Figure 4.6 that follows for a pictorial presentation of the Water Penetration Meter.

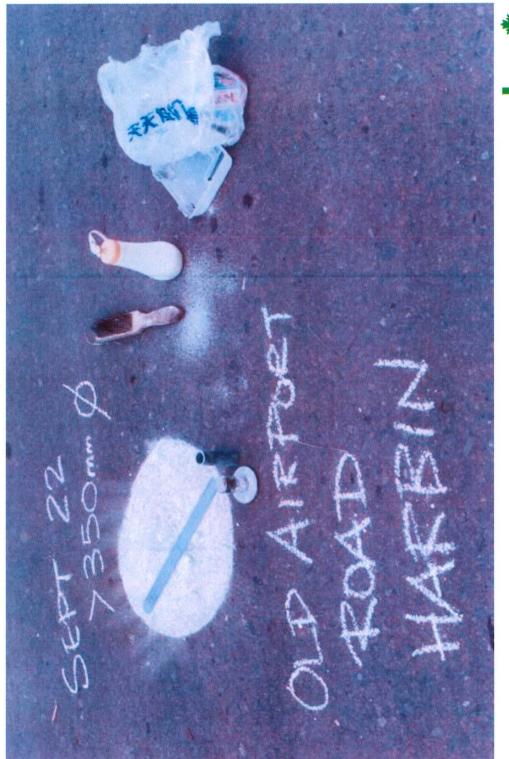
Figure 4.7 Sand Patch Test

The sand patch test (ASTM Standard E965-96 OR China Standard T 0961-95) will be used to ascertain the Pavement Macrotexture (Depth of Structure). Comparison will be undertaken at several locations on the untreated section in close proximity to the Water Penetration Meter tests.

See Figure 4.7 which follows, showing the sand patch testing procedure.
