**CROWN CAPITAL ENTERPRISE  
LIMITED**

**Demonstration of RJSeal™  
G212 Highway, Lanzhou, Gansu,  
Peoples Republic of China**

**November 2005**

**TS² Consulting Inc.  
Lamma, Hong Kong**

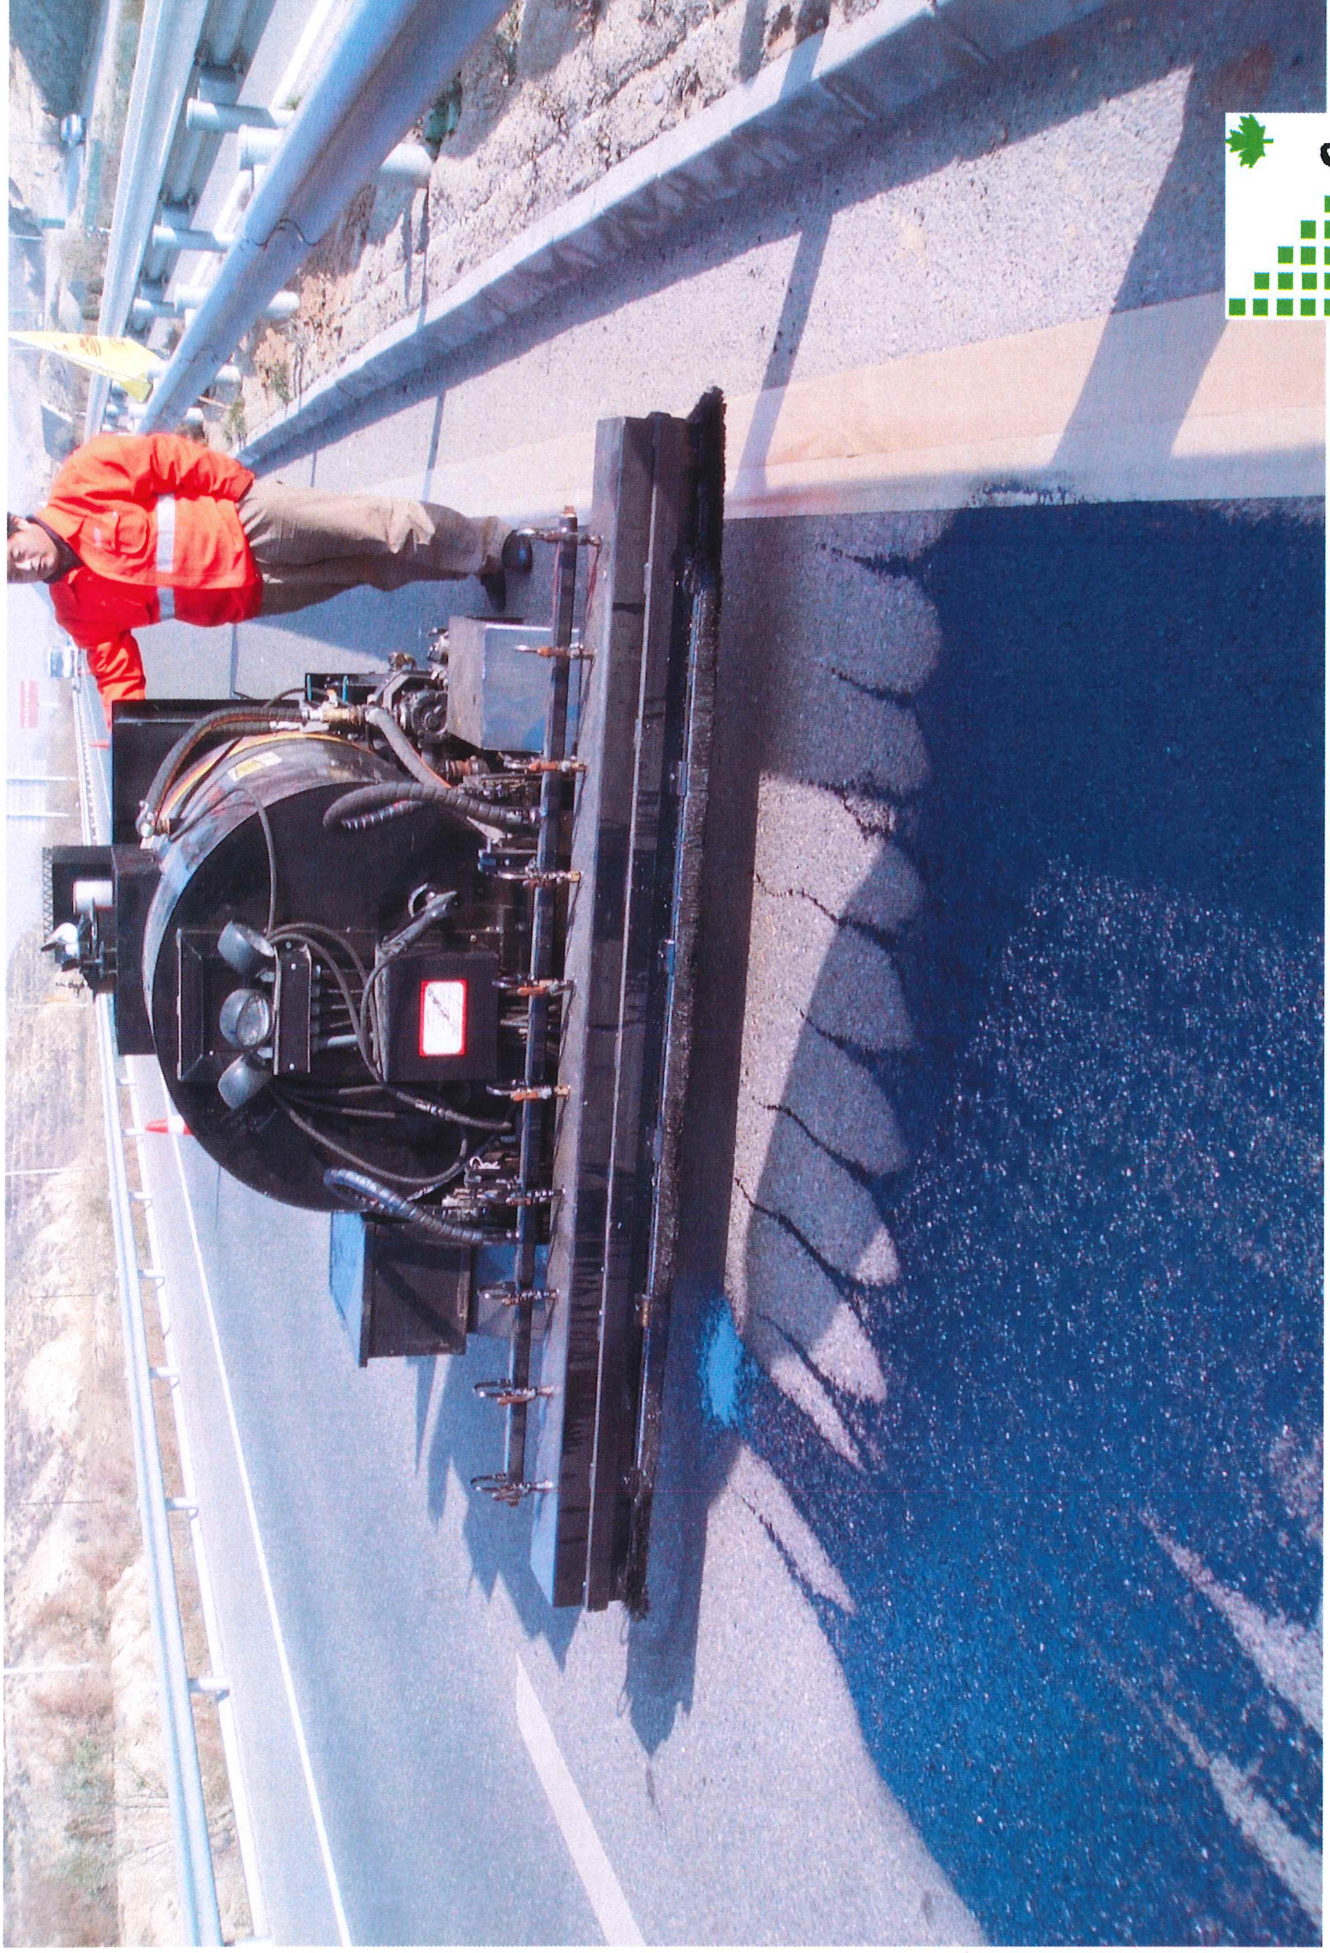
Figure 4.1 Test Strip at Application Site

On November 4, a test strip in the southbound, lane of the G212 Highway (two lane highway), was treated with RJSeal™. The test strip with respect to the demonstration portion of the highway is graphically shown in figure 4.1, which follows.

Subsequent inspection of the initial test strip, showed that the trial application rate of 5.0 m<sup>2</sup>/kilogram was adequate. The portion of G212 Highway that had RJSeal applied was at the following geographic location:

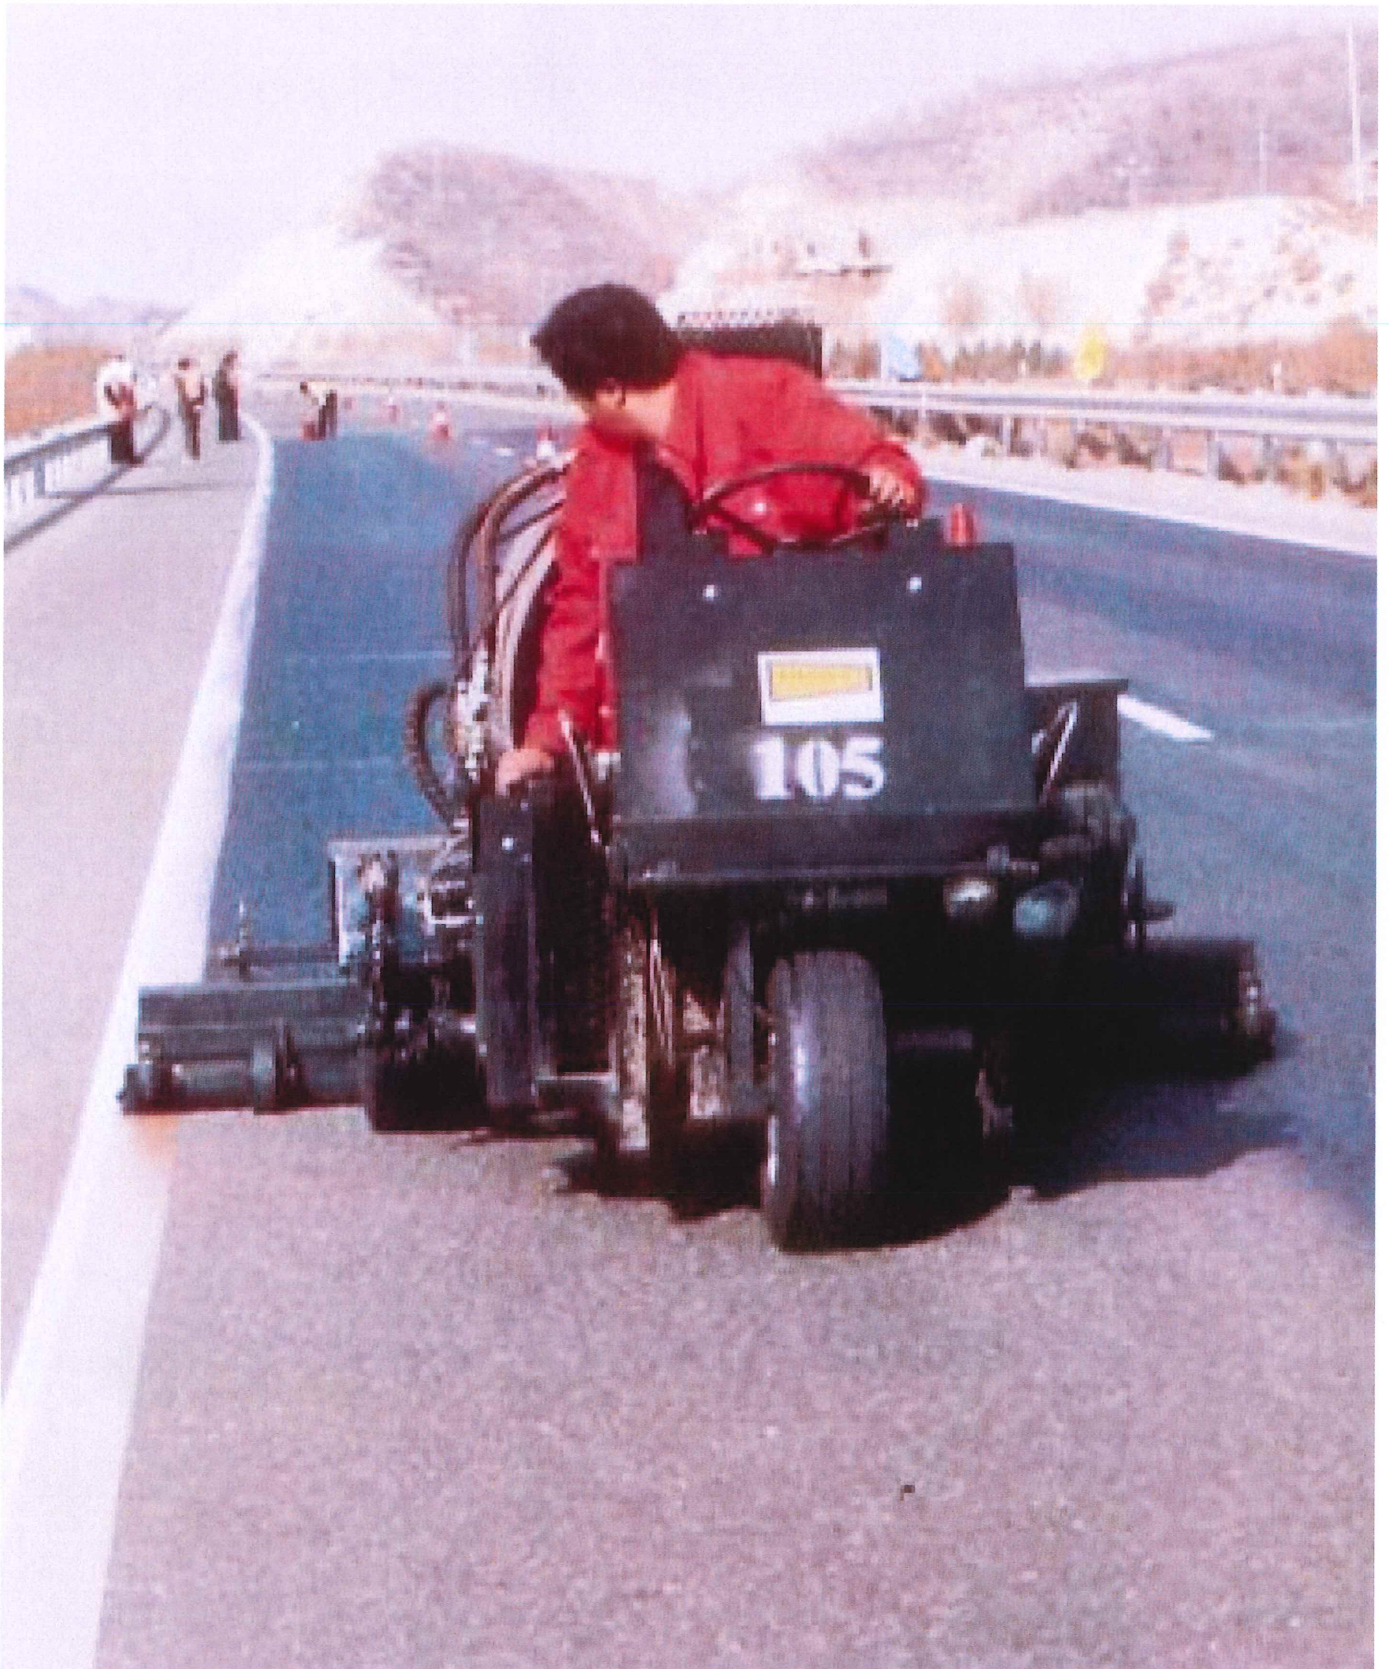
Figure 4.2 Typical Application Procedure

Ambient temperatures were 2 degrees Celsius at the commencement of work at 9 am and rose to 12 degree Celsius by mid-afternoon, with humidity in the 50% range. The application of RJSeal™ was undertaken on the southbound lane. Following the application of RJSeal™ the entire work area was treated with copper slag at an application rate of 0.22 kgs/square metre, immediately after the application of RJSeal™. Photos showing the application of RJSeal™ follow in figures 4.2 and 4.3 on the following pages.

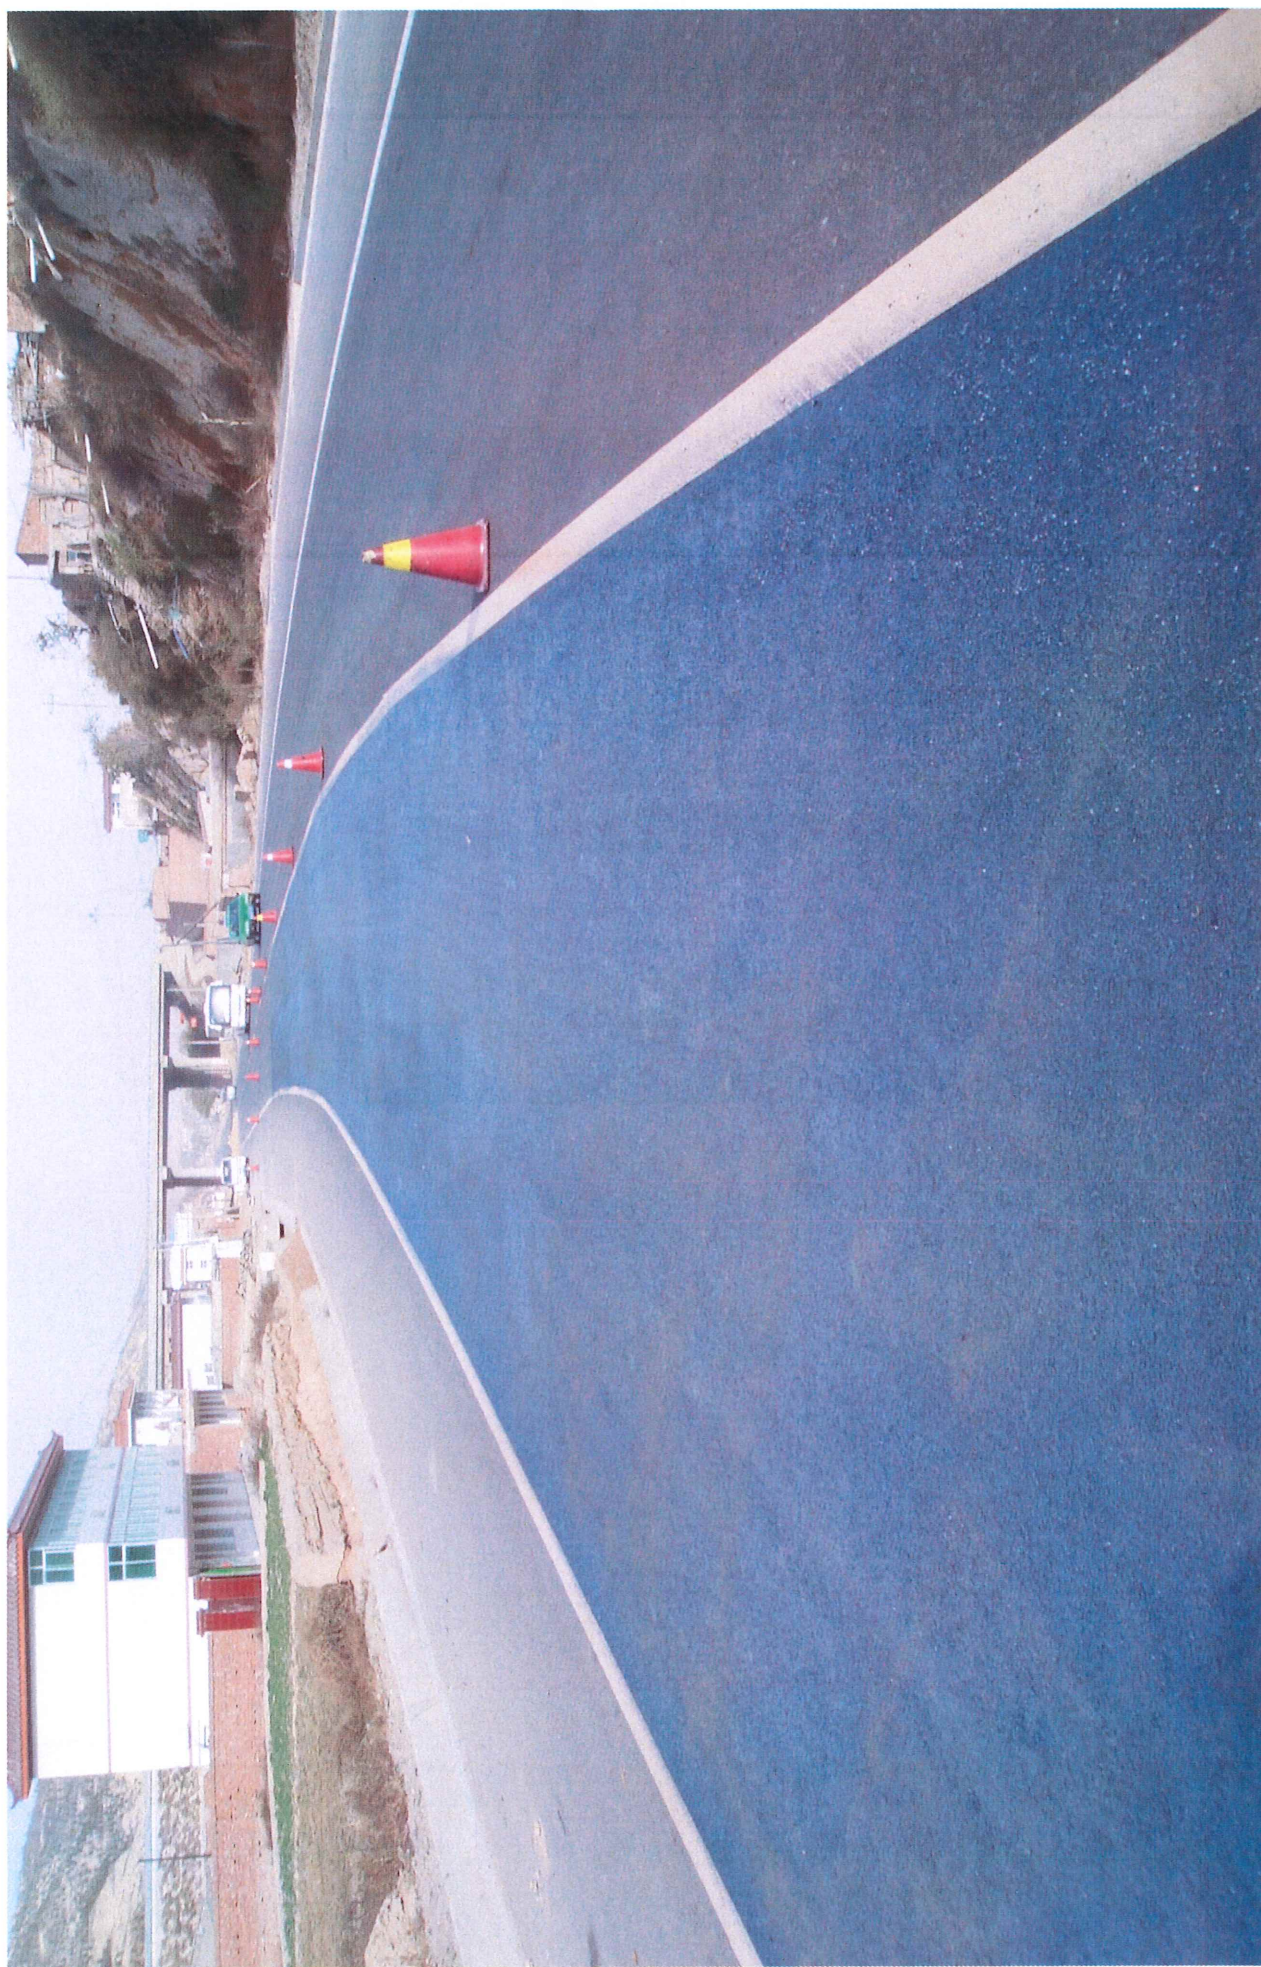
Figure 4.4 Finished Surface

The site was visited on September 6 around 8:00 am and a difference was readily perceived on the southbound lane, between the RJSeal™ treated section and the adjoining northbound untreated lane. A screwdriver was used to dig two small holes in the asphalt pavement, to a depth of 3 centimetres, some 5 metres south of the extreme north end of the demonstration section, to determine the penetration of the RJSeal™. This was one day after the application of RJSeal™ and at these two locations the newly rejuvenated surface was evident, by the black resilient surface layer, which was now approximately 1 millimetre thick. Below that depth, the grey, oxidized layer of asphalt was evident.

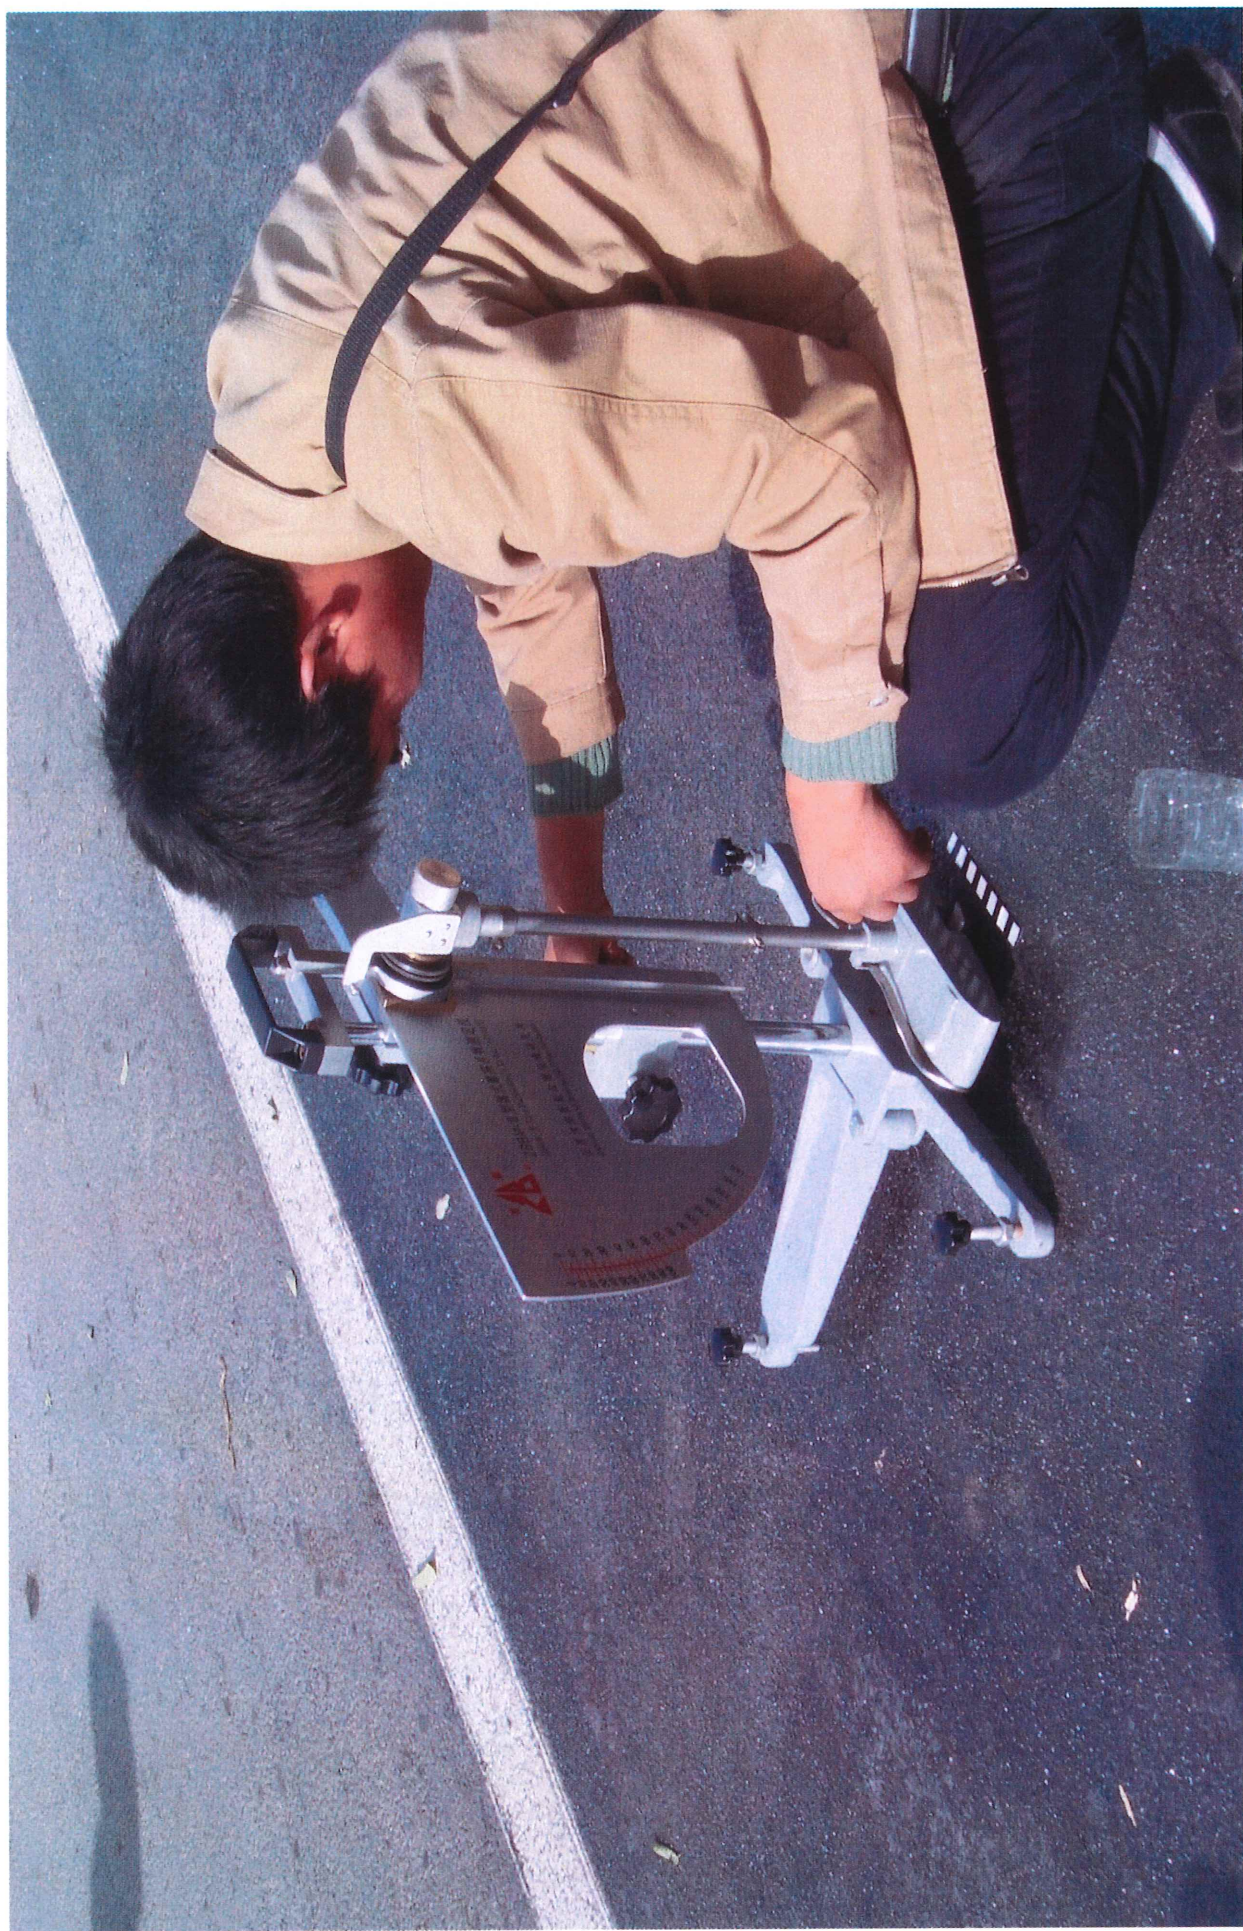
Figure 4.5 British Pendulum

A British Pendulum ASTM Standard E303-93 OR China Standard T 0964-95) was employed to determine the skid resistance of the road surface prior to the application of RJSeal™ and also after the application.

See Figure 4.5 that follows for a pictorial presentation of the British Pendulum during testing.

A BPN of 40 or higher is indicative of an acceptable road surface from a skid resistance point of view. Whereas a BPN of 30 or less infers that the road surface is unacceptable. The test results from the British Pendulum, are not directly correlate-able with the sand patch test.

Table 4.3 British Pendulum Testing	Particulars of Testing Location			BP # (Fb20)	
	Distance from start of job	Lane	Wheel Path	Before	After
				BP #	BP#
Testing Location					
Km Marker 12+120	120 metres	Overtaking	Left wheel path	41	55
Km Marker 12+120	120 metres	Overtaking	Right wheel path	42	45

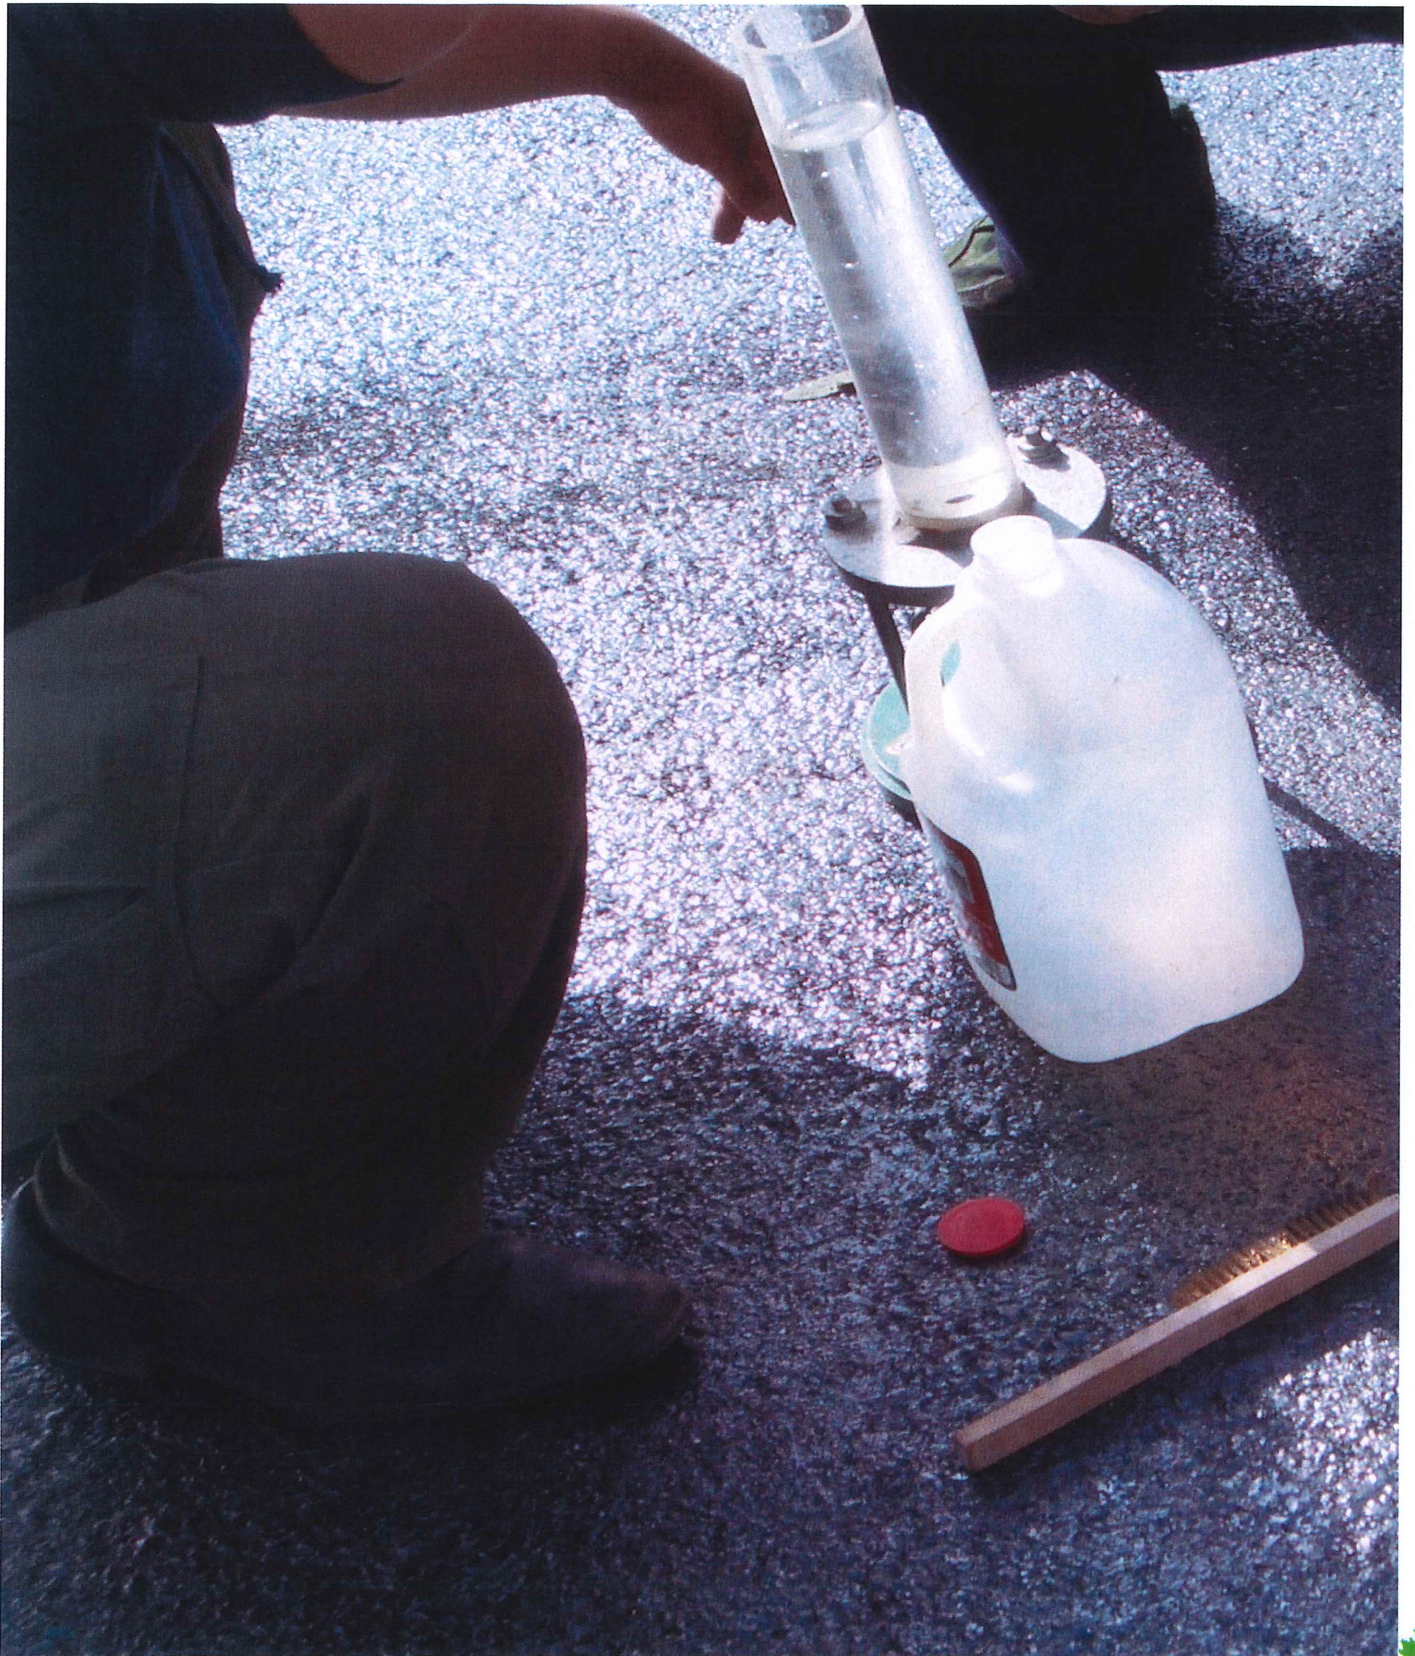
Figure 4.6 Water Penetration Test

Water Penetration Tests (China Testing Standard T 0730-2000) were undertaken at several locations on the untreated portion of the road, in close proximity to the test strip and later on the RJSeal™ treated section, in close proximity to the British Pendulum tests.

See Figure 4.6 that follows for a pictorial presentation of the Water Penetration Meter.

Table 4.4 Water Penetration Testing	Particulars of Testing Location			Water penetration	
	Distance from start of job	Lane	Wheel Path	Before	After
				ml/min	ml/min
Testing Location					
Km Marker 12+120	120 metres	Overtaking	Left wheel path	0	0
Km Marker 12+120	120 metres	Overtaking	right wheel path	0	0
