**Demonstration of RJSeal™
ZhongChuan Airport Expressway, Lanzhou,
Gansu,
Peoples Republic of China**

November 2005

**TS² Consulting Inc.
Lamma, Hong Kong**

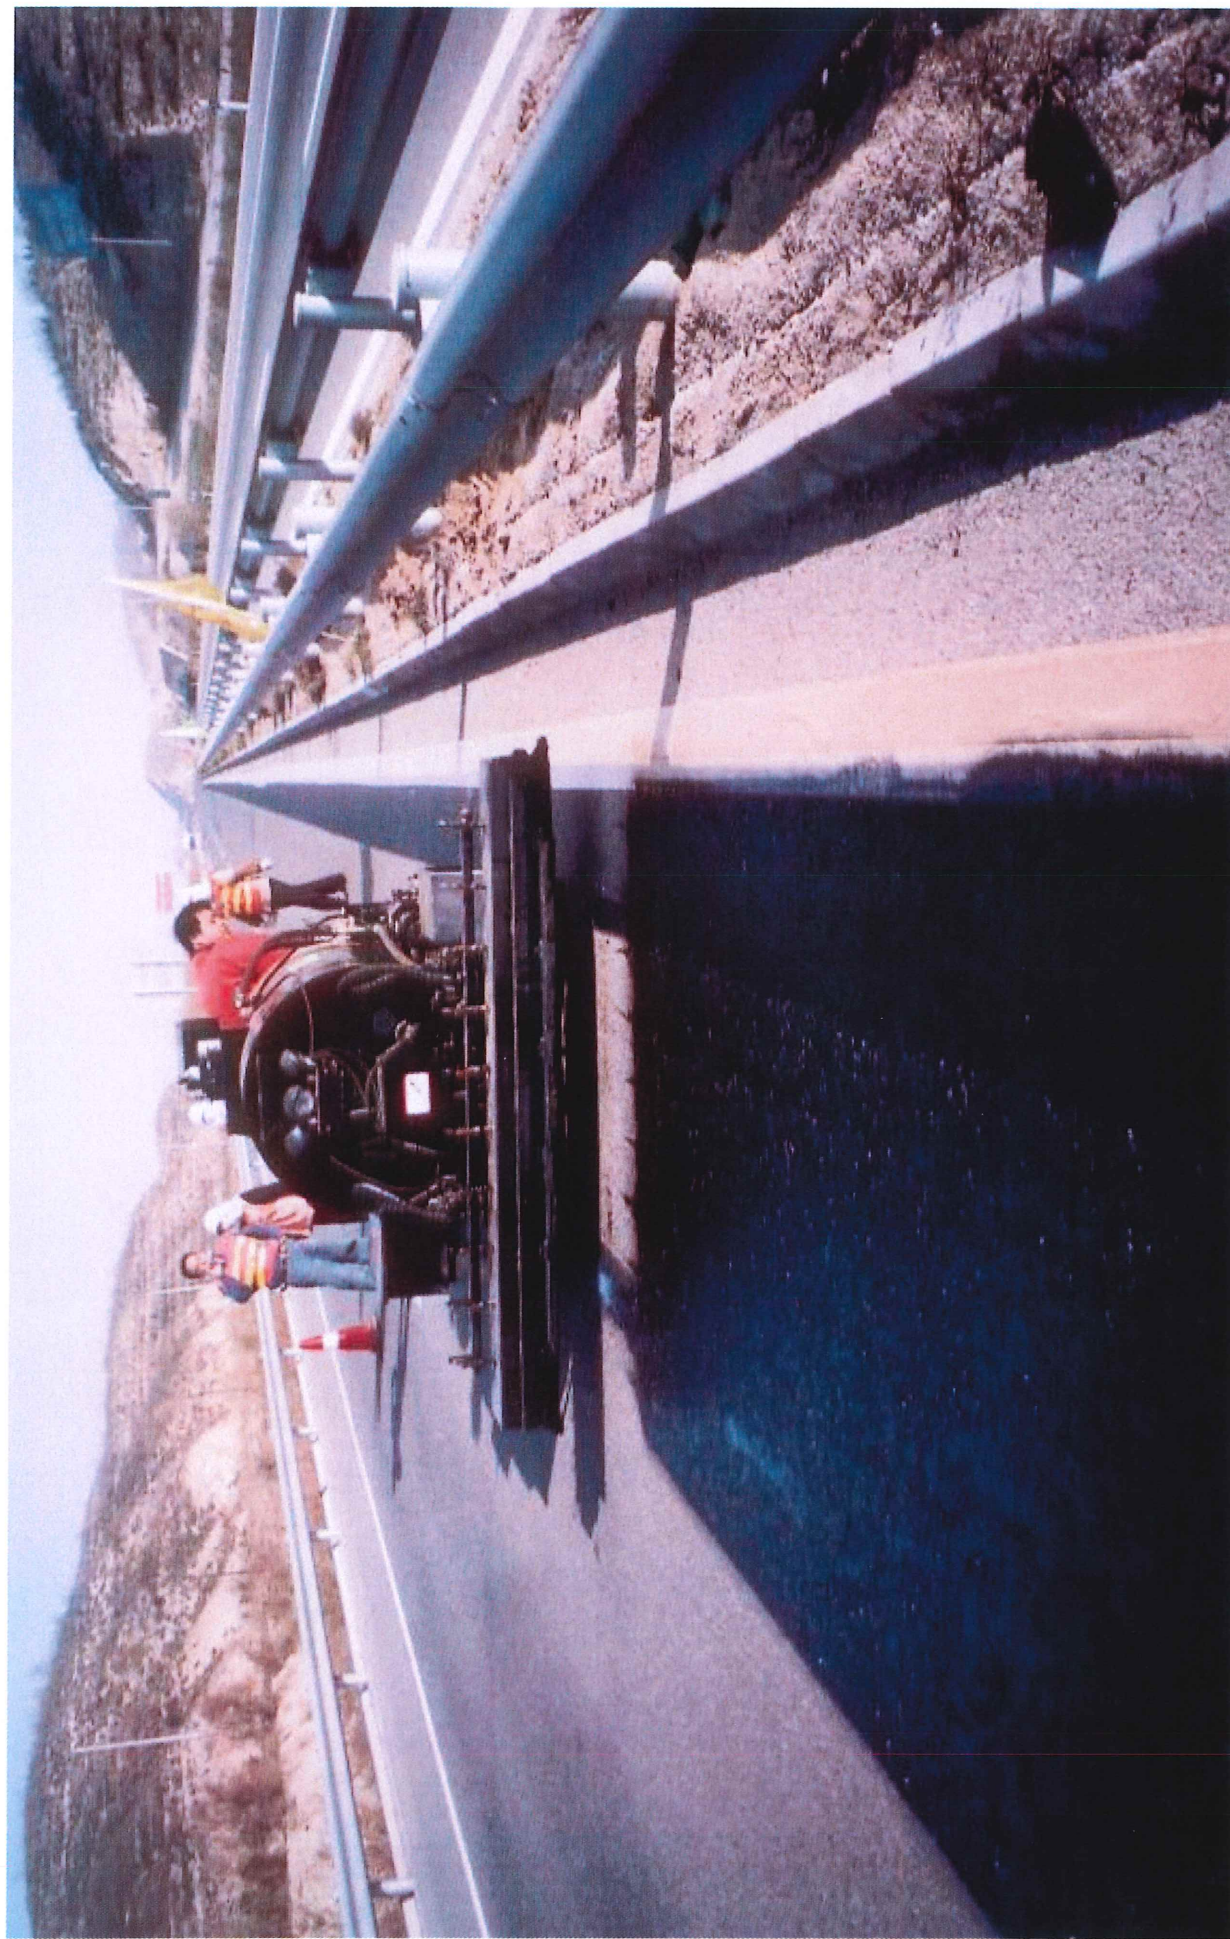
Figure 4.1 Test Strip at Application Site

On November 4, a test strip in the southbound, slow lane of the ZhongChuan Airport Expressway (four lane highway, with a median), was treated with RJSeal™. The test strip with respect to the demonstration portion of the street is graphically shown in figure 4.1, which follows.

Subsequent inspection of the test strip, showed that the trial application rate of 4.0 m²/kilogram was adequate. The portion of ZhongChuan Airport Expressway that had RJSeal applied was at the following geographic location:

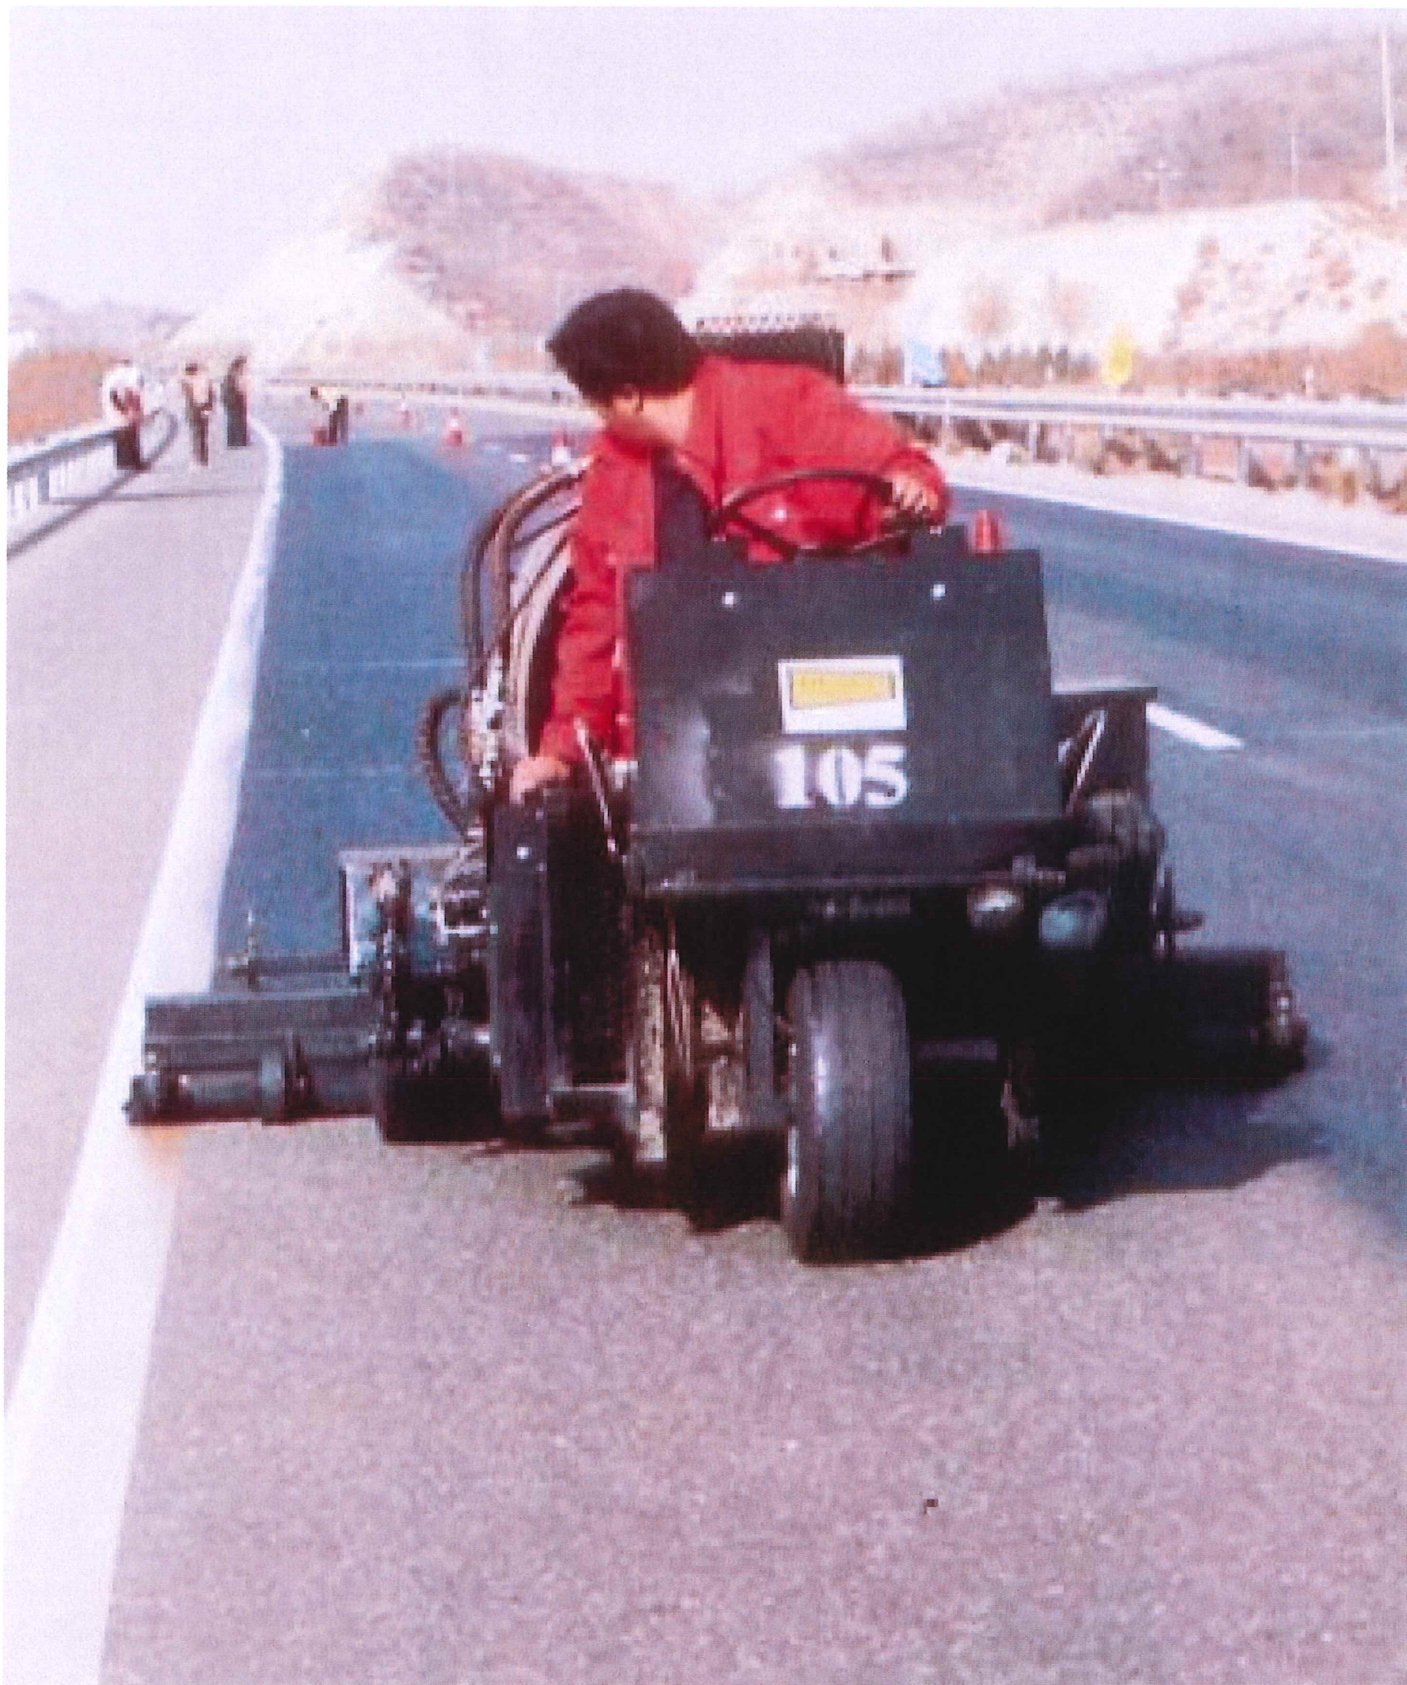
Figure 4.2 Typical Application Procedure

Ambient temperatures were 2 degrees Celsius at the commencement of work at 9 am and rose to 12 degree Celsius by mid-afternoon, with humidity in the 30% range. The application of RJSeal™ commenced on the southbound driving (slow) lane at 9 am thru until 11 am. When the RJSeal™ had dried, then RJSeal™ was applied on the overtaking (inside) lane and work ceased at 3:30 pm. The entire work area was treated with copper slag at an application rate of 0.17 kgs/square metre, immediately after the application of RJSeal™. Photos showing the application of RJSeal™ follow in figures 4.2 and 4.3 on the following pages.

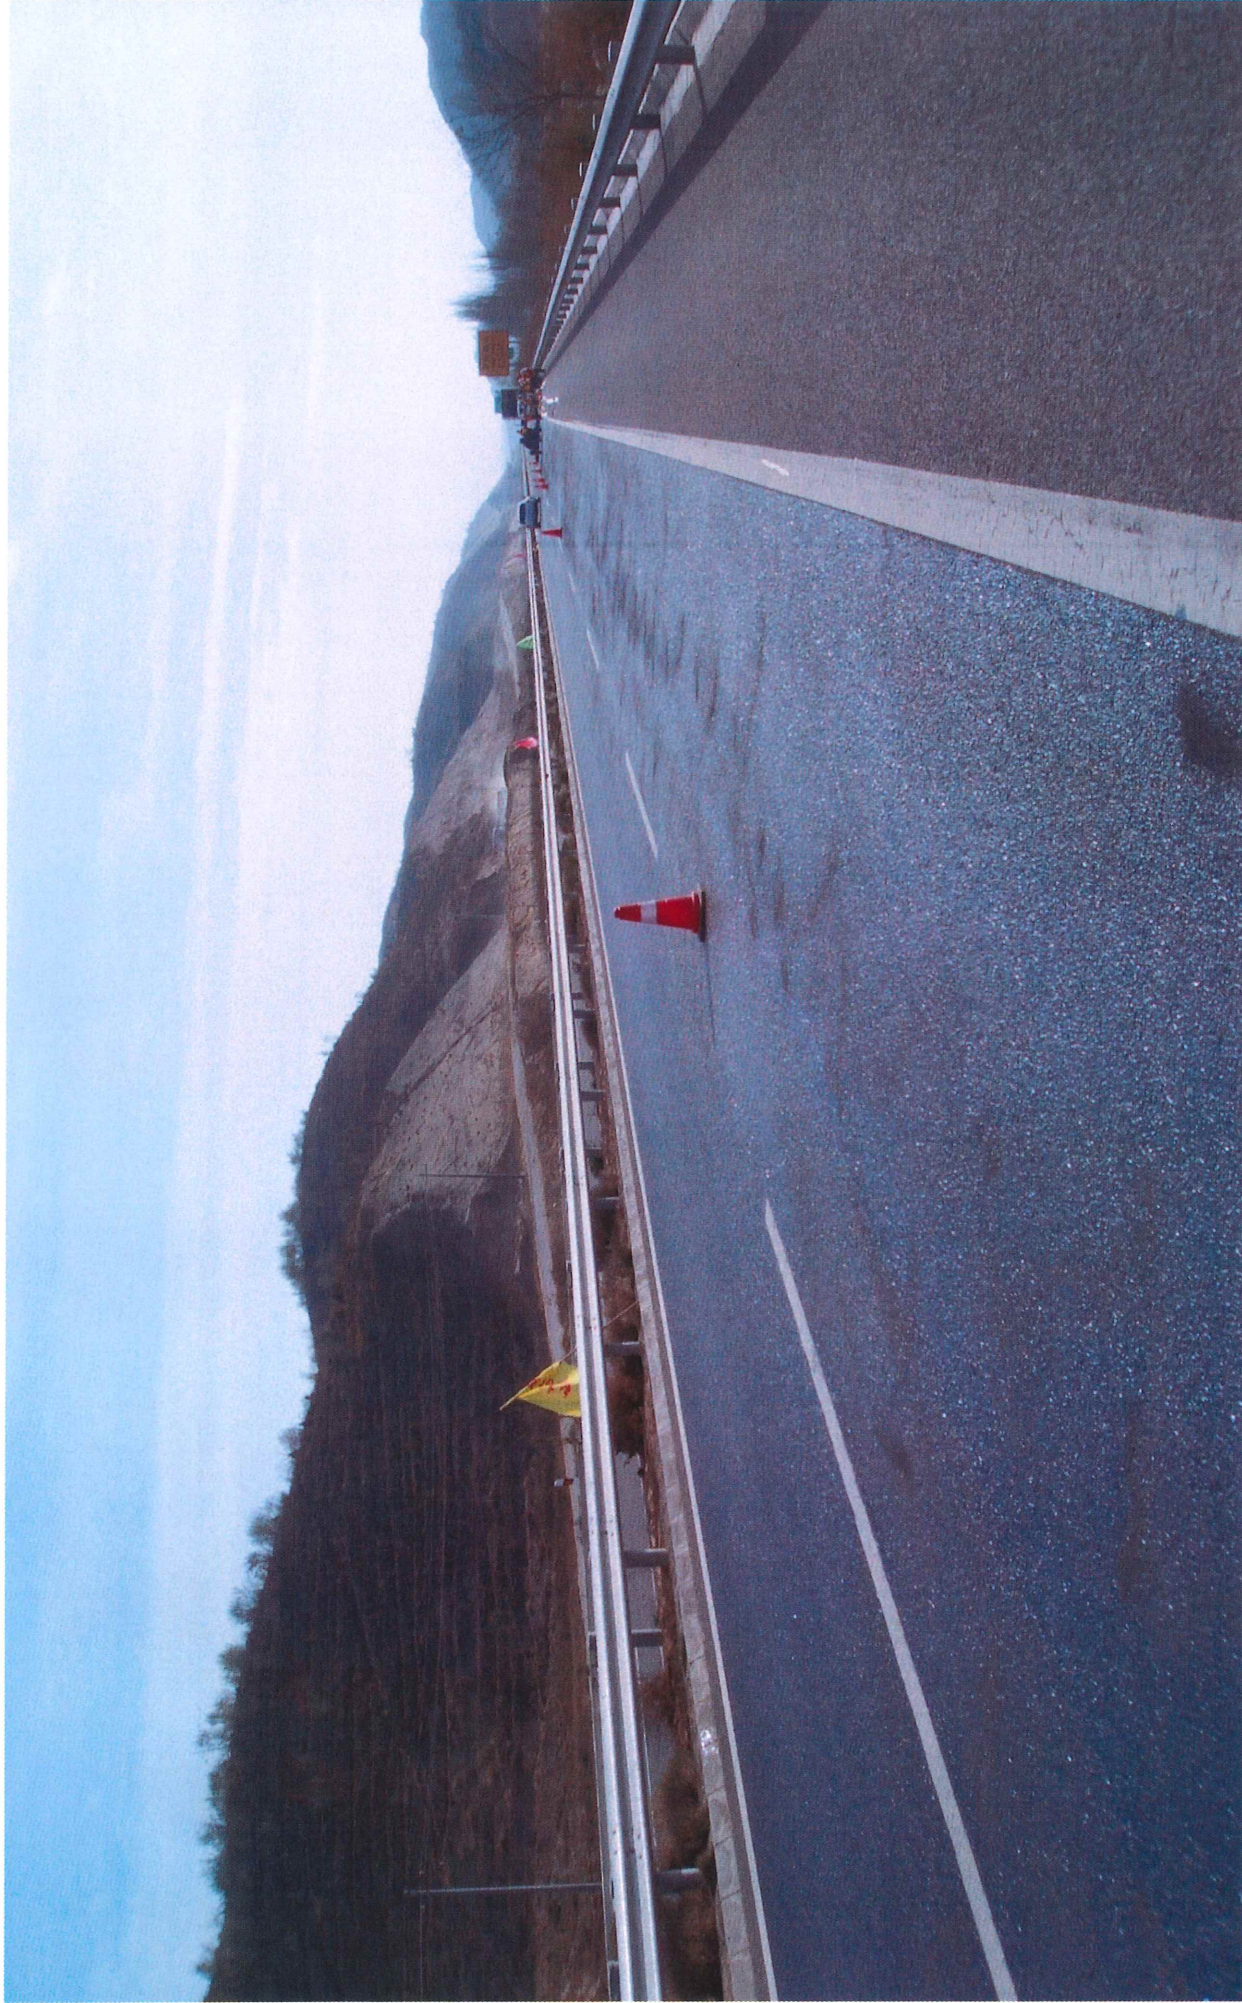
Figure 4.4 Finished Surface

The site was visited on September 5 around 7:15 am and a difference was readily perceived on the two southbound lanes, between the RJSeal™ treated section and the adjoining untreated lanes. A screwdriver was used to dig two small holes in the asphalt pavement, to a depth of 3 centimetres, some 5 metres north of the extreme south end of the demonstration section, to determine the penetration of the RJSeal™. This was one day after the application of RJSeal™ and at these two locations the newly rejuvenated surface was evident, by the black resilient surface layer, which was now approximately 1 millimetre thick. Below that depth, the grey, oxidized layer of asphalt was evident.

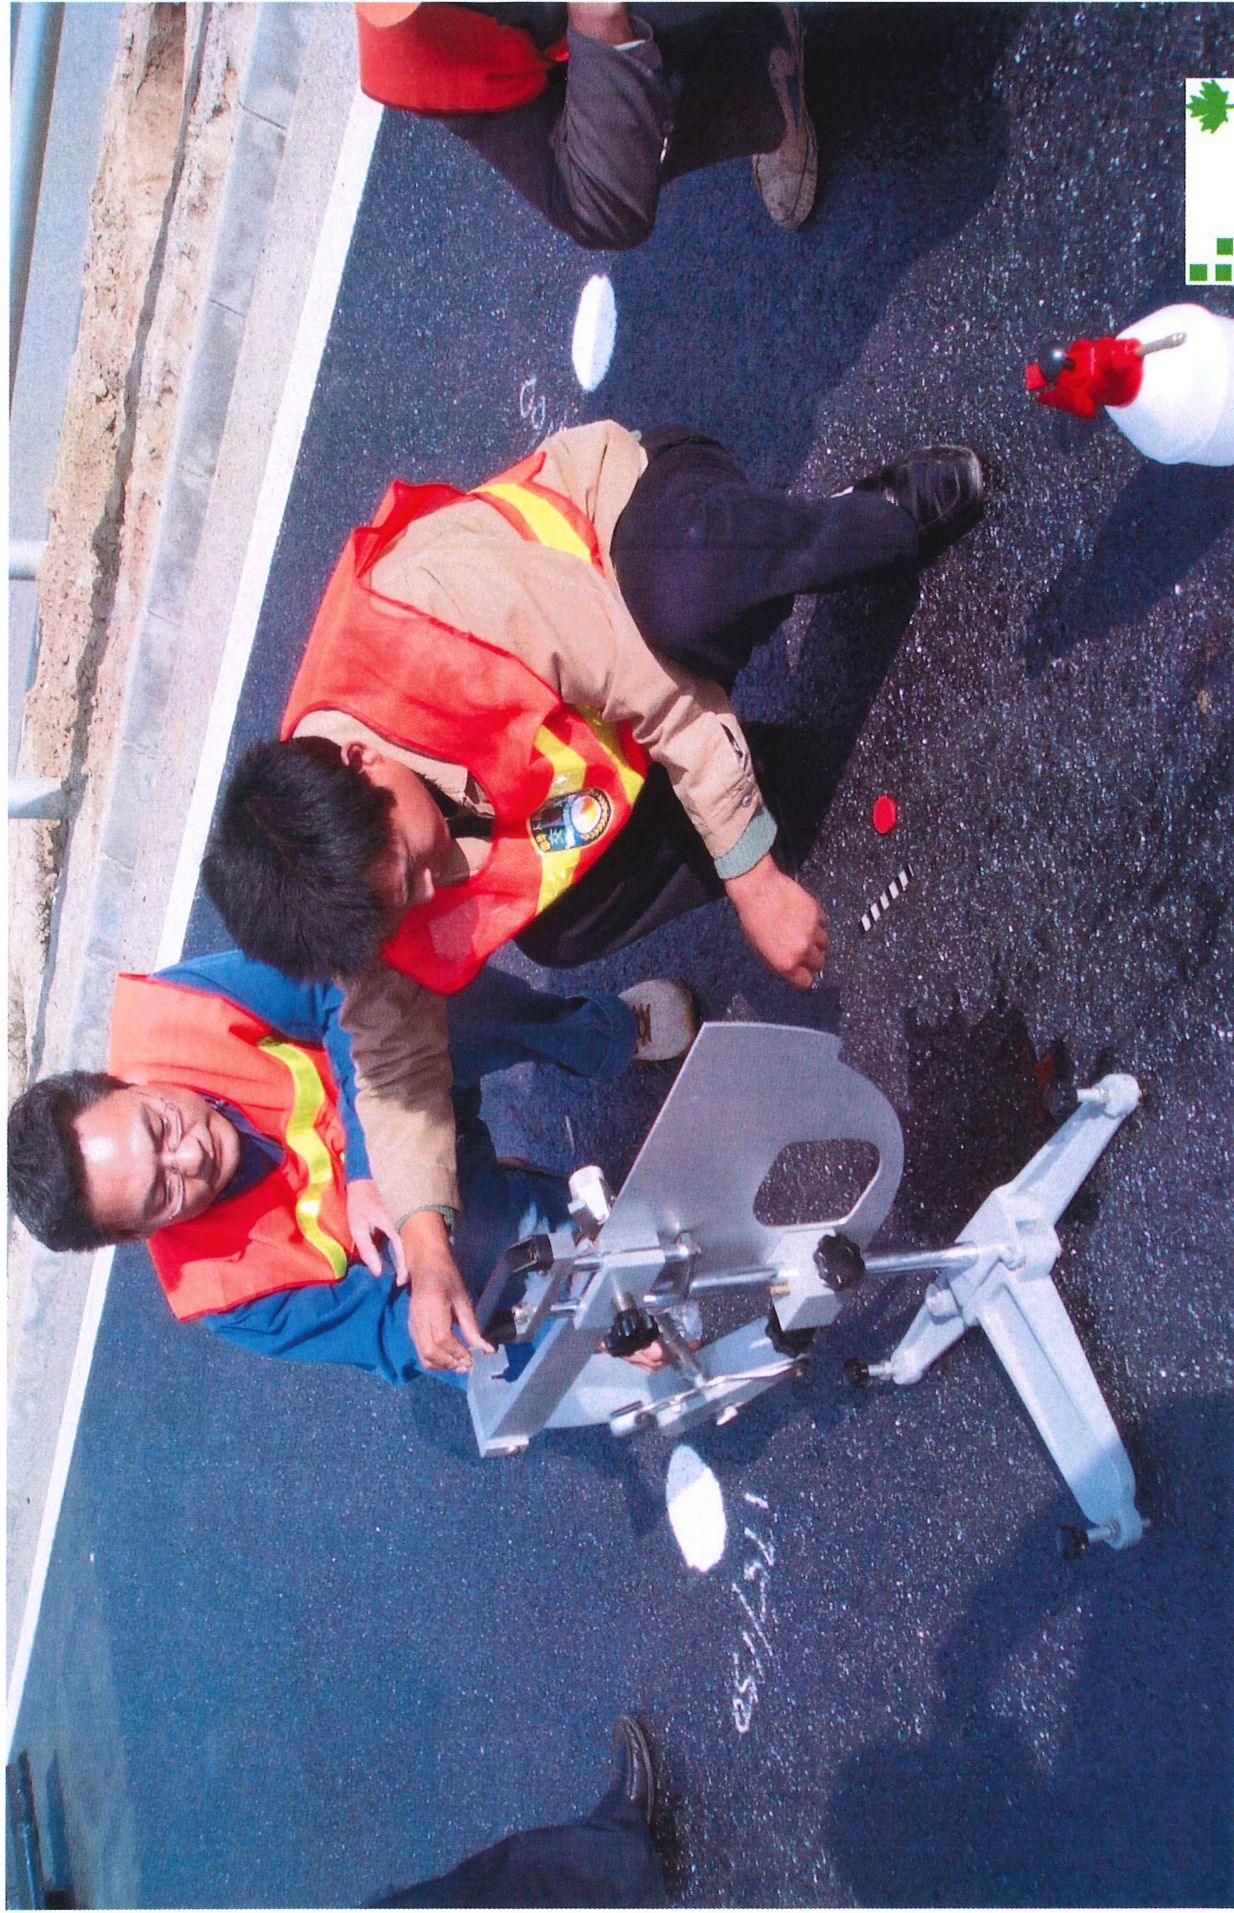
Figure 4.5 British Pendulum

A British Pendulum ASTM Standard E303-93 OR China Standard T 0964-95) was employed to determine the skid resistance of the road surface prior to the application of RJSeal and also after the application.

See Figure 4.5 that follows for a pictorial presentation of the British Pendulum during testing.

A BPN of 40 or higher is indicative of an acceptable road surface from a skid resistance point of view. Whereas a BPN of 30 or less infers that the road surface is unacceptable. The test results from the British Pendulum, are not directly correlate-able with the sand patch test.

Table 4.3 British Pendulum Testing	Particulars of Testing Location			BP # (Fb20)	
	Distance from start of job	Lane	Wheel Path	Before	After
				BP #	BP#
Testing Location					
Km Marker 15+000	0 metres	Overtaking	Left wheel path	50	52
Km Marker 15+000	0 metres	Overtaking	right wheel path	45	48

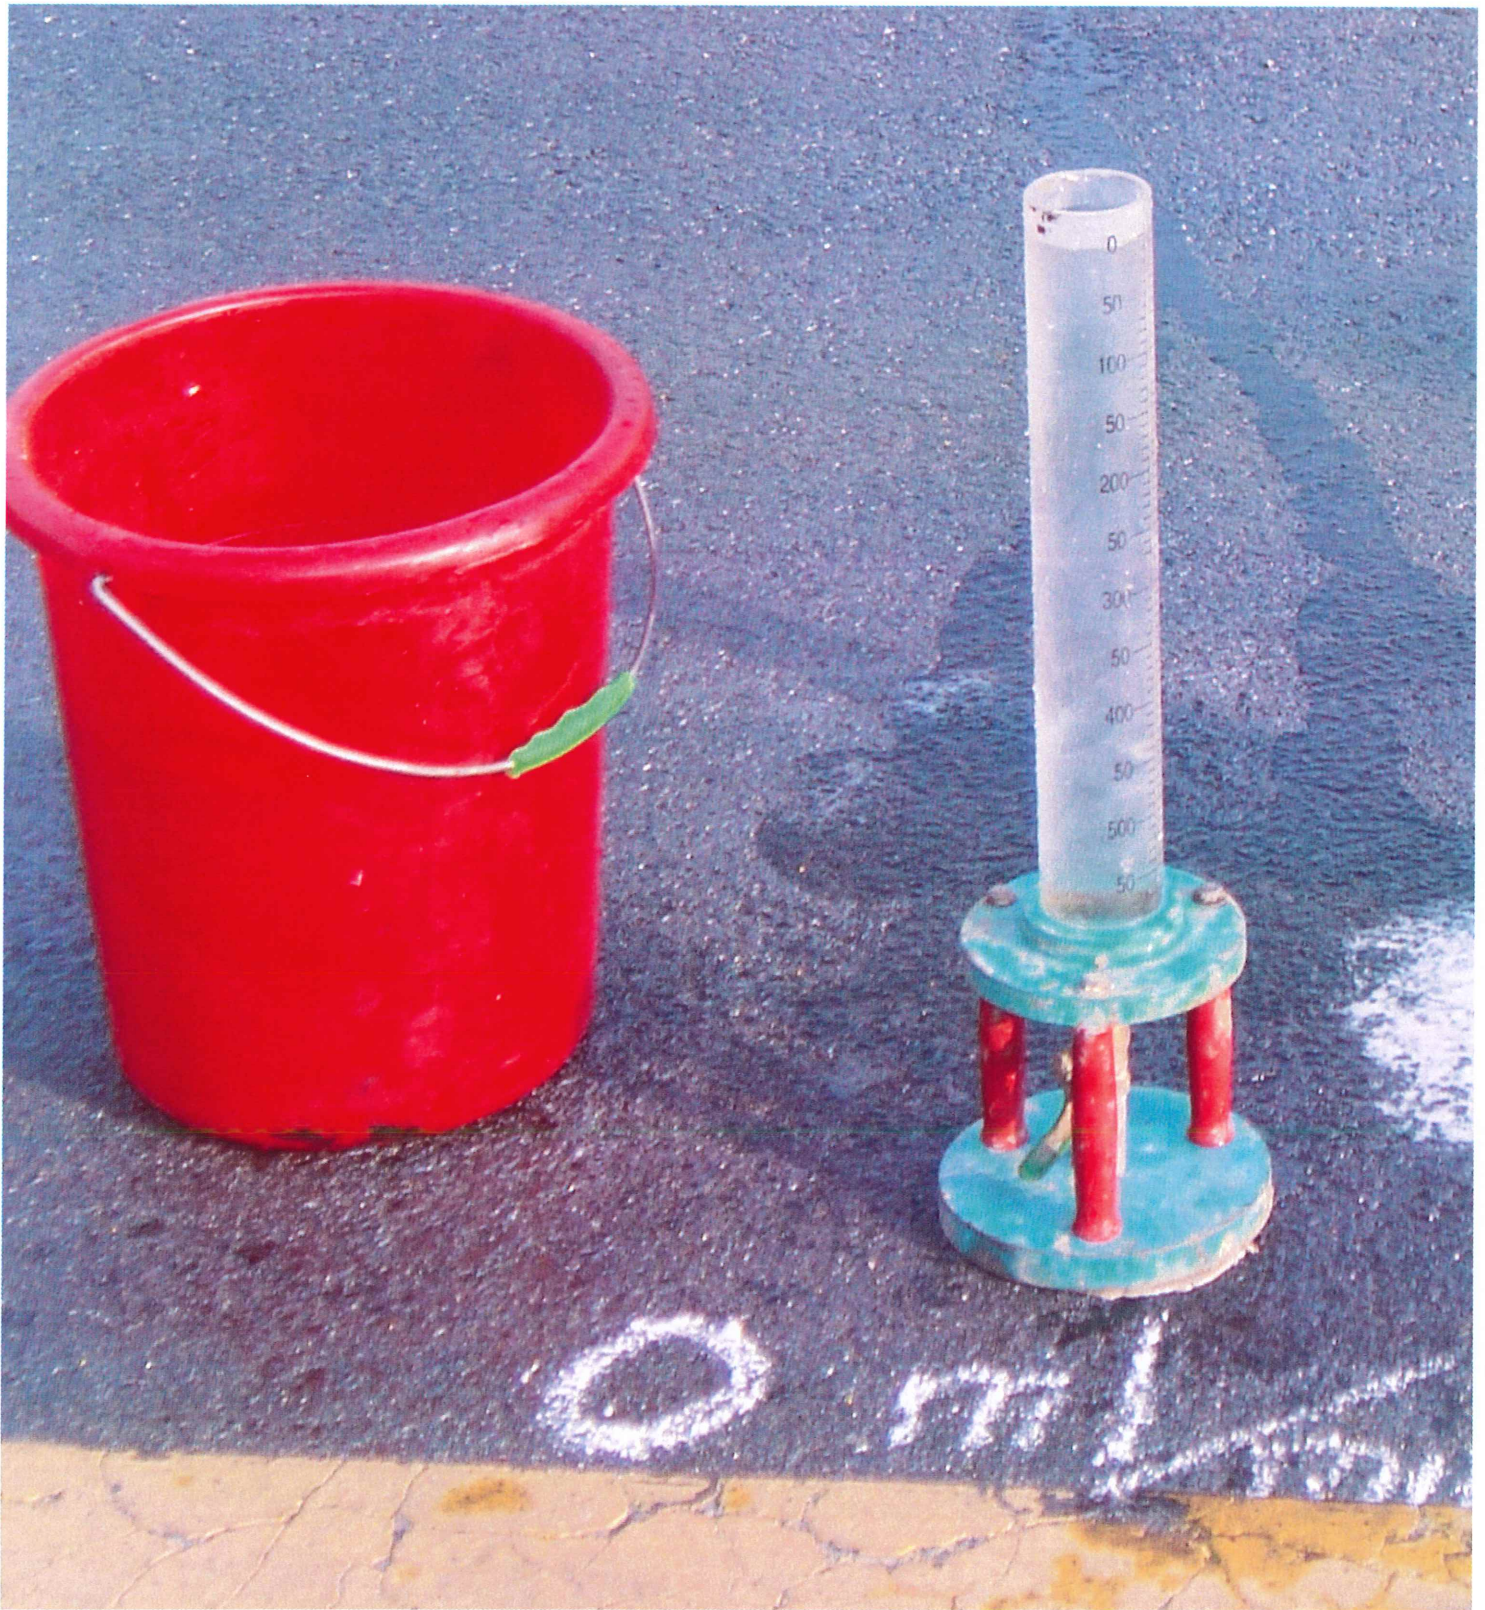
Figure 4.6 Water Penetration Test

Water Penetration Tests (China Testing Standard T 0730-2000) were undertaken at several locations on the untreated portion of the road, in close proximity to the test strip and later on the RJSealTM treated section, in close proximity to the British Pendulum tests.

See Figure 4.6 that follows for a pictorial presentation of the Water Penetration Meter.

Table 4.4 Water Penetration Testing	Particulars of Testing Location			Water penetration	
	Distance from start of job	Lane	Wheel Path	Before ml/min	After ml/min
Testing Location					
Km Marker 15+000	0 metres	Overtaking	Left wheel path	23	17
Km Marker 15+000	0 metres	Overtaking	right wheel path	17	10
