JEGEL 199232

April 27, 2001

SAND REJUVASEAL PERFORMANCE MONITORING REPORT

ENTWISTLE SAND REJUVASEAL DEMONSTRATION PROJECT

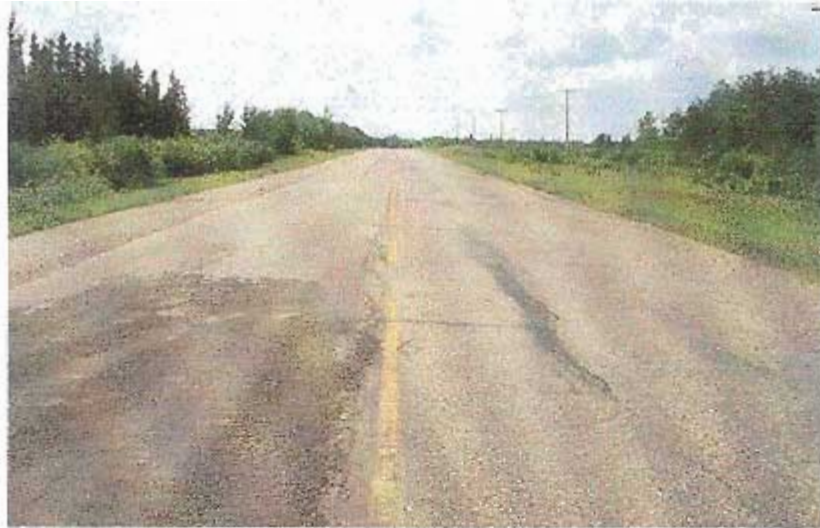
PHOTOGRAPH 1 Entwistle Sand RejuvaSeal Demonstration Project Site

General view of the 44 year old asphalt concrete pavement, with an aged deteriorating chip seal surface, prior to application of the Sand RejuvaSeal. The chip seal is losing fines and coarse aggregate. The pavement is in overall very poor condition with cracking, patching, some flushing, chip seal loss and some wheel-path rutting. This pavement would normally be repaired and resurfaced with hot-mix asphalt.

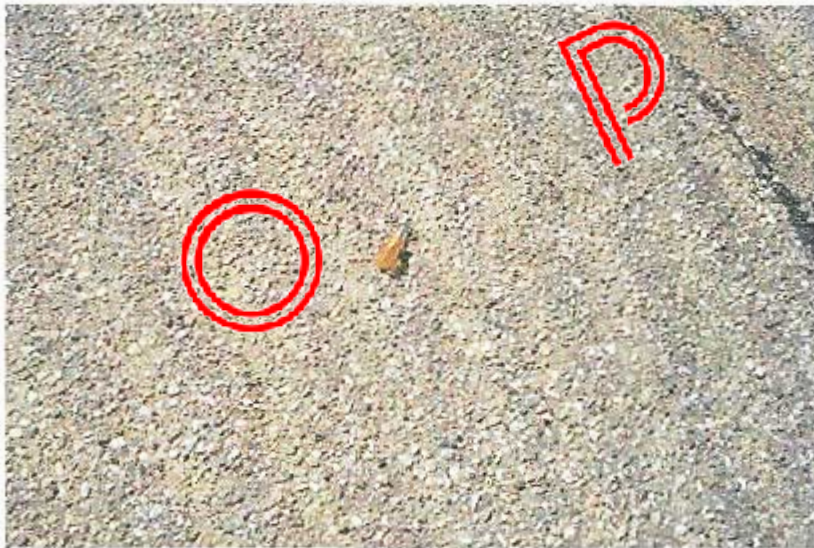
PHOTOGRAPH 2 Entwistle Sand RejuvaSeal Demonstration Project Site

Close-up view of the aged deteriorating chip seal surface (surface treatment) prior to application of the Sand RejuvaSeal. There has been significant loss of chip seal fines, resulting in the coarse aggregate being readily removed by traffic wear and maintenance activities. The main purpose of the demonstration project was to determine how well the Sand RejuvaSeal would limit the chip seal loss for this very poor condition pavement. The Sand RejuvaSeal was applied on September 29, 1999.

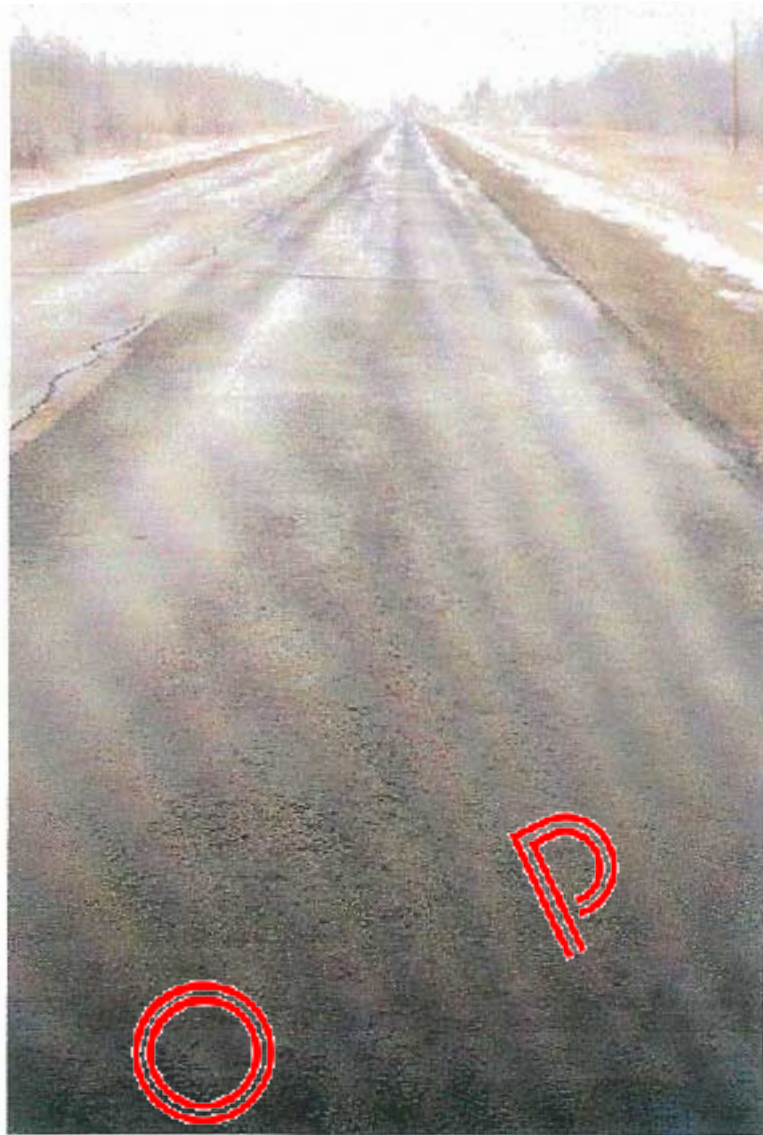
PHOTOGRAPH 3 Entwistle Sand RejuvaSeal Demonstration Project Performance
(Snowy/Wet Day) October 31, 1999 [JJE]
General view of the demonstration project one month after the Sand RejuvaSeal application. The Sand RejuvaSeal (0.27 l/m^2) was applied to the west bound lane (right side of photograph), with the east bound lane (left side of photograph) used as an untreated control. The Sand RejuvaSeal has a good appearance, particularly compared to the untreated control which is still deteriorating.

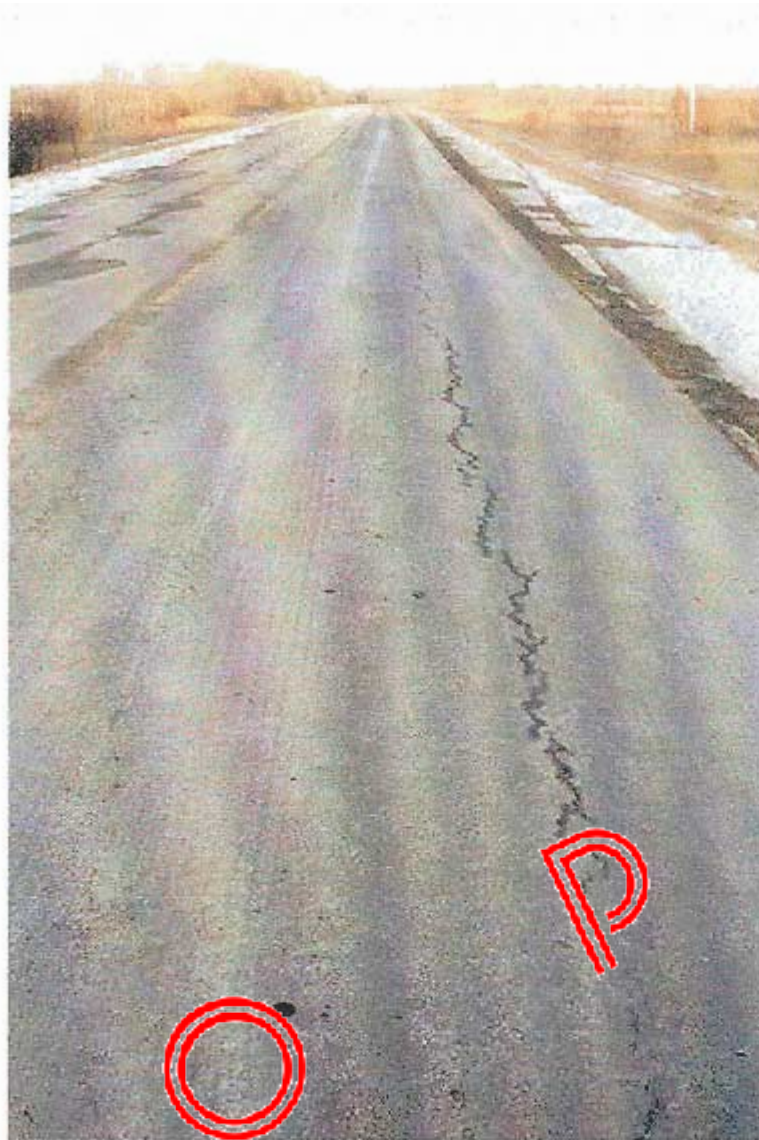
PHOTOGRAPH 4 Entwistle Sand RejuvaSeal Demonstration Project Performance
(Cold/Dry Day) December 4, 1999 [JJE]

General view of the demonstration project two months after the Sand RejuvaSeal application (close to photograph 3 location). The Sand RejuvaSeal (right side of photograph) has a good appearance after two months of cold, wet/snow condition and traffic/maintenance activities particularly compared to the untreated control which is still deteriorating (left side of photograph). The chip seal coarse aggregate has been 'locked' in-place by the Sand RejuvaSeal with some edge sealing of the existing cracks, thus limiting the deterioration of the chip seal.

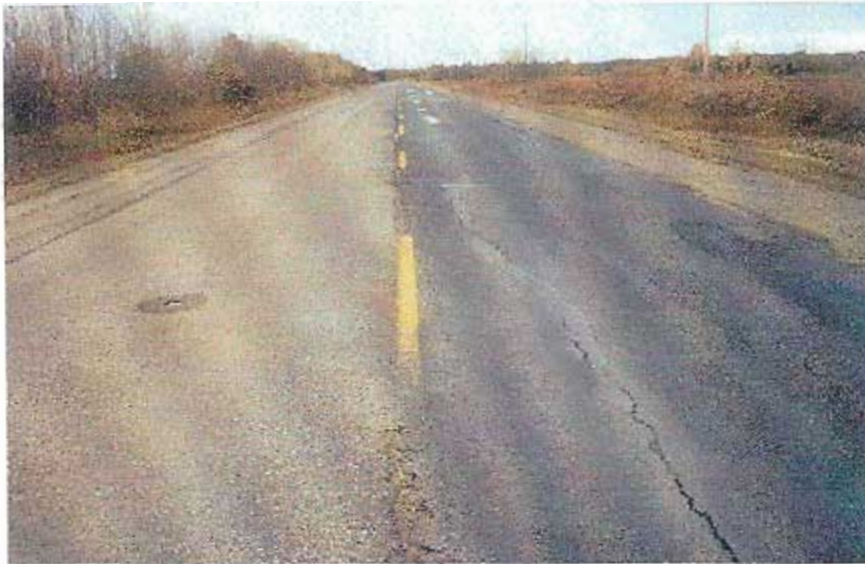
PHOTOGRAPH 5 Entwistle Sand RejuvaSeal Demonstration Project Performance
October 2, 2000 [JJE]

General view of the demonstration project one year after the Sand RejuvaSeal application (close to Photographs 3 and 4 location). The Sand RejuvaSeal (right side of photograph) still has a good overall appearance, particularly compared to the untreated control which is still deteriorating (left side of photograph). The overall rate of deterioration for the Sand RejuvaSeal treated chip seal appears to be far less than for the untreated control. It should be noted that Sand RejuvaSeal will not stop pavement structural deterioration.

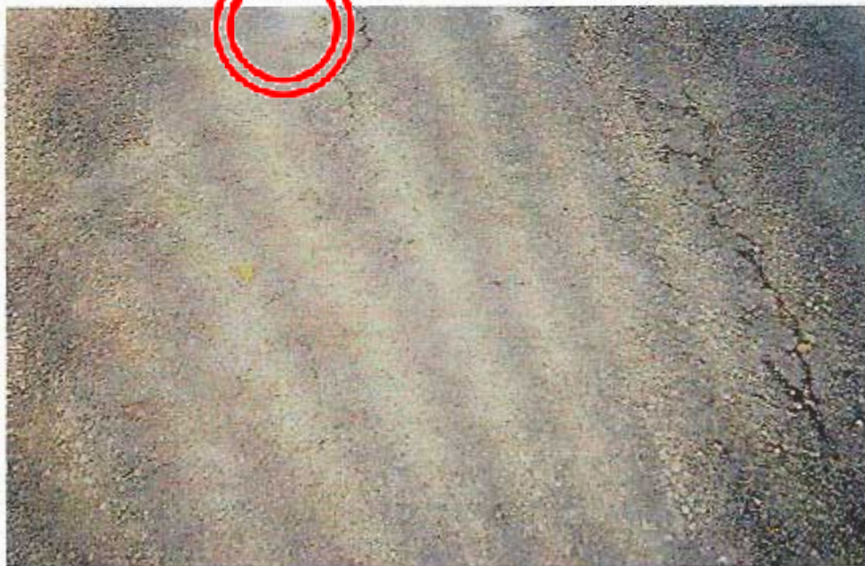
PHOTOGRAPH 6 Entwistle Sand RejuvaSeal Demonstration Project Performance
October 2, 2000 [JJE]

The coarse aggregate continues to be 'locked' in place by the Sand RejuvaSeal and this has reduced the rate of chip seal deterioration. There has been some winter maintenance (plow) chip seal damage (right side of photograph), but the treated chip seal appears to be in good condition, particularly compared to the untreated control.

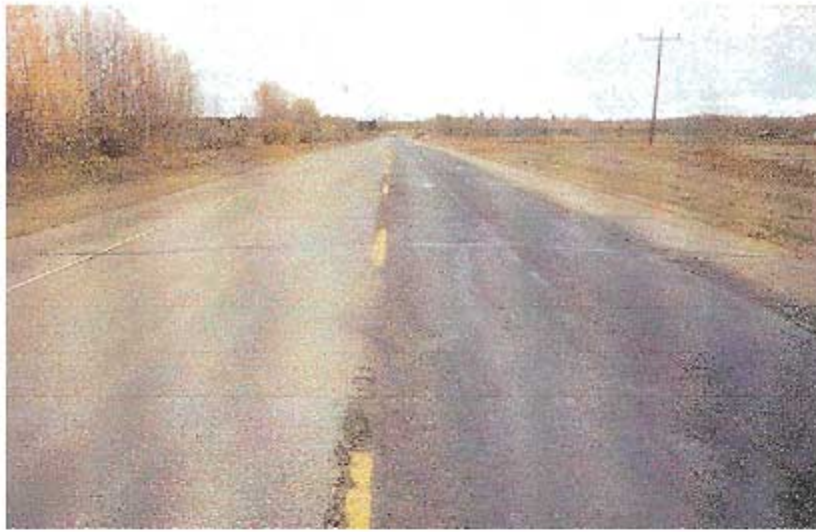
PHOTOGRAPH 7 Entwistle Sand RejuvaSeal Demonstration Project Performance
October 2, 2000 [JJE]

Another general view of the demonstration project one year after the Sand RejuvaSeal application (to the west of Photograph 5). The Sand RejuvaSeal treated chip seal has a good overall appearance throughout (both for 0.27 l/m^2 as shown in Photographs 3 to 8 and 0.23 l/m^2 for a short trial at the east end of the demonstration project), particularly compared to the untreated chip seal that is clearly still deteriorating. The 0.27 l/m^2 treatment has a somewhat better appearance/performance than the 0.23 l/m^2 treatment.

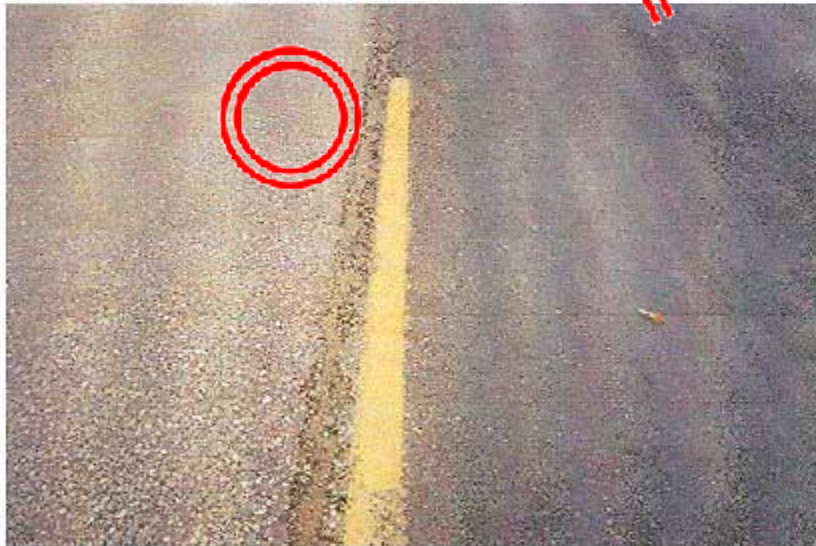
PHOTOGRAPH 8 Entwistle Sand RejuvaSeal Demonstration Project Performance
October 2, 2000 [JJE]

Close-up view of the Sand RejuvaSeal treated chip seal (right side of the photograph) and the untreated control (left side of photograph) in Photograph 7 area. The action of the Sand RejuvaSeal in retaining ("locking") the chip seal coarse aggregate shows up quite clearly. The retention of chip seal coarse aggregate results in the desired reduction in the rate of chip seal deterioration.
