RJSeal[™] Application Century Street, DaQing, HeilongJiang, Peoples Republic of China

June 2003

Re: Commercial Application of RJSealTM on Century Street, DaQing.

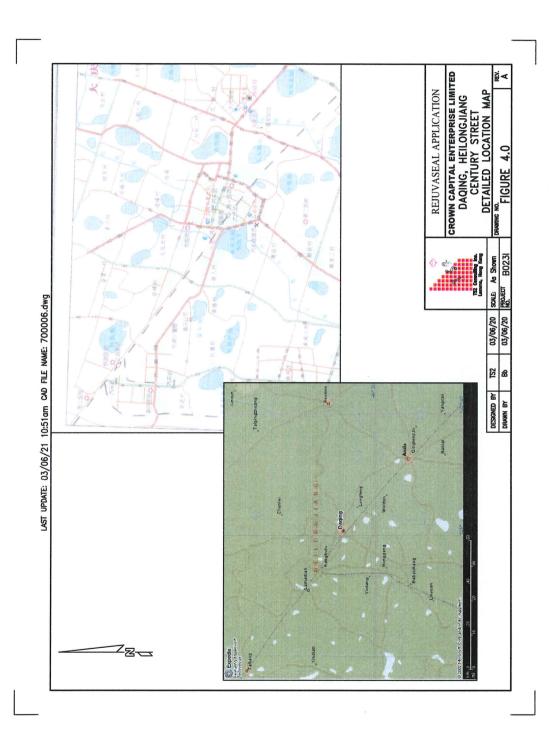
On July 24, 2003 a test strip in the westbound lane of Iron Man Street (continuation of Century Street) an eight lane street with service road on either side, was treated with RJSealTM. The test strip at the curb lane and adjoining lane segment was selected for an application of RJSealTM at the following geographic location:
